**Gulfstream Aerospace Corporation**

**Party Submission**

**Arizin Ventures LLC – SK Travel LLC – Operated  
Aircraft N121JM**

**ERA14MA271**

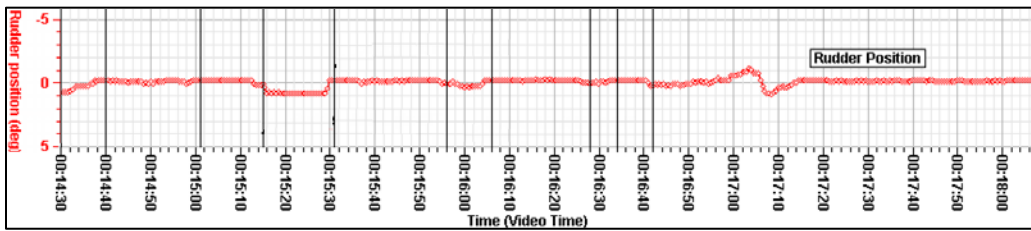
FIGURE 14 – RUDDER POSITION (GUST LOCK ON TAXI TEST)

During normal taxi operations, the crew can use manual inputs to the NWS tiller, mounted on the LH side console, to steer the aircraft. Even while using the NWS system, rudder movements during taxi are expected from random aircraft vibrations and from the yaw damper. The yaw damper system attempts to compensate for changes in aircraft yaw attitude by commanding rudder deflections in the opposite direction (to maintain intended flight path). Even with the gust lock system engaged, Gulfstream taxi testing showed that rudder movement is possible, although with a very limited range (see Figure 14).

Based on the NTSB FDR Factual Report, the accident aircraft utilized rudder travels that range from a 4 degree total band during the previous taxi, to a 7 degree band during the previous successful takeoff (see Figure 15). However, during the accident aircraft's attempted takeoff, the rudder travel was within a 2 degree total band during taxi, attempted takeoff, and during the rejected takeoff (see Figure 16). This limited rudder movement is additional evidence that the gust lock was engaged during this timeframe.

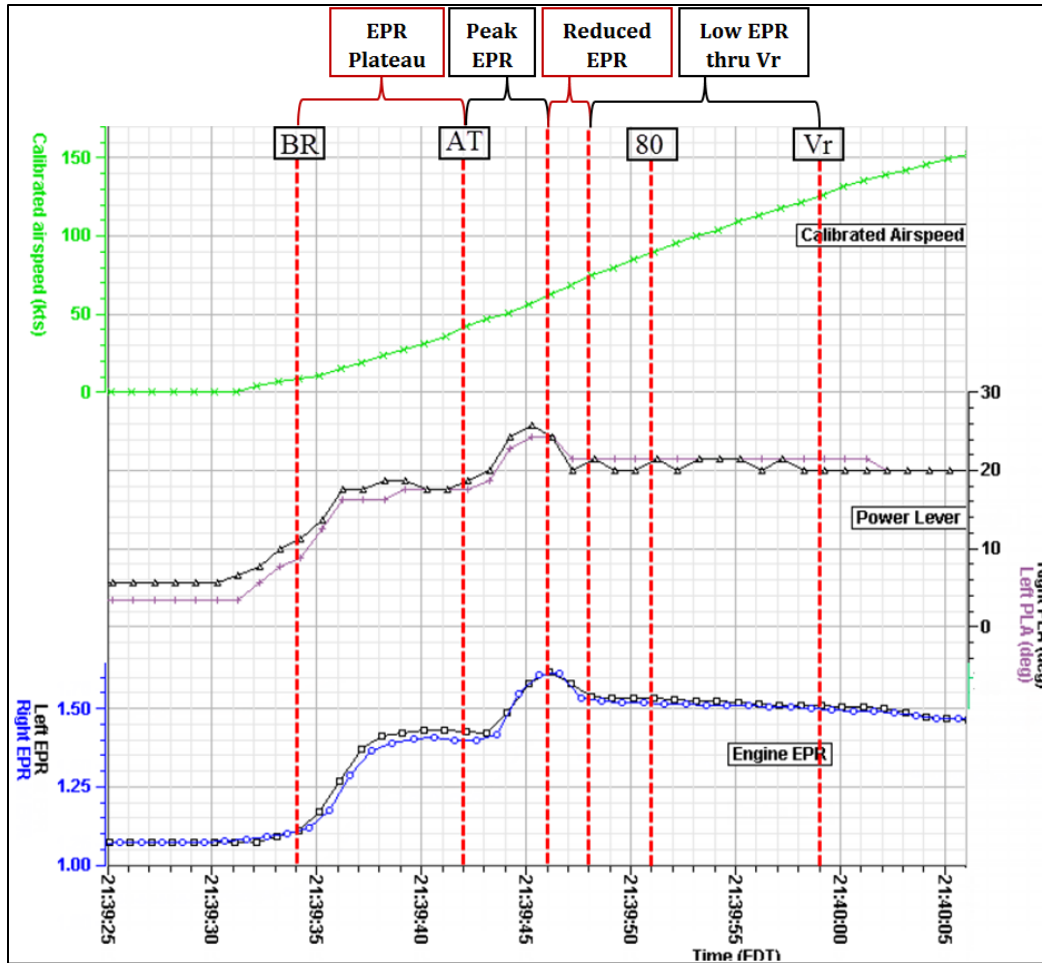
FIGURE 18 – FDR TAKEOFF ROLL (PRE Vr)

Other than one statement by the PF that he **“Couldn’t get \* \* \* ”**, the CVR provides little insight into the crew’s actions from the beginning of the takeoff roll until the PF unsuccessfully attempted to rotate the aircraft at Vr. The FDR plot of the PLA and EPR, parameters provide the most insight into the status of the gust lock system and the crew’s awareness of that status (see Figure 18). The following sections discuss the most probable explanation of the pertinent FDR parameters based upon extensive testing and analysis.

The accident FDR data are split into different segments in an effort to explain the activity occurring in the cockpit during this critical phase of takeoff. The segments are chronologically organized as follows:

- Initial PLA/EPR Plateau: An initial period of constant PLA and EPR, between brake release and AT engagement, during manual throttle command.
- Peak PLA/EPR: The PLA and EPR parameters reach a momentary peak.
- Reduction in PLA/EPR: The PLA and EPR suddenly reduce when power should be increasing.
- Low EPR thru Vr: The reduced PLA and EPR remain in their reduced state thru Vr. The 80 kt call occurs during this segment.

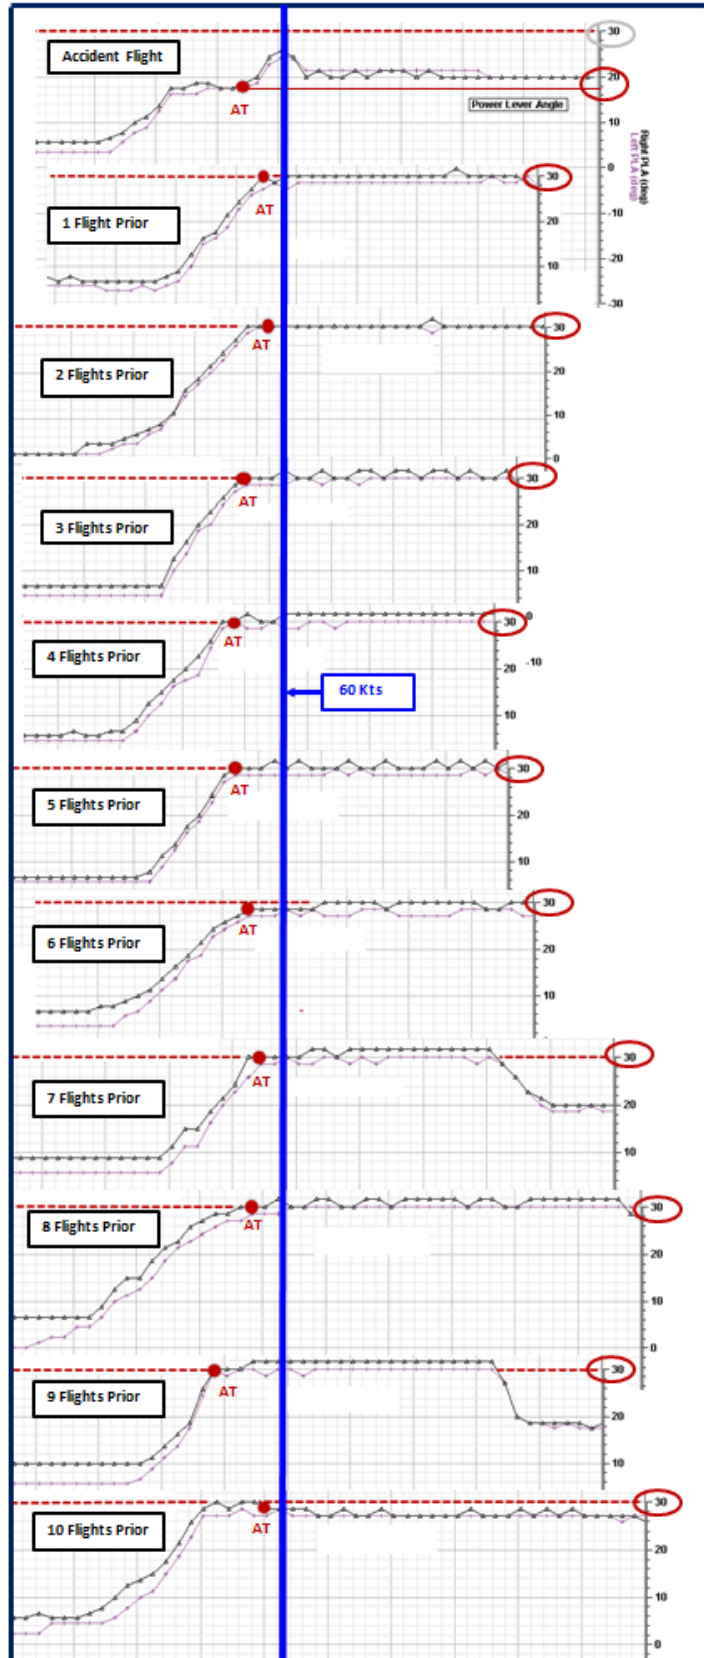
FIGURE 20 – CREW THROTTLE ADVANCE TECHNIQUE-PLA vs. TIME (FDR ADDENDUM #2)

QAR data for the ten previous takeoffs was provided by the NTSB (Reference 20). The prior ten takeoffs demonstrate the crew's<sup>10</sup> typical throttle advancement technique (manual advancement of the throttles to RATED EPR and subsequent AT engagement). Figure 20 overlays the previous takeoffs with the accident takeoff attempt, aligning each graph around the 60 kts calibrated airspeed ("KCAS") line (when the AT 'HOLD' mode activated). The timing and achieved PLA at AT engagement can be compared for each graph.

It should also be noted that the timing of the AT activation, unlike the previous ten takeoffs, occurred during this period of low PLA/EPR setting. On those previous takeoffs, AT was never engaged until the target PLA/EPR had already been achieved.

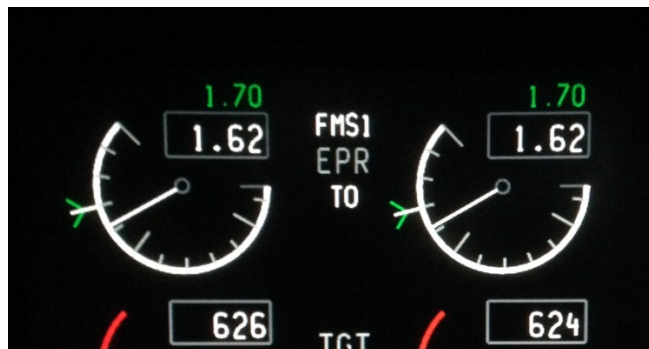
FIGURE 26 –SIMULATED MOMENTARY ACCIDENT PEAK EPR VALUE BEING ACHIEVED

Based on this information, it is reasonable to conclude that the crew was targeting a RATED EPR of 1.70 for this takeoff. The FDR data shows that the peak EPR of 1.62 was reached at about 62 knots, but by 70 knots and less than 2 seconds later, it had reduced to 1.53. As previously noted, the crew likely acknowledged the difficulties in achieving EPR, but there is no subsequent evidence in the CVR of the crew either verbalizing or noticing the power reduction. There is also no indication on the FDR of any action being taken to correct the low EPR by disconnecting the AT system and manually increasing power. Figure 24 below shows the data from the FDR and the absence of PLA inputs.

Figure 26 shows what the crew would have seen at the momentary peak EPR (1.62) compared to the 1.70 RATED EPR target.

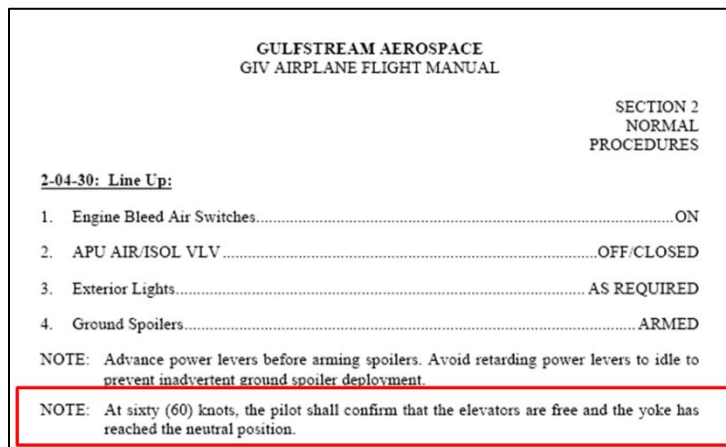
**FIGURE 28 – AFM 60 KT FCS CHECK**

The AFM contains additional notes following Step 4 in Section 2-04-30 that call for a specific check to be performed by the pilots during the takeoff run (see Figure 28). The FDR shows there is no elevator control surface movement at 60 kts.

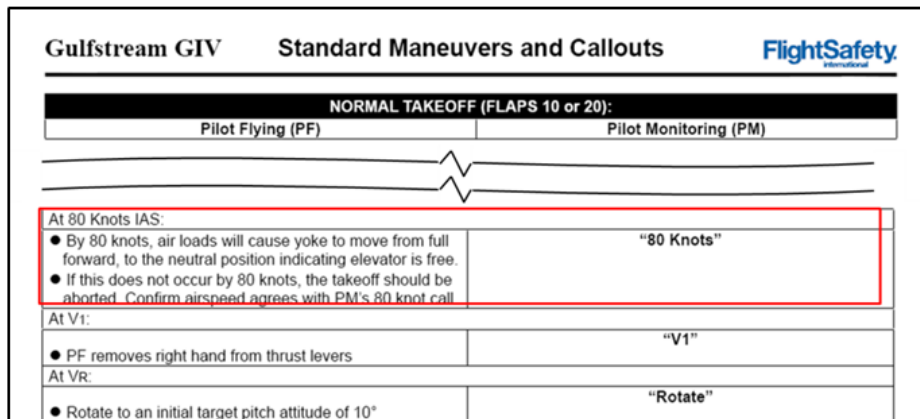
**FIGURE 29 – FSI 80 KT FCS CHECK**

The FDR recording shows that the elevator control surfaces never moved from the full trailing edge down position which corresponds to the yoke remaining in the full forward position in the cockpit during the attempted takeoff at this and higher speeds.

The CVR transcript shows the pilot in the right seat making the “80 knots” call but there is no indication from either pilot that they are recognizing or responding to the yoke remaining uncharacteristically in the full forward position or that the yoke has failed to “float” to the neutral position. There is no takeoff abort call from either pilot at this point.

FDR data from the prior flight and QAR data from the prior 176 flights as reported by the NTSB, show that on this aircraft, the elevators began moving at 60-80 kts during previous takeoff rolls. Given this data, the crew should have noticed this anomalous condition because the control column would have been 5-6 inches further forward than would have been expected.

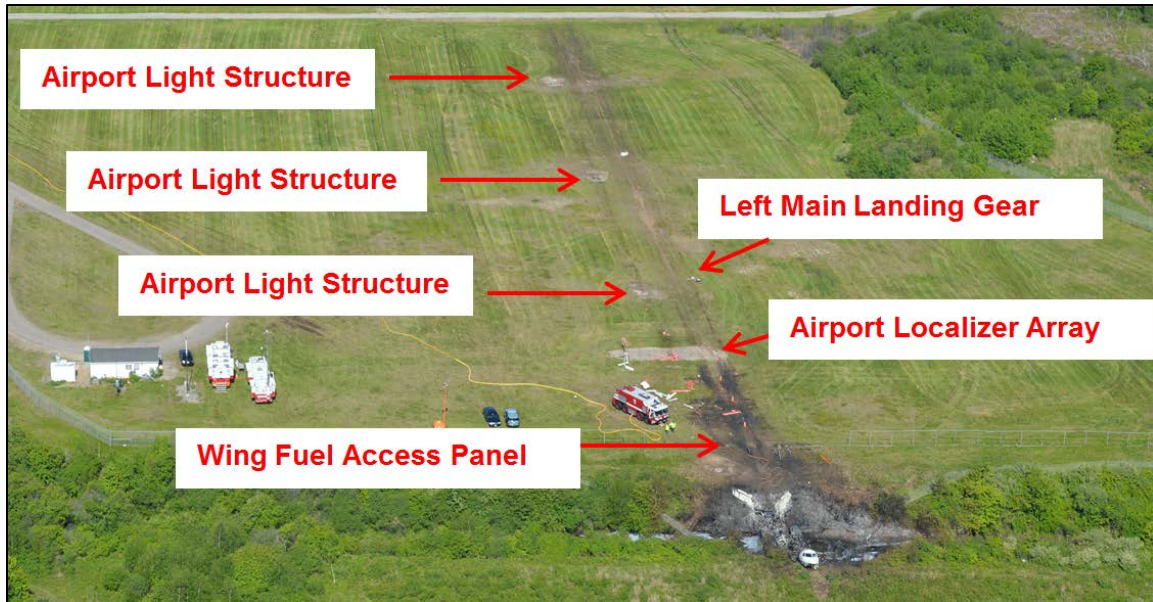
FIGURE 33 – OVERVIEW OF WRECKAGE PATH

The ruts formed by the main gear were approximately 40 feet in length and became abruptly shallower as the landing gear began collapsing. The rut from the left main gear measured 16 inches deep in one of its deeper locations. The nose gear rut was approximately 85 feet long (see Figure 33).

From the initial impact location and to the point of impact with the ground localizer antenna array, there is no evidence of fuel spillage (see Figure 33).

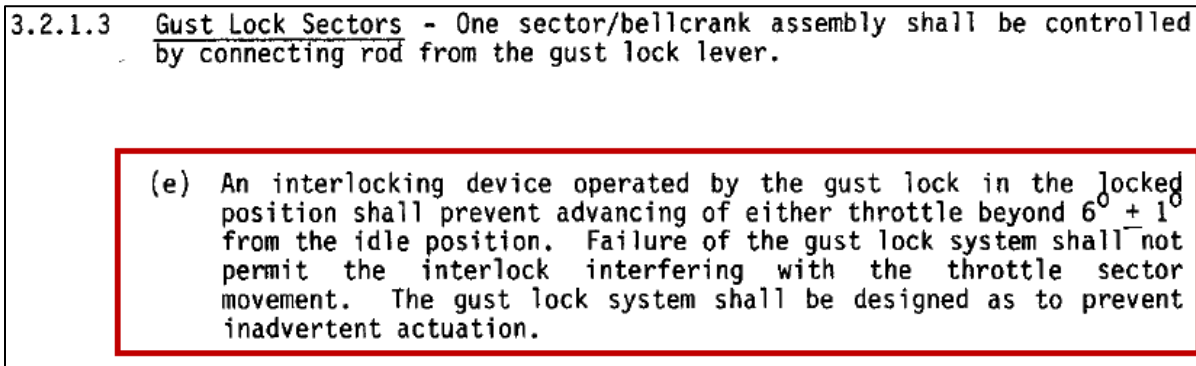
FIGURE 36 – GUST LOCK SPECIFICATION EXCERPT (1159SCF451)

The "design and construction requirements" section of this SCD contained a requirement that stated: "an interlocking device operated by the gust lock in the locked position shall prevent advancing of either throttle beyond  $6^\circ \pm 1^\circ$  from the idle position" (see Figure 36).

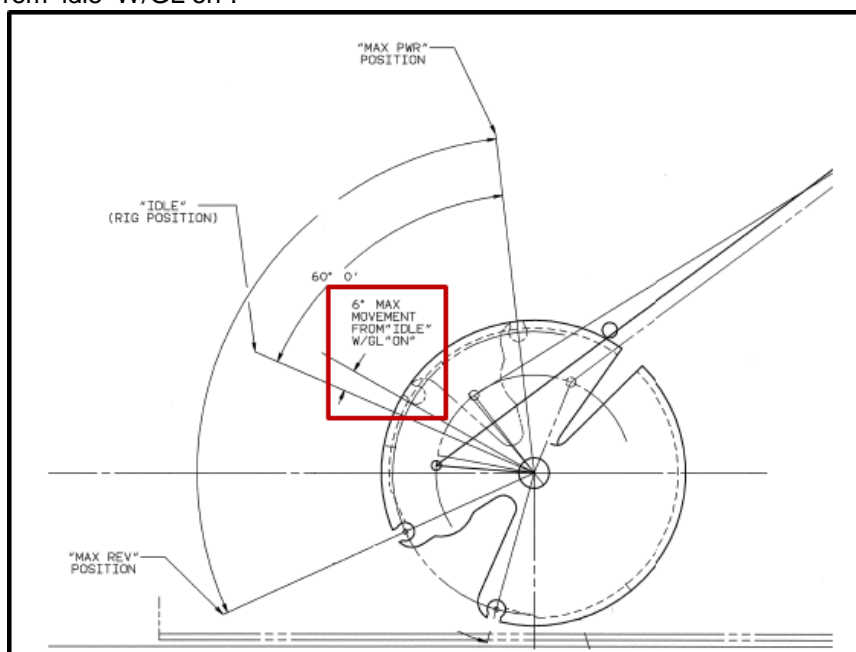
FIGURE 37 - GUST LOCK SPECIFICATION EXCERPT (1159SCF450)

Drawing 1159SCF450 also contains a diagram defining the operating range requirements of the power lever sheaves with the gust lock handle assembly positioned to its ON and OFF positions. The drawing (see Figure 37) shows the gust lock ON position with an operating range requirement of: "6° max movement from 'idle' W/GL on".

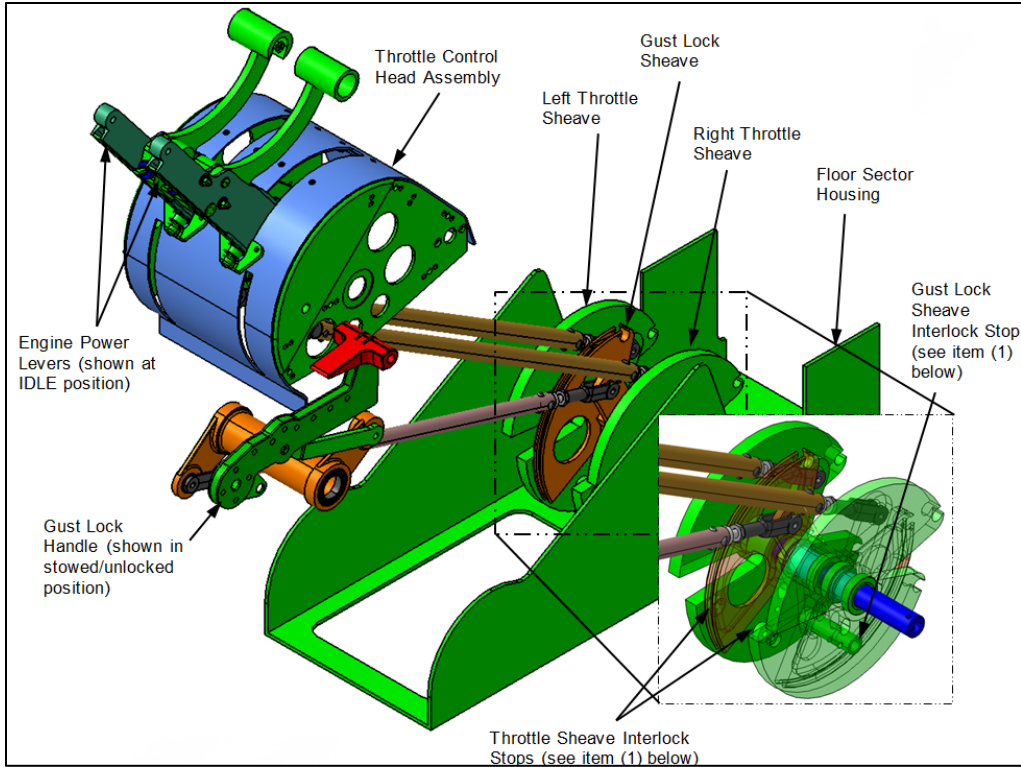
FIGURE 38 – INTERNAL PEDESTAL MECHANISMS (THROTTLES, GUST LOCK, INTERLOCK)

As documented in the NTSB Airworthiness Factual Report, there is a potential for a maximum of approximately 23 degrees of TLA from the power lever rigged idle position with gust lock in the engaged position for a properly rigged aircraft at the worst-case tolerance conditions (and also including the designed 6° +/-1° gap between the gust lock and throttle interlock stops). This combination of tolerances is highly unlikely, but the analysis was done to demonstrate the maximum possibility.

- (1) The designed gap of approximately 6° between the gust lock interlock stop and the throttle interlock stop (see Figure 38 above). This feature alone gives a starting TLA of approximately six degrees (design requirement is 6° +/- 1°, given in Gulfstream 1159SCF451) above the rigged idle position. This feature is intentional to allow some throttle motion with gust lock engaged, but not allow enough engine thrust for takeoff before encountering the interlock hard stops.
- (2) The design clearance and tolerances between the gust lock handle internal locking pin and the interfacing detent slot wall (see Figure 39 above). This feature can allow in excess of 7° of additional TLA with worst-case tolerances applied.
- (3) The tolerances in the gust lock handle internal slider mechanism (see Figure 39 above). This feature can allow approximately 1° of additional TLA.
