**Party Submission to the
National Transportation Safety Board**

**Investigation of the Airbus Helicopters A350B2 Accident
East River, NY, March 11, 2018**

ERA18MA099

**Presented by Jillian O'Brien,
Party Coordinator for
NYONair LLC and FlyNYON LLC**

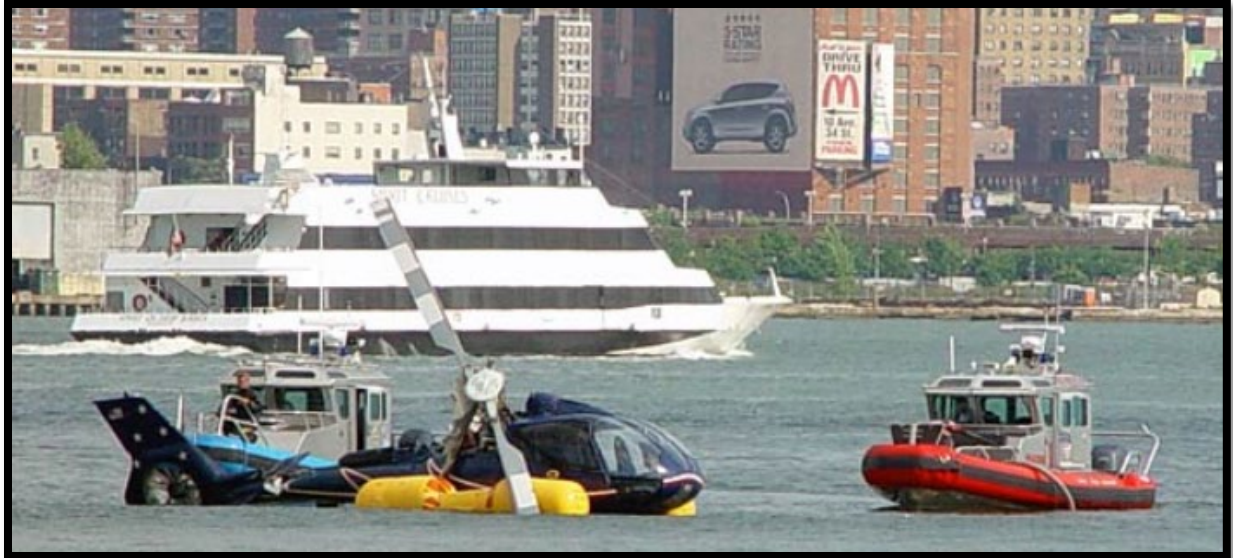
Drowning is a significant post-impact hazard in many otherwise survivable water landings.⁴¹ As such, emergency flotation systems are critical safety equipment relied on by operators, pilots and passengers flying over water. When functioning as intended, emergency flotation systems have made it possible for helicopter occupants to safely evacuate after water landings without injury. For example, on July 7, 2007, a Liberty Helicopters Eurocopter EC-135, conducting a sightseeing tour over New York City, experienced a rotor blade fracture and separation midflight.⁴² The pilot made an emergency autorotation onto the water and activated the emergency flotation system. The helicopter landed upright on its floats and remained upright in the water for hours and was towed and recovered from the river. The pilot and seven passengers were unharmed.

Figure 12: Photograph of Liberty EC-135 following the July 7, 2007 emergency water landing

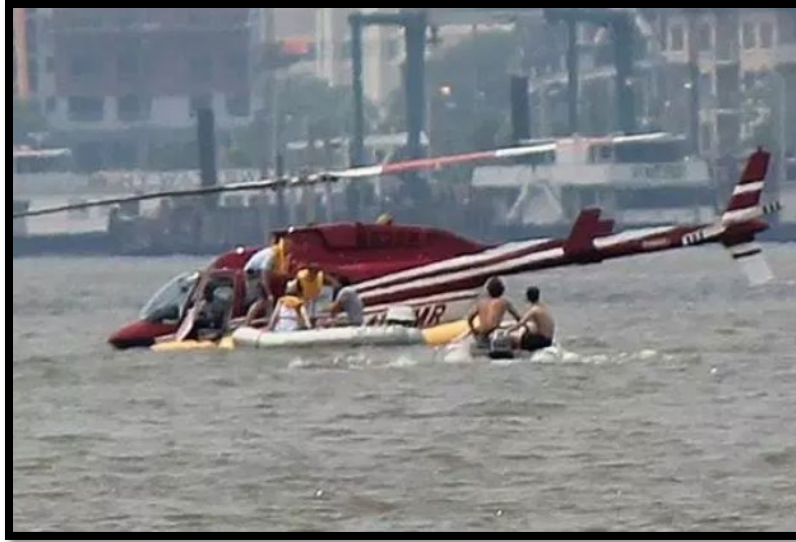
Later, on June 30, 2013, a Bell 206 helicopter operated by New York Helicopter experienced a loss of engine power during a sightseeing tour over New York City.⁴³ The pilot performed an emergency autorotation to the Hudson River and deployed the skid-mounted flotation system. The flotation system functioned properly and kept the aircraft upright and stable in the water on the six inflated float bags.⁴⁴ The pilot and four passengers remained inside the helicopter until help arrived, as seen in the photograph below. All were unharmed. The helicopter was towed to a nearby marina and remained afloat for hours after the incident until it was recovered from the river.

Figure 13: Photograph of passengers evacuating the New York Helicopter Bell 206 following the June 30, 2013 emergency water landing

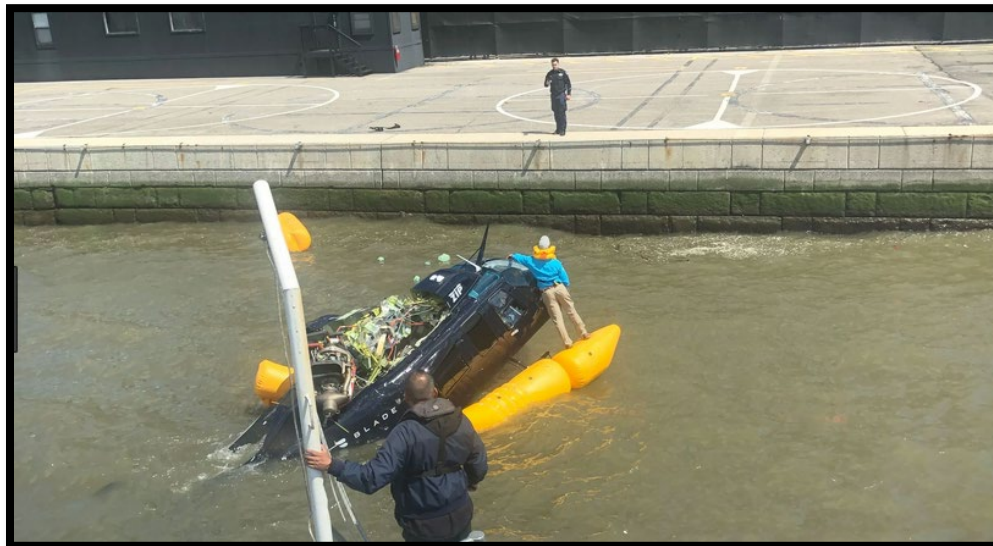
Also, in 2019, following the subject accident, a ZIP Aviation Bell 206 helicopter experienced a tail rotor failure and made an emergency water landing on the Hudson River. The pilot deployed the emergency flotation system seconds before impact. The helicopter remained afloat until hours later, when the aircraft was recovered from the water. The pilot, shown below standing on the skid, was unharmed.

Figure 14: Photograph of pilot evacuating the Zip Aviation Bell 206 following the May 15, 2019 emergency water landing
