Subject: Gulfstream Submission to NTSB Investigation ERA111A316

Gulfstream G200 SN 165 Incident Summary & Conclusions

Root Cause Analysis for G200 S/N 165

Collapsed Landing Gear, During Landing

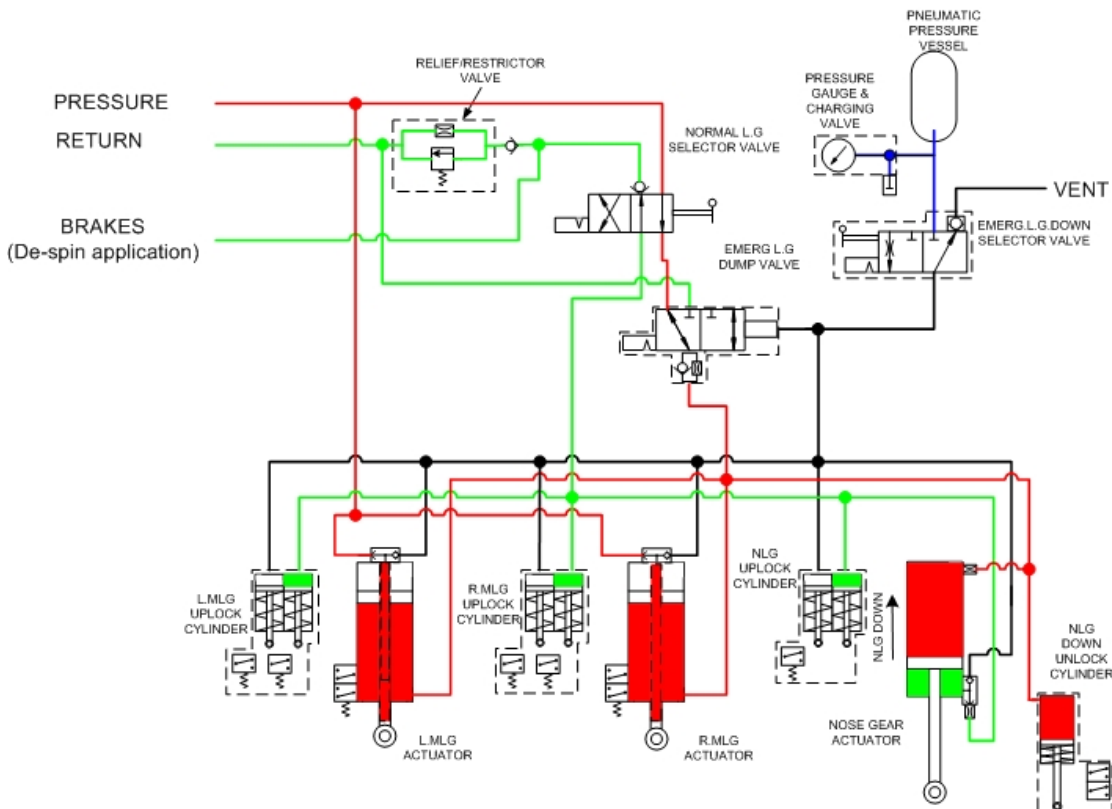
Figure 1-L/G Retracted Hydraulic Schematic

The NLG in up position is locked up by means of spring loaded mechanical load.

The L/Gs are continually pressurized toward retract direction during flight (as long as gear handle is in up position)

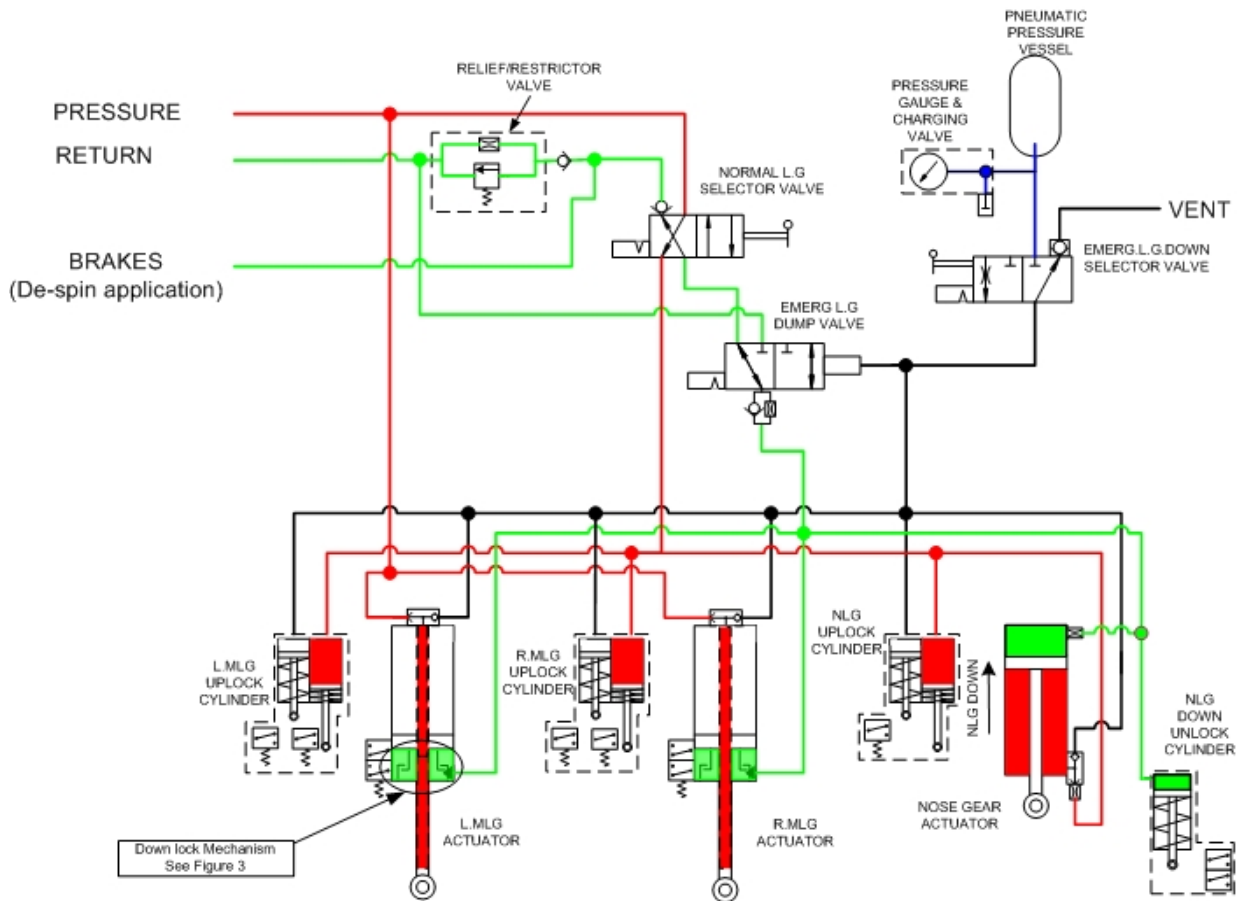
Figure 2-L/G Extended Hydraulic Schematic

When L/G control handle is placed in the down position, pressure is applied to unlock the L/Gs uplocks (all three) while retract chambers of the MLG actuators are connected to return pressure, The MLG extend chambers which continually connected to high pressure then pushes the MLGs toward down position.

On the NLG actuator, high pressure is ported to retract chamber while extend chamber is connected to return system as a result, NLG actuator retracts and NLG extends

The down lock segment threshold ATP requirement for unlocking is ~240 psi (min) for no load condition, as a result, if the back pressure of the system is higher than the value above, down lock segment will remain triggered (unlocked) continually regardless of operation mode (normal or emergency).

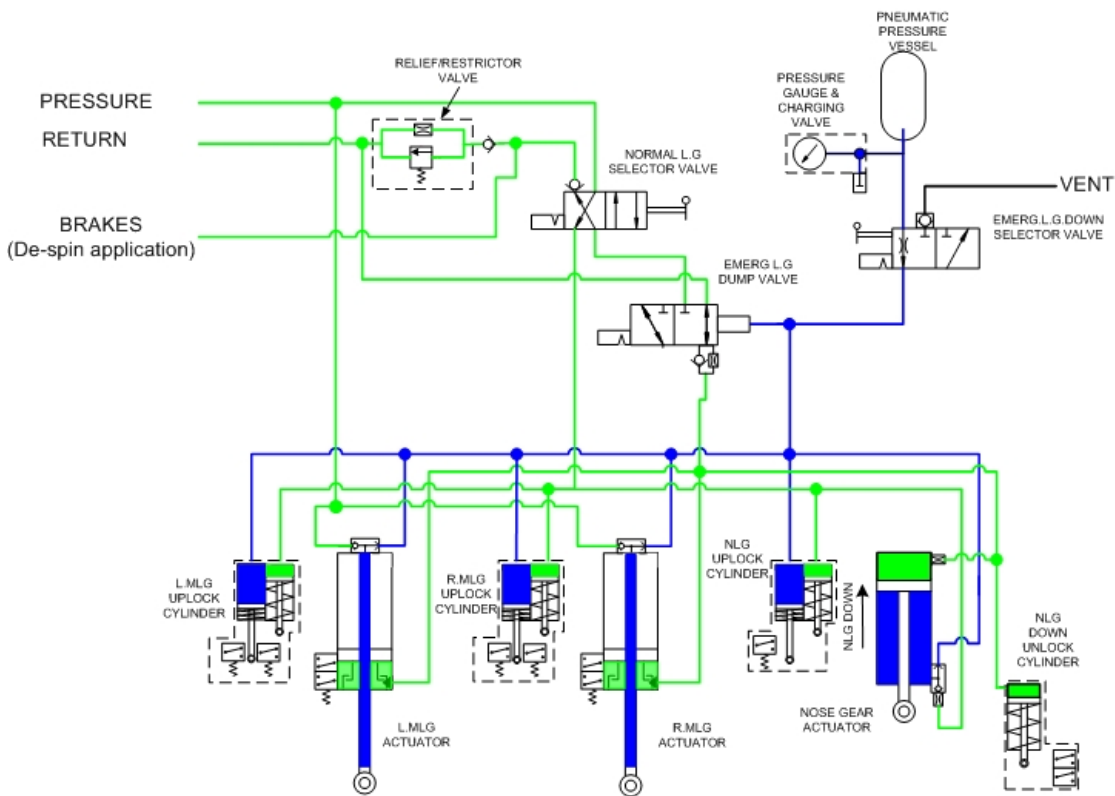
Figure 4- L/G Emergency Extension Hydraulic Schematic

Emergency extension of the L/Gs is accomplished by placing the landing gear control handle in down position and then releasing and pulling the emergency gear down handle, which in its turn opens emergency selector valve to supply nitrogen pressure to extend the L/Gs. In addition, nitrogen pressure triggers the L/Gs dump valve which connects the L/Gs actuators retract chambers to return pressure in order to by-pass the L/G selector valve and De-spin restrictor relief.

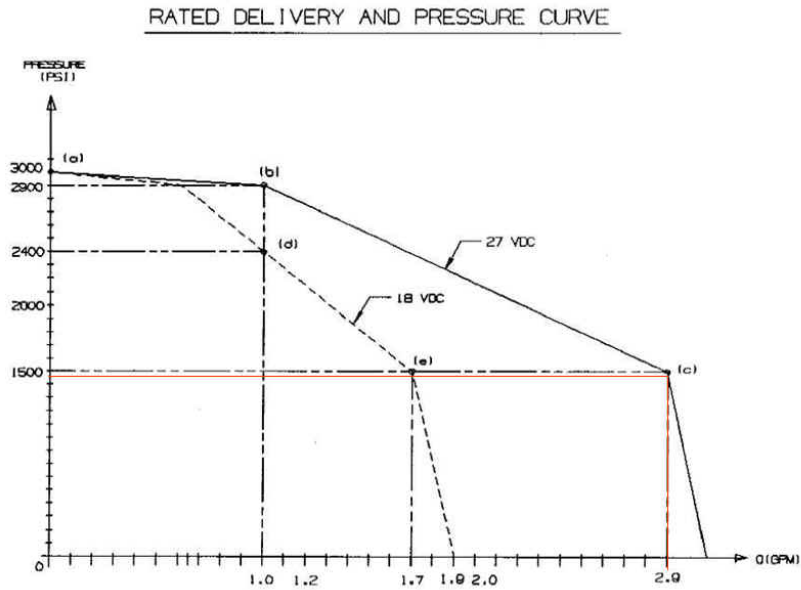
Figure 9-G200 EMP flow vs. pressure curve

Pump with flat cut off characteristics (such as the EDP) will suffer from a rapid discharge pressure drop upon reaching its maximum flow delivery capabilities. System pressure of ~1400-1500 psi indicates that the EDP was at the flat cut off curve after gears were selected down (before engine throttling to IDLE), in these initial conditions, after engine RPM was reduced to IDLE, the EDP would have likely to suffer from additional discharge pressure drop.
