**USAir 1016 SUBMISSION
TABLE OF CONTENTS**

I. EXECUTIVE SUMMARY

At approximately 18:42 local time (22:42 UTC) on July 2, 1994, a DC-9-31 operating as USAir flight 1016 crashed while executing a go-around from the ILS approach to 18R at Charlotte-Douglas Airport (CLT) in Charlotte, North Carolina. At the time of the accident, the aircraft was embedded in an extremely heavy localized rainshower.

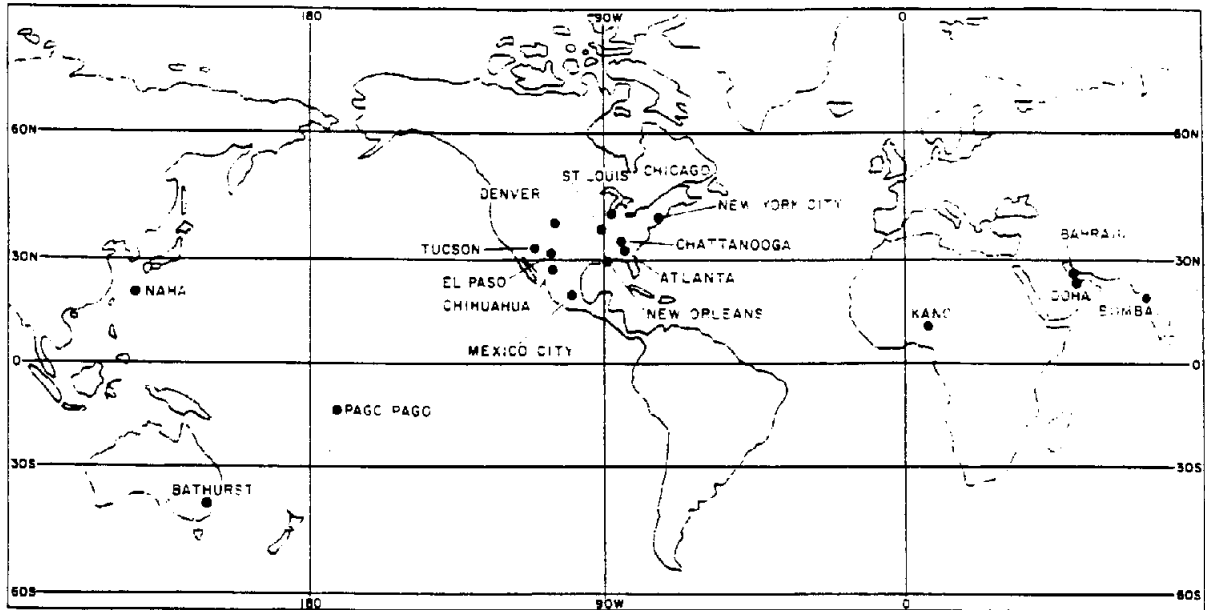
Figure 1. Pre - 1985 microburst related air crashes [from Fujita (1985)]

Microbursts are not confined to the U.S. Locations of pre-1985 microburst related accidents are shown in Figure 1, on page 21 (taken from Fujita, 1985).

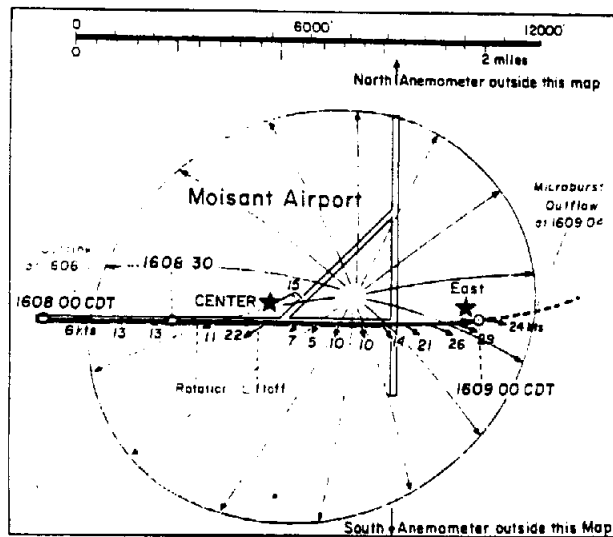
Figure 2. The New Orleans Microburst of July 9, 1982 [from Fujita (1992a)]

Figure 2 shows the relationship of the microburst outflow to the airport and the sensors. At the time of the crash, the microburst outflow was less than 3 kilometers (2 miles) in diameter [less than one mile in radius] and less than one minute old.

Fig. 4.1-7 The PAA 759 microburst on 9 July 1982 at Moisant Airport, New Orleans, Louisiana. This microburst intensified very rapidly while the aircraft was climbing above Runway 10.

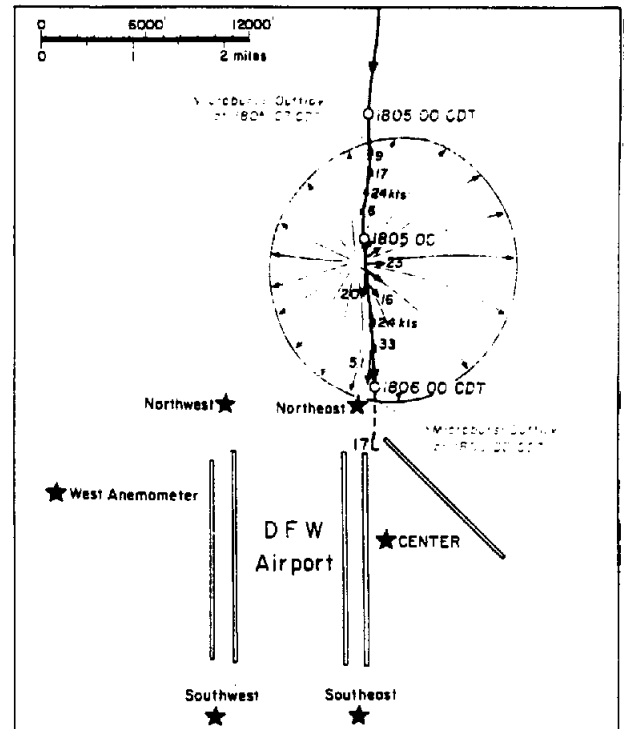
Figure 3. The DFW Microburst of August 2, 1985 [from Fujita (1992a)]

Figure 3 shows the relationship of the microburst to the airport and the sensors.

Fig. 4.1-9 The Delta 191 microburst which escaped detection by the six anemometers encircling the runway area. The microburst touched down outside the airport and expanded quickly into the runway area.

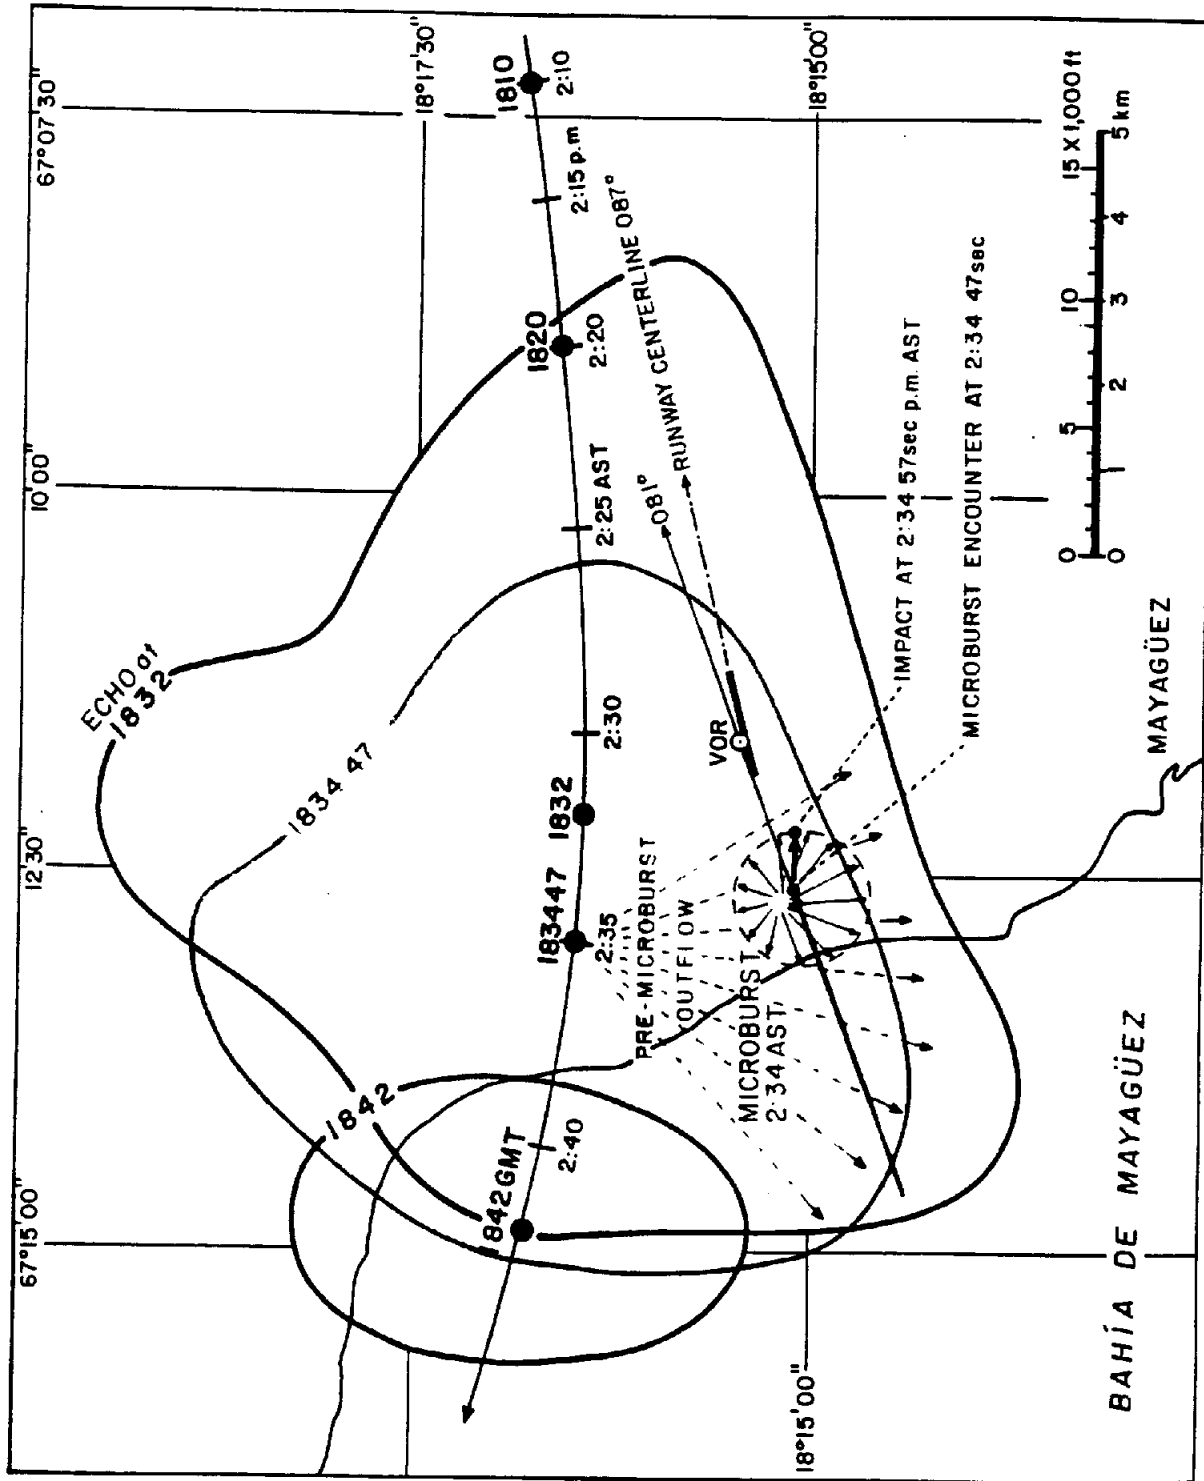
Figure 7. Motion and collapse of the Mayaquez Microburst on June 7, 1992 [from Fujita, et al (1992b)]

Figure 7 is a replica of Figure 21 from that report, showing the track of the diminishing radar echo (as indicated in the radar images as the falling high reflectivity passed through the beam height of the San Juan, PR Radar), the mesoscale outflow, and the microburst outflow which was, unfortunately, encountered by a landing commuter aircraft during approach to the Mayaguez Airport.

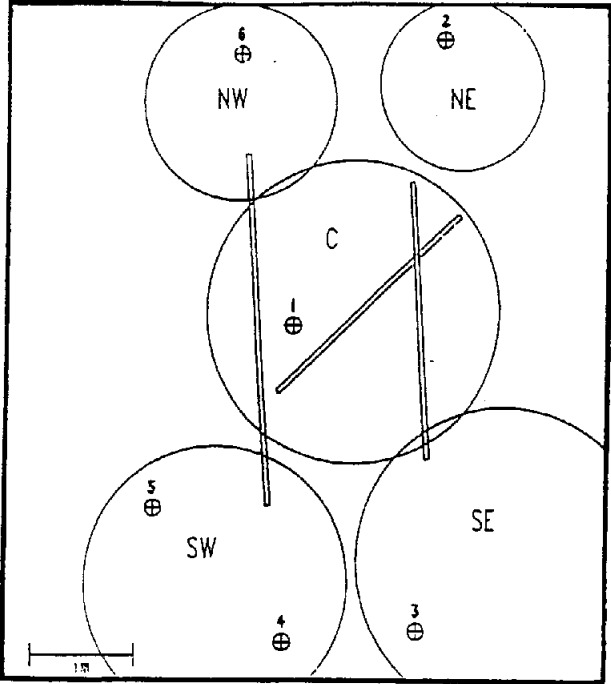
Figure 8. Placement of LLWAS sensors at Charlotte

Initially installed in Charlotte in 1981, the LLWAS System there contained six sensors - as shown in **Figure 8**. All were mounted on telephone poles at various heights of:

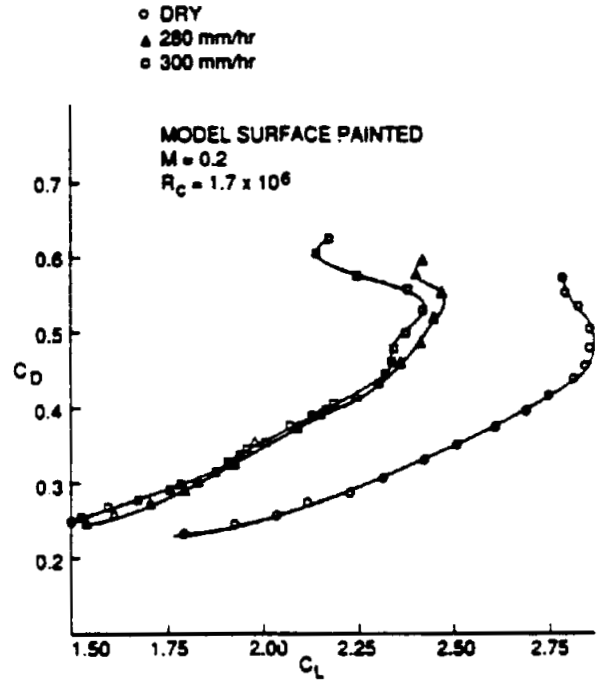
FIG. 7. DRAG COEFFICIENT VERSUS LIFT COEFFICIENT

Figure 7 shows the drag polars obtained under the same test conditions. For a lift coefficient of 1.8, the drag coefficient was increased by 30% for the wet cases. At the higher lift coefficient of 2.3, the drag penalty was up to 43% higher under wet conditions.

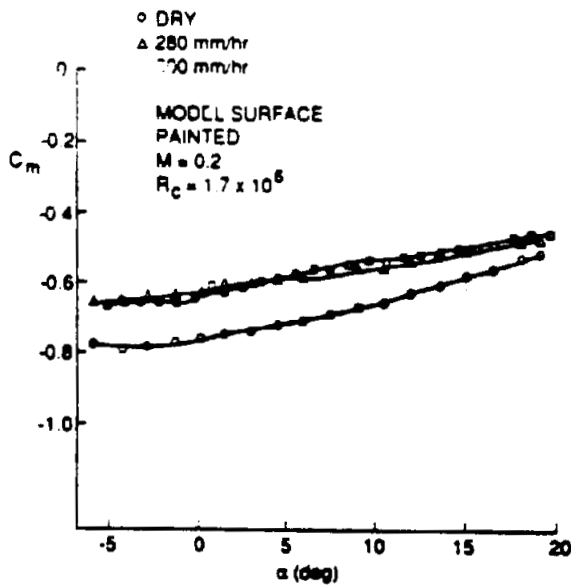
FIG. 8. PITCHING MOMENT COEFFICIENT VERSUS ANGLE OF ATTACK

Figure 8 shows the variation of pitching moment coefficient with angle of attack. The changes due to increasing angle of attack is more gradual under wet conditions. At higher angles of attack, the curves tend to converge to the same value under wet or dry conditions. Pitching moment is significantly increased by the presence of water.

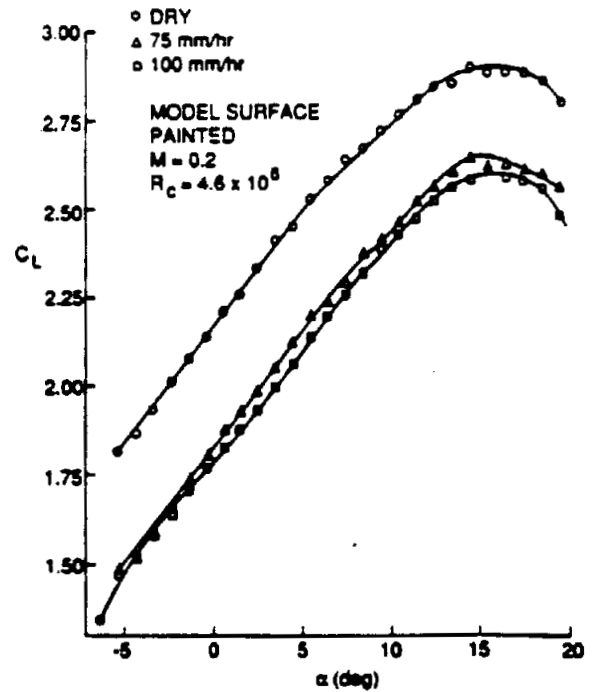
FIG. 9. LIFT COEFFICIENT VERSUS ANGLE OF ATTACK

Figure 9 shows the lift curves obtained at a chord Reynolds number of 4.6×10^6 . The wet condition results were obtained at lower rain rates, 75 mm/hr and 100 mm/hr than the first case. The effect of the change in rain rate results in clearly measurable differences in C_l . It will be noted that the lift curves are now much smoother as compared with the lower Reynolds number case. A maximum lift coefficient of about 2.65 is obtained at an angle of attack of about 15° under wet conditions, while a maximum lift coefficient of 2.9 is obtained under dry condition at an angle of attack of about 16° . The increase in maximum lift under dry conditions at this higher Reynolds number is to be expected. The reduction of about 9% in maximum lift coefficient under wet condition is observed. It should be noted that the decrease in lift under wet conditions is constant over the entire angle of attack range which is not the same as in Case 1.

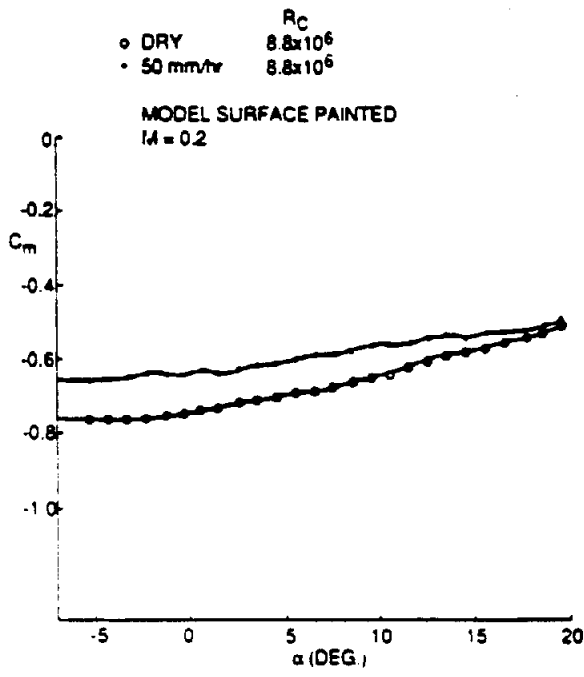
FIG. 14: PITCHING MOMENT COEFFICIENT VERSUS ANGLE OF ATTACK

The pitching moment coefficient curves are shown in Figure 14. At 0° , there is a 17% difference in the pitching moment coefficient between 'wet' and 'dry'. The difference is reduced to a 7% difference at 19° .

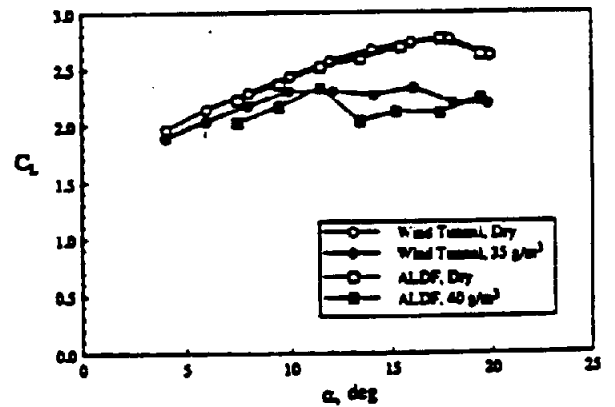
Fig. 6. Comparison of lift coefficient data from wind tunnel and ALDF tests.

Preliminary results of the ALDF full-scale tests show that the maximum lift coefficient and stall angle of attack are reduced in the same manner as the wind tunnel test results. A comparison of the wind tunnel and full-scale lift curves at similar rain rates is shown in figure 6. The agreement between the data sets may indicate a lack of significant scaling effects at these conditions. The ALDF tests are continuing at reduced rain rates to determine the sensitivity to rain rate and the minimum rate at which significant performance penalties exist.

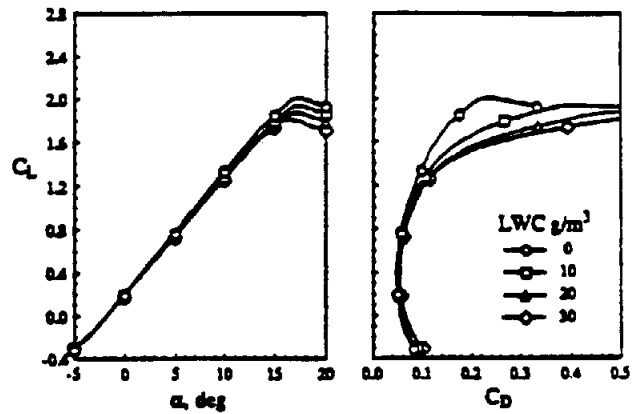
Fig. 10 Heavy rain aerodynamic model for airplane in a take-off configuration. (Flaps 5°, Gear up)

Two examples of the resultant wet airplane aerodynamic model are presented in figures 10 and 11 for a take-off and landing configuration, respectively. The decrease in maximum lift coefficient and stall angle of attack, which was prevalent in the airfoil data is also evident in the airplane model, but to a lesser extent than the high lift section data. There is also a considerable drag increase at the higher lift coefficients.

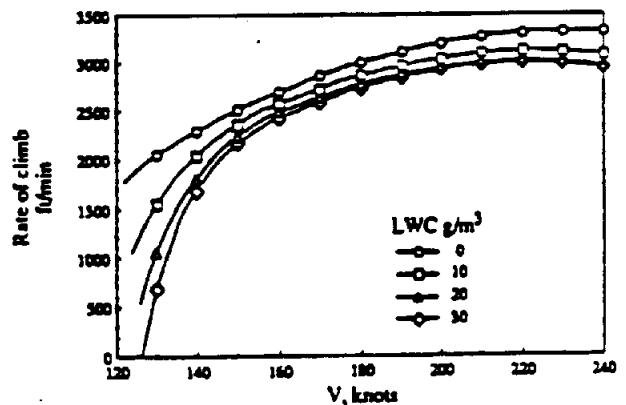
Fig. 12 Effect of heavy rain on climb performance in a take-off configuration.

The performance impact of heavy rain was demonstrated by computing the airplane's climb performance under increasing rain concentrations. Figures 12 and 13 show the steady-state rate of climb as a function of airspeed with rain concentrations of 0, 10, 20 and 30 g/m³, for a take-off and landing configuration, respectively. The take-off and landing configurations were defined as follows:

Figures 12 and 13 show a loss in climb performance of at least 200 ft/min at rain concentrations of 20 g/m³ and greater, for both the take-off and landing configurations. The greatest performance loss occurred at the low speeds where the higher angles of attack were required.

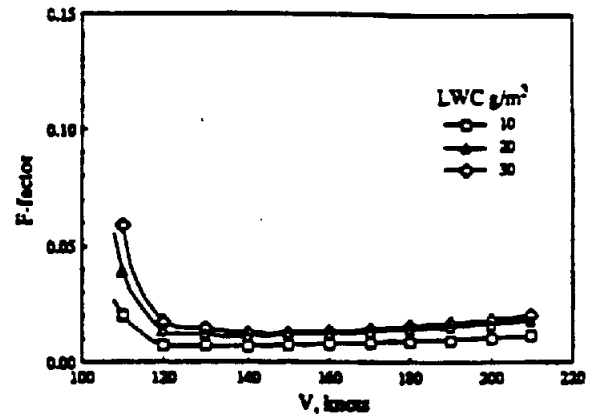
Fig. 16 Heavy rain equivalent F-factor in a landing configuration.

Figure 14 shows the steady-state rate of climb as a function of airspeed at various F-factor values, for the take-off configuration. By cross-plotting figures 12 and 14, an equivalent F-factor curve can be derived for each rain concentration curve. Figures 15 and 16 show the equivalent F-factor as a function of airspeed for the take-off and landing configurations, respectively. For the 20 g/m³ case, the equivalent F-factor was about 0.02 for the majority of the speed range. An F-factor of this magnitude represents 20 percent of the currently accepted wind shear alert threshold. At the low speeds the F-factor was significantly greater. From figure 14, it can be seen that an F-factor of 0.16 or more may result in the airplane being unable to climb or maintain altitude. The 20 g/m³ case therefore represents a loss of at least 12 percent of the climb performance margin of the airplane.

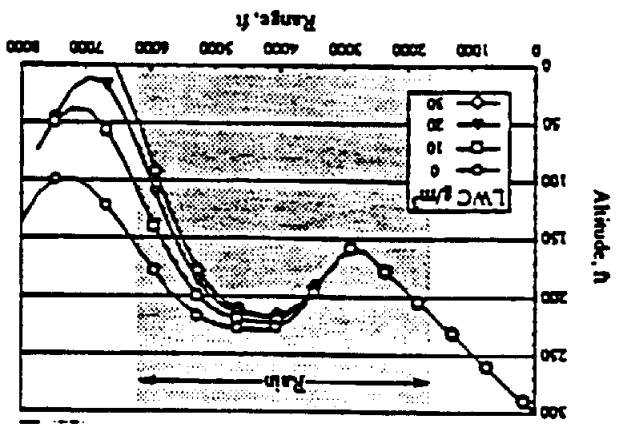
Fig. 20 Effect of heavy rain on wind shear escape performance in a take-off configuration.

The results of the simulated wet microburst encounter are presented in figures 20 and 21 for the take-off and landing cases, respectively. The higher rain concentrations had a considerable impact on the recovery performance of the airplane. At 30 g/m³, the airplane was unable to recover from an otherwise recoverable microburst encounter.
