Carson Helicopters, Inc. is writing to the National Transportation Safety Board regarding the final report and findings of the NTSB on the Sikorsky S61N helicopter crash near Weaverville, California on August 5, 2008. By this letter Carson is hereby filing a Letter of Petition to review the findings in this accident. Carson contends that, A) there is new and additional information regarding contaminants in the fuel system that should be given careful consideration, and B) the Board was not given complete and accurate performance information for review in reaching its findings regarding aircraft flight performance.

**Comparison of four sets of FCU-PRV
Particle Contamination and E-Poly fuel
pump coating**

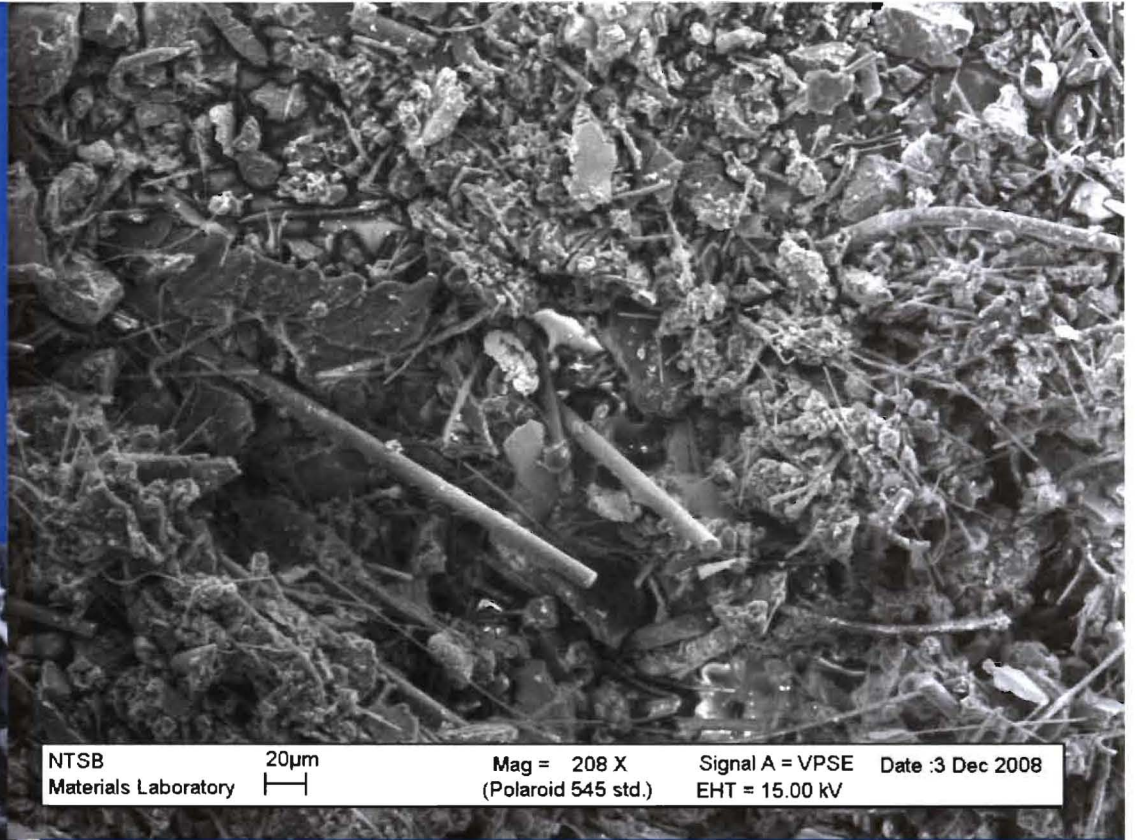
N612AZ PRV - 208X

Accident Helicopter N612AZ # 2 FCU-PRV 208 X

NTSB Materials Laboratory 20µm Mag = 208 X Signal A = VPSE Date :3 Dec 2008 EHT = 15.00 kV

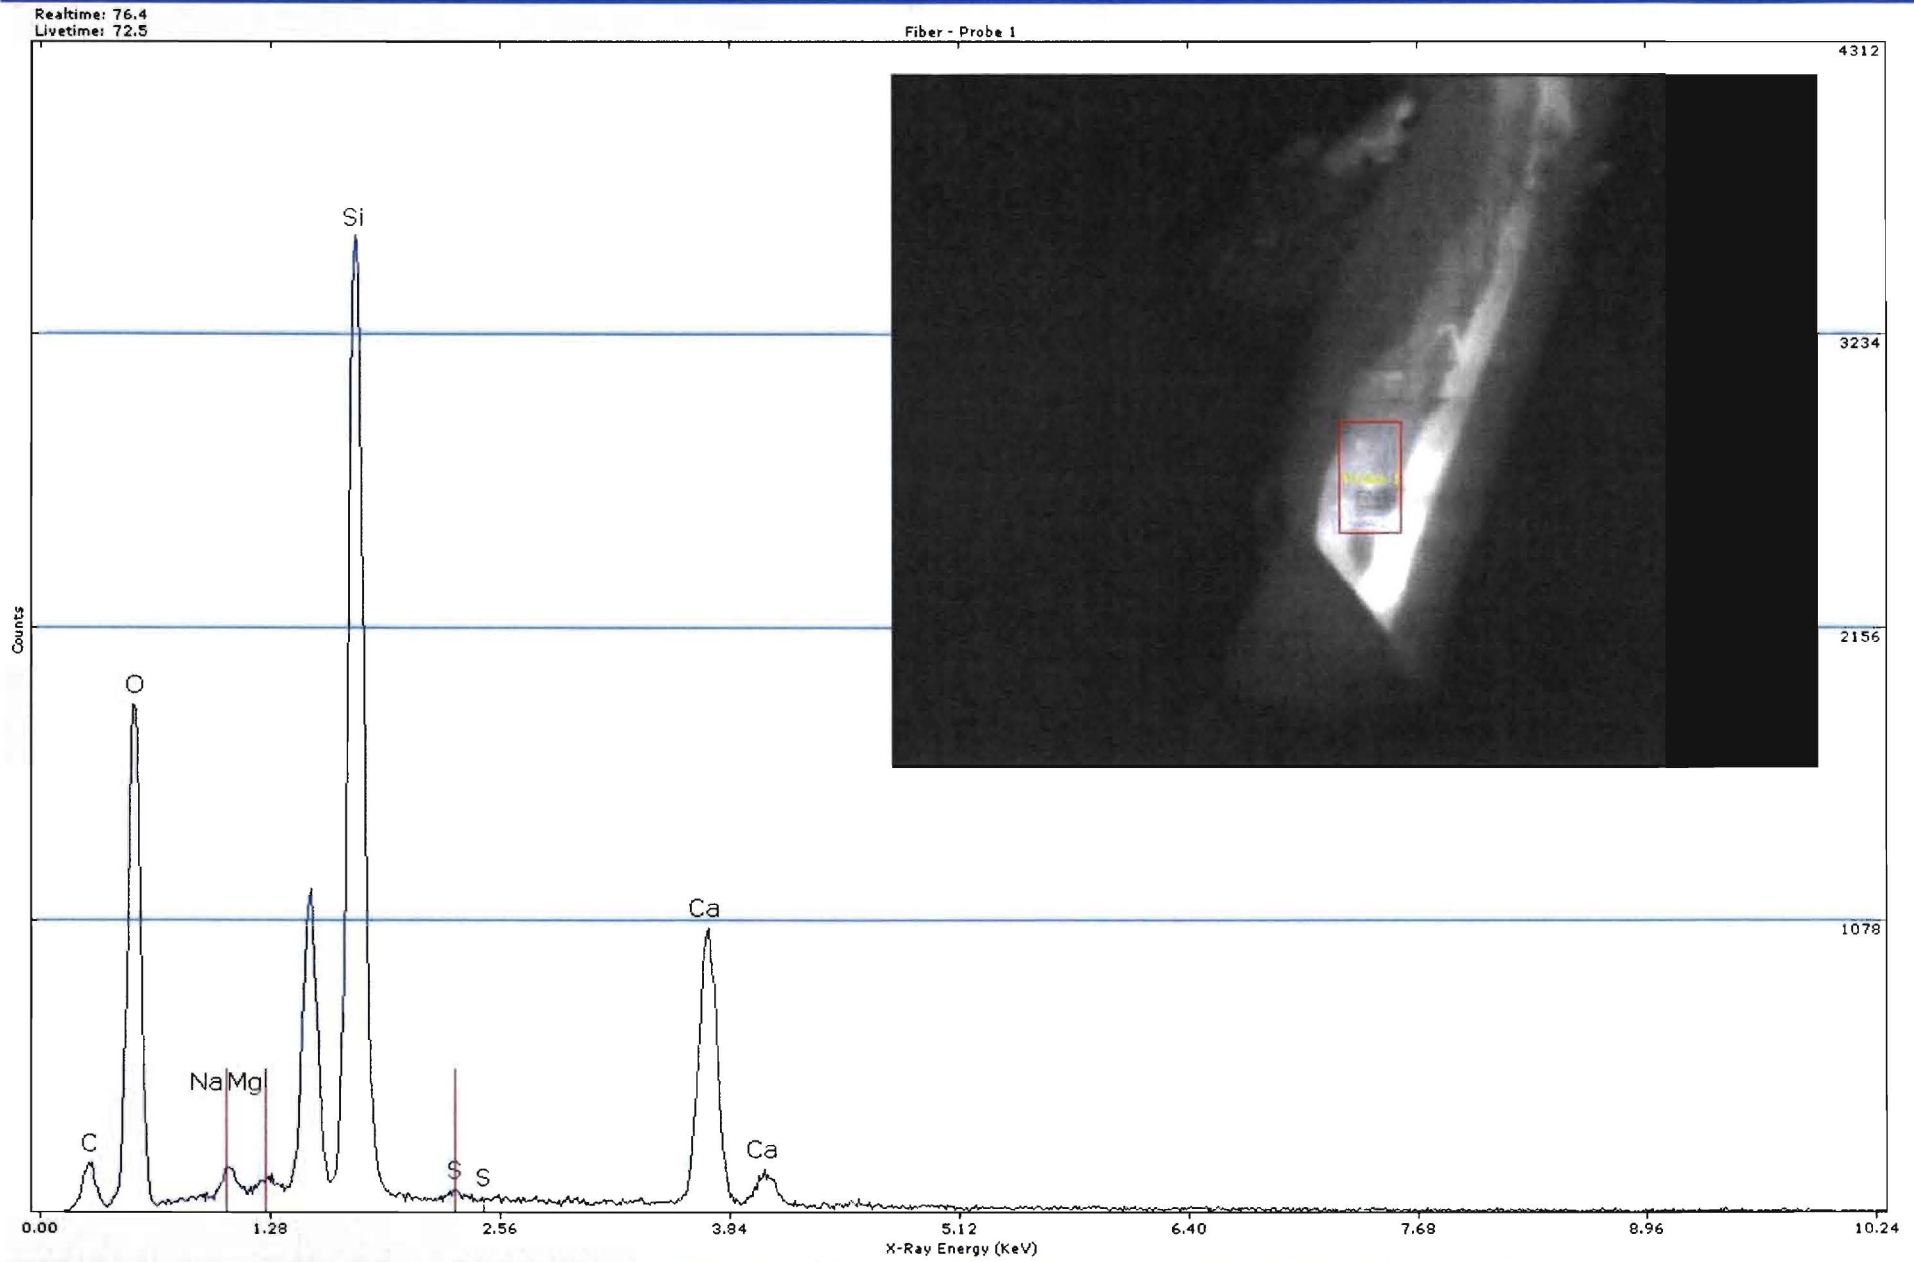
Blow-up scale of long straight fiber from matrix – note ED spectra.

NTSB EDS spectrum of the straight fiber from N612AZ PRV contained major elemental peaks of silicon, aluminum and calcium with minor elemental peaks of iron, magnesium, carbon, and oxygen, consistent with e-glass. (direct from NTSB Materials report)
