RE: Navion N 4827K crash 09/24/2014 Atigun Pass Alaska

Re: Navion Propeller and Clamp pictures you shared

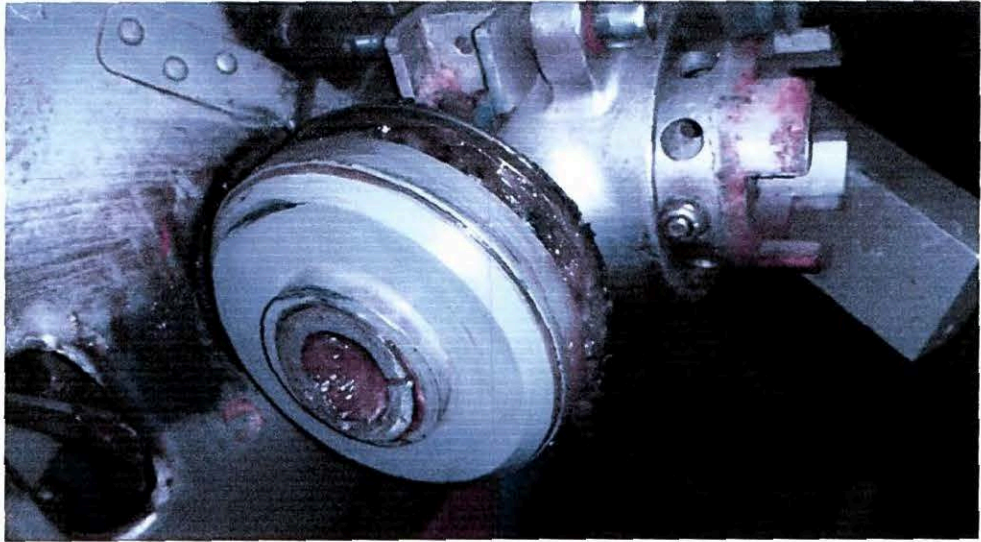
Ok, I'm pretty sure it's all impact related. However, the bolts holding the prop clamps appeared to be re-used and there was multiple witness marks behind the hub indicating that the missing bolt possibly fell out before the crash...not that it had anything to do with it, just a curiosity. Actually, it might be a hit on the prop shop Ottesen out of AZ.
