# National Transportation Safety Board

## Pipeline Accident Brief

### Birmingham Public Housing Gas Explosion

| <b>Accident No.:</b> | DCA14MP001 |

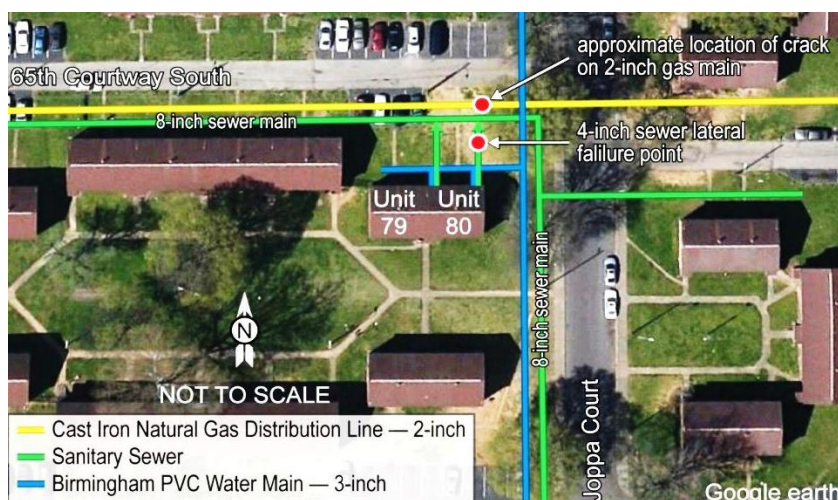
A 2-inch, cast iron natural gas main operating at 19.5 pounds per square inch gauge (psig) ran along the north side of units 79 and 80 parallel to 65th Courtway South. One and one-half-inch service lines supplied gas to units 79 and 80. (See figure 4.) The natural gas lines from the meter outlets into the duplex consisted of threaded, black-iron pipe. The unit 80 line entered the apartment through the wall about 3 feet above the concrete slab at the northeast corner of the unit. From this point, the line followed the north wall and turned south into the kitchen. The gas service line continued vertically into the structure along the wall, turned horizontally directly below the second level concrete slab, and traveled the length of the kitchen toward the back of the building. The pipe dropped vertically on the wall behind the sink to provide gas to the range. The pipe continued downward where it supplied the water heater; it then passed through an adjacent wall to supply gas to the living room heater where flues for the heater and water heater joined and routed to a central chase in the closet with the water heater.<sup>2</sup>

The Alagasco employees noticed bubbles in standing water that had accumulated near the curb on the northeast side of the apartment, which is an indication of a subsurface gas leak. At 7:14 a.m., they excavated down to the gas main and found a tree root tightly wrapped around the cast iron gas main. A rock was wedged between the tree root and the cast iron pipe. Investigators observed a crack in the main at that location. (See figure 4.) They confirmed the gas main leak using a soap solution while the line was at operating pressure. According to the Alagasco technician, the gas was escaping through a crack at the 5 o'clock position and was approximately one-quarter to one-half inch long. At 9:30 a.m., they removed the tree root, cleaned the pipe surface, and installed a mechanical clamp to stop the leak. On December 18, 2013, Alagasco technicians cut an 8-foot segment with the newly-installed clamp out of gas main and replaced it with a plastic pipe. The pipe segment, rock, and tree root that had been wrapped around the pipe were sent to the NTSB laboratory in Washington, DC, for examination.

**Figure 4.** Aerial view showing route of underground utilities near unit 80.
