**National Transportation Safety Board**

**Group Chairman's Factual Report of the Investigation**

**CenterPoint Energy Minnesota**

**Minnehaha Academy, Minneapolis, MN**

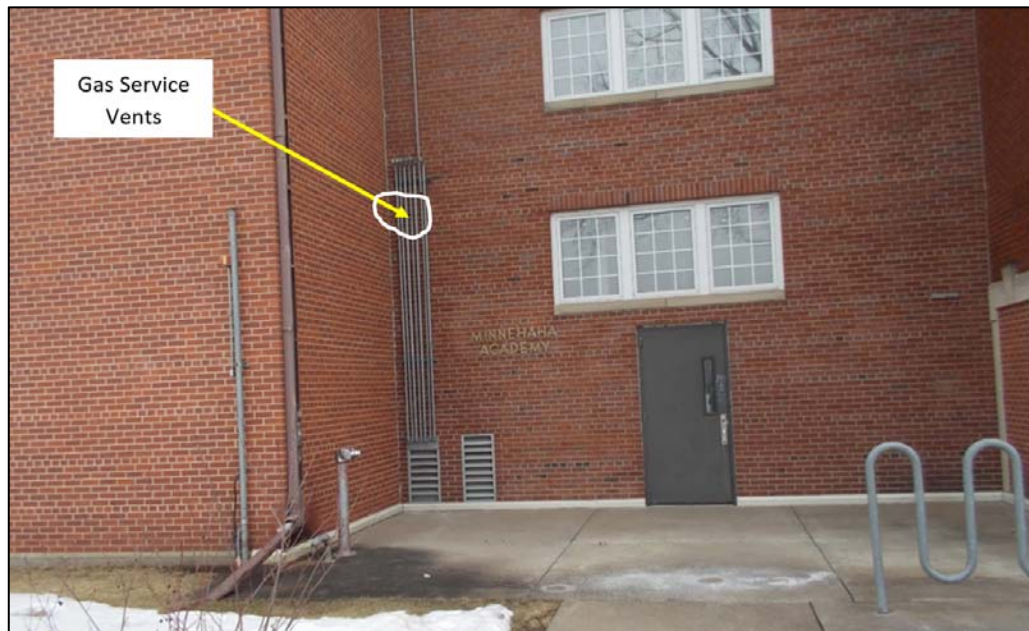
Figure 3 – Sidewalk over utility bunker (gas meter room) at the rear (west end) of the Minnehaha Academy building showing gas vent pipes. Source: CPEMG, taken: Feb2016

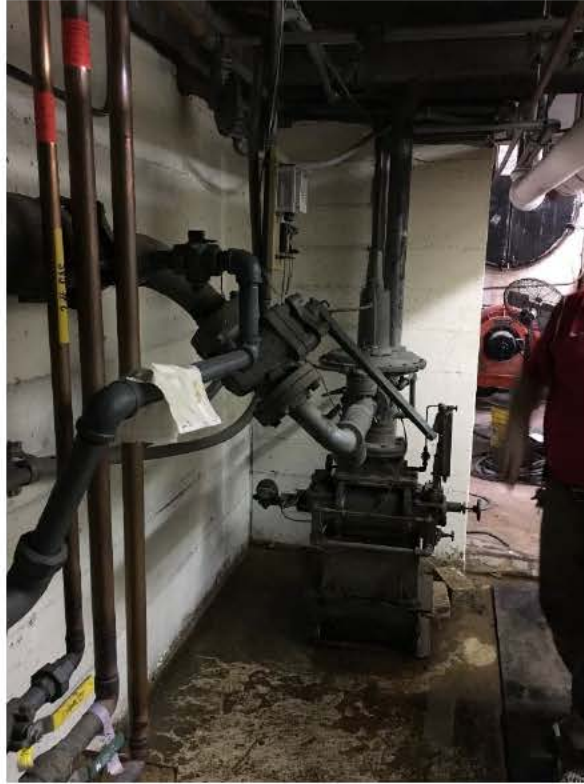
Figure 4 – View from utility bunker (gas meter room) into boiler room. Source: CPEMG, taken Feb 2017

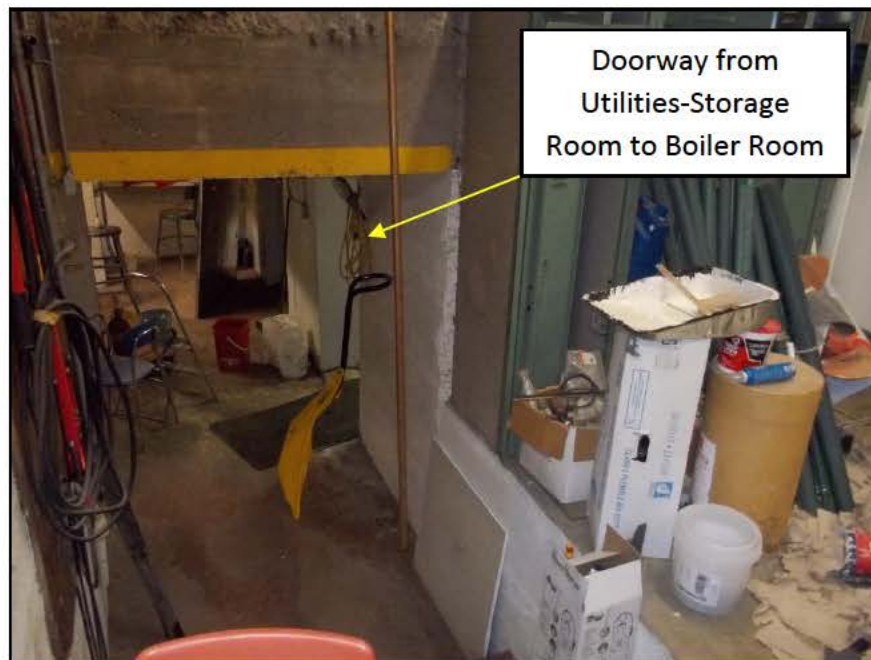
Figure 5 – View from utilities-storage room into boiler room. Source: CPEMG, taken Feb2016

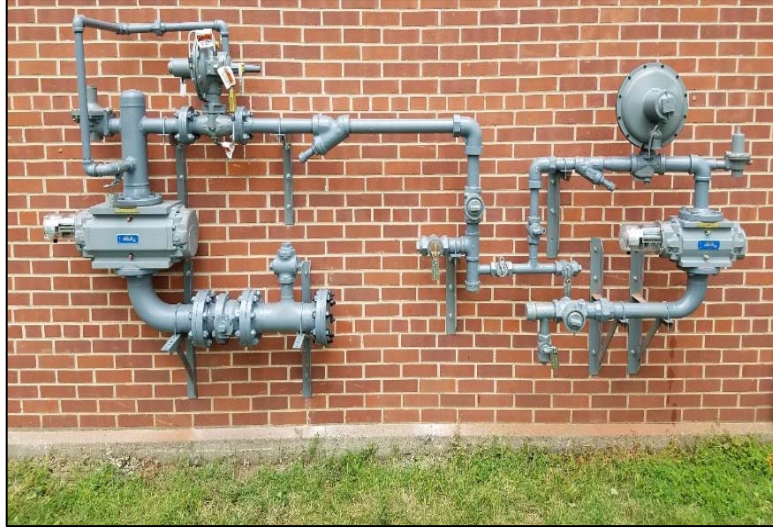
*Figure 8 – Two new gas meters assemblies mounted on the west rear wall of the Minnehaha Academy building by CPEMG on June 29, 2017; the planned new location. Source: CPEMG.*
