**NATIONAL TRANSPORTATION SAFETY BOARD**  
Office of Railroad, Pipeline, and Hazardous Materials  
Investigations  
Washington, D.C. 20594

### **Group Chairman's Factual Report of the Investigation**

#### **NiSource / Columbia Gas**

#### **Merrimack Valley, Massachusetts**

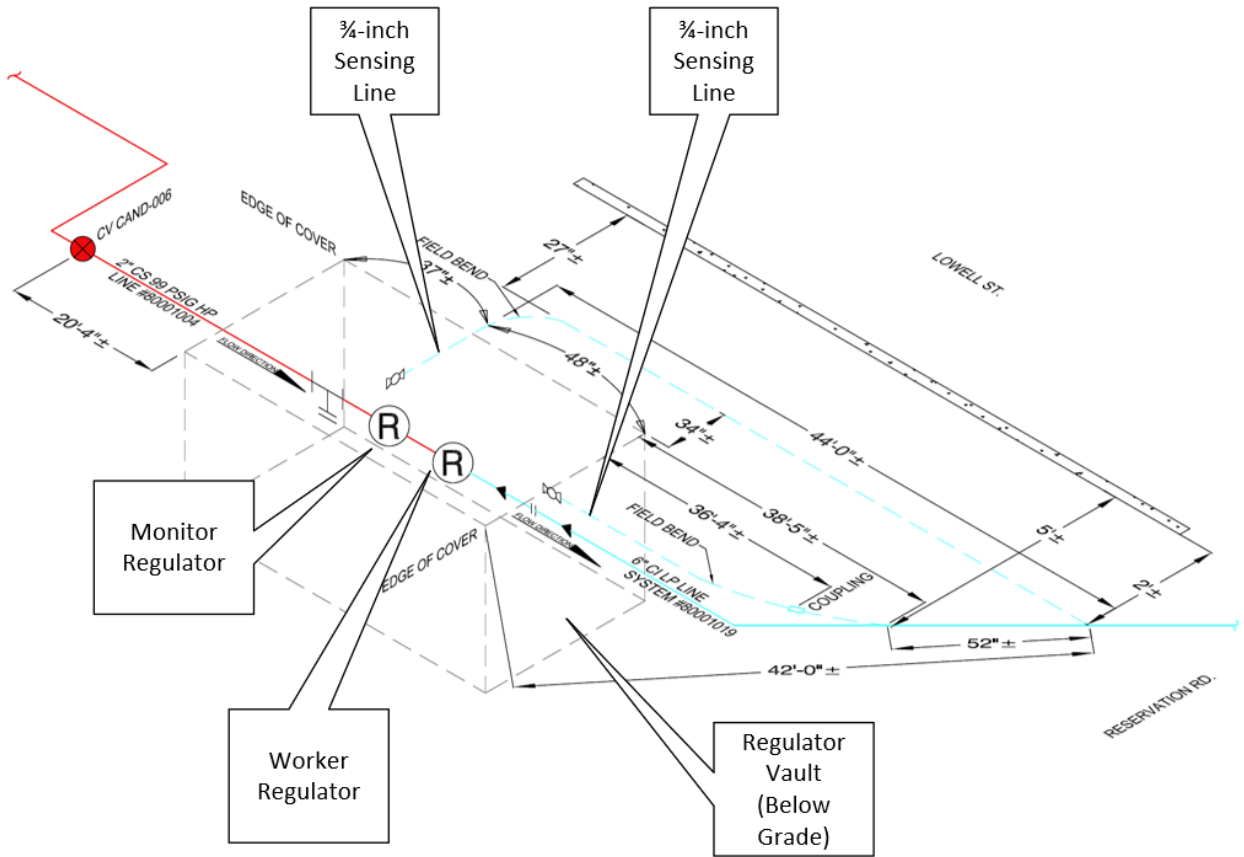
Figure 5 – Isometric Drawing Containing Sensing Lines

This sensing line information was not included in the NiSource GIS system. Following the accident, NiSource added the geometry of over 2,000 sensing lines to the GIS systems for the seven states serviced by their company. Engineers and technicians can now view the sensing line geometry from several electronic platforms; a capability that was unavailable at the time of the accident. Figure 5 is an example of a current-day isometric containing sensing lines.

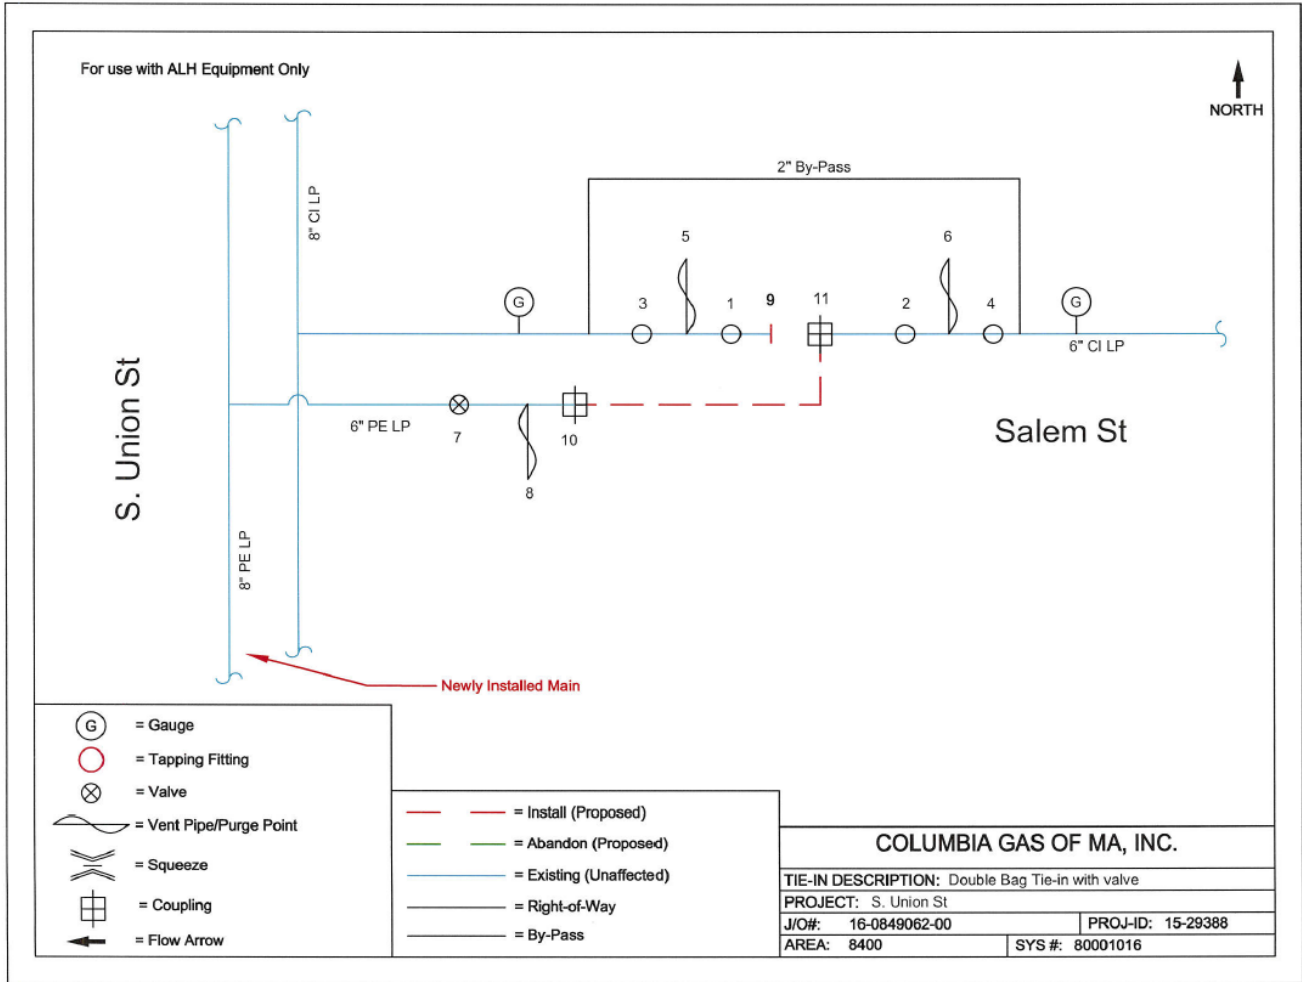
Figure 9 -- Tie-in Procedure for Tie-in of Low Pressure Main on Salem Street East of the Intersection of Salem Street and South Union Street

The bags were installed to seal the cast iron main while the section of cast iron was to be removed for the tie-in. After the bags were installed, areas between each pair of bags were purged to assure the bags were preventing flow. After assuring the bags were holding and the by-pass valves confirmed open, the 6-inch cast iron section between points 9 and 11 (See Figure 9 and Figure 10) was removed from the system. The end at section (point 9) was capped and torqued. Bags 3 and 1 were removed.
