NATIONAL TRANSPORTATION SAFETY BOARD
Office of Aviation Safety
Washington, D.C. 20594

POWERPLANT GROUP CHAIRMAN'S FACTUAL REPORT

NTSB No: ENG14IA019

Aircraft: Delta Air Lines, Boeing 767-332, registration number N139DL, Flight 101

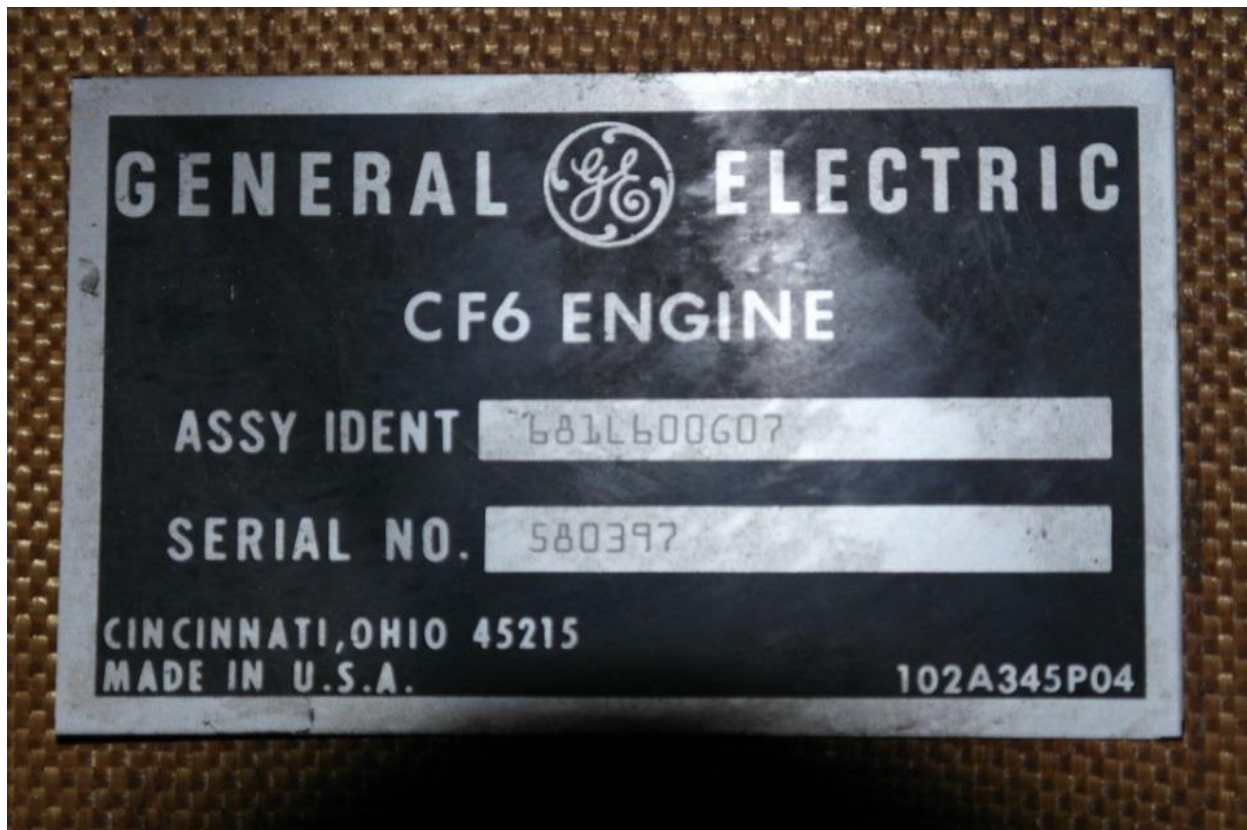
PHOTO 1: ENGINE DATA PLATE

The No. 1 engine installed on the incident airplane was a GE CF6-80A2 turbofan engine, engine serial number (ESN) 580-397 (**PHOTO 1**). At the time of the fire event, ESN 580-397 had accumulated 52,550 hours time since new (TSN), 22,708 cycles since new (CSN), 7,892 hours time since last shop visit (TSLSV), 2,350 cycles since last shop visit (CSLSV), 6,184 hour time since last inspection (TSLI), and 1,743 cycles since last inspection (CSLI).

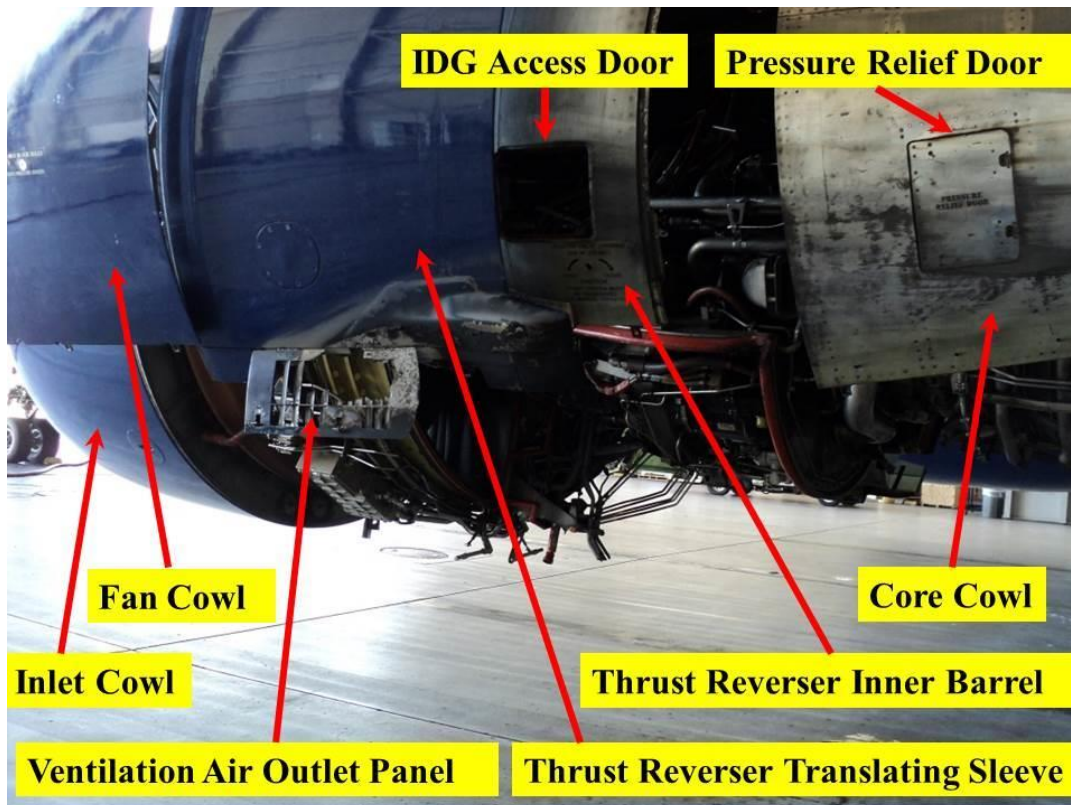
The following information was provided by DAL since the Powerplant Group did not travel to LAX for an on-site examination and evaluation of the event airplane and engine. The inlet cowl, the fan cowl, and the core cowl were undamaged (**PHOTO 2**); they remained on the airplane and were not sent with the engine for further evaluation by the Powerplant Group. The left TR exhibited the most thermal distress and fire damage while the right TR exhibited minor thermal distress. DAL mechanics at LAX found damage to the IDG power feeder cables (subsequently referred to as simply the power feeder cables) and repaired them in accordance with the Standard Wiring Practice Manual (D6-54446) Chapter 30-30-13 and, 20-30-11; the power feeder cables were cut at the engine heatshield and were sent with the engine and TR halves for evaluation.

PHOTO 2: NO. 1 ENGINE NACELLE HARDWARE CONDITION – LEFT SIDE

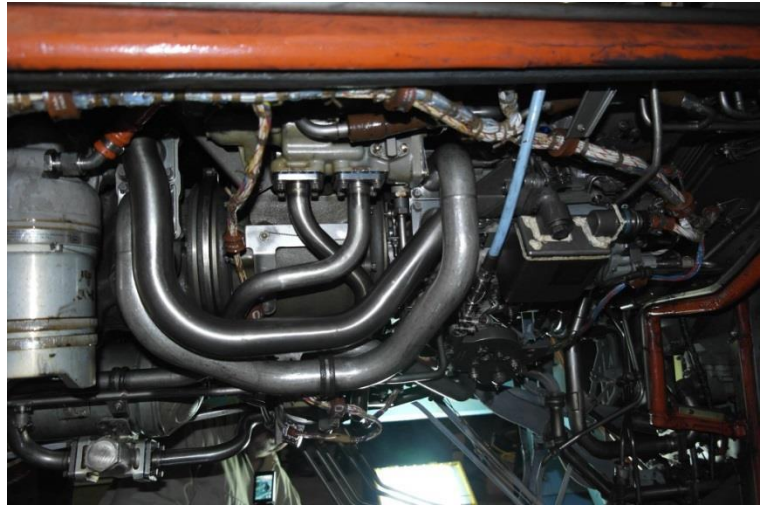
PHOTO 9: NO FIRE DAMAGE ON RIGHT SIDE OF ENGINE UNDERNEATH ENGINE HEATSHIELD

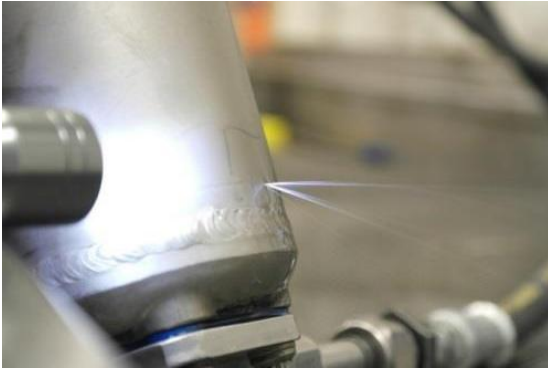
The test was performed on Fuel Flow Test stand #22 (46271), with a calibration sticker indicating re-calibration due date of May 9, 2015. With the oil inlet and outlet ports capped, fluid was flowed at various pressures through the core and fluid was observed spraying from the crack previously identified. At 10 pounds psi fluid pressure a light spray was observed (**PHOTO 18**). According to the IDG Fuel/Oil Heat Exchanger Component Maintenance Manual (CMM) the fuel side of the unit is pressure checked by capping off the fuel outlet port and applying 1800 ± 20 psi fuel pressure to the inlet port for 2 minutes. No external or internal leakage is permissible. Due to concerns with the structural integrity of the unit because of the main housing body crack, the Powerplant Group decide not to bring the pressure up to the CMM test pressure of 1800 ± 20 psi but instead agreed to bring the pressure up to only 400 psi. At 60 psi fluid pressure, the spray pattern was more pronounced. At 100 psi fluid pressure, the spray pattern was visible essentially the same as at 60 psi test point (**PHOTO 19**). At 250 psig fluid pressure, the spray pattern was visible essentially the same as at 60 psi and 100 psi test points

PHOTO 18: LEAK AT 10 PSI FLUID PRESSURE

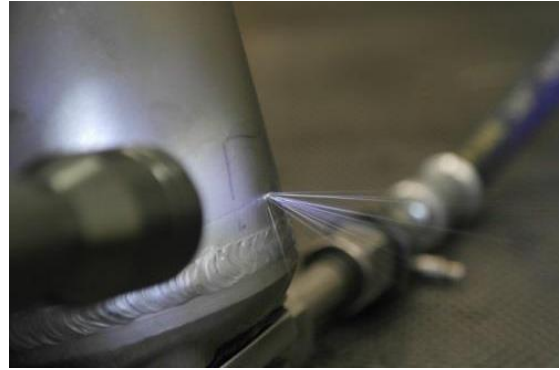
PHOTO 19: LEAK AT 60 PSI FLUID PRESSURE

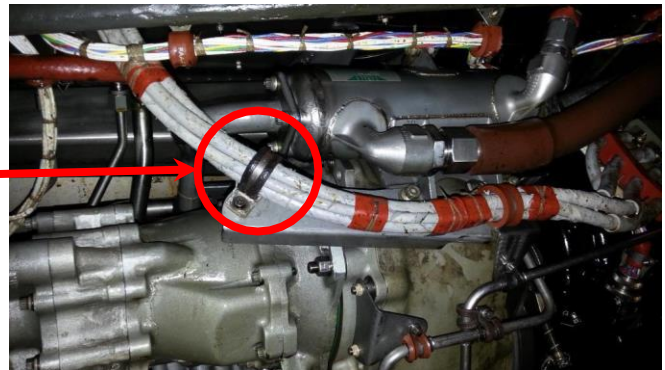
The slack observed on the IDG power feeder cables for the event engine was compared to an exemplar DAL 767 CF6-80A powered airplane. On the exemplar engine, the power feeder cables ran along the power feeder cable support bracket (PN 332T1111-142)⁵ and had no slack before it passed-through the engine heatshield (**PHOTO 31**), which was not the case in the event installation. For simplicity the power feeder cable support bracket will be subsequently referred to as the ‘cable bracket’. Also noted was the difference in orientation of the forward P-clamp; on the event engine the clamp was oriented down (attachment bolt is above the clamp) and on the exemplar engine the clamp was oriented up (attachment bolt is below the clamp). The correct orientation of the forward P-clamp is up (See Section 6.0 for more details). Also noted was the amount of tape to bundle the event power feeder cables was much more extensive than what was observed on the exemplar engine.

PHOTO 31: EXEMPLAR ENGINE IDG POWER FEEDER CABLE ORIENTATION WITH FORWARD P-CLAMP UP

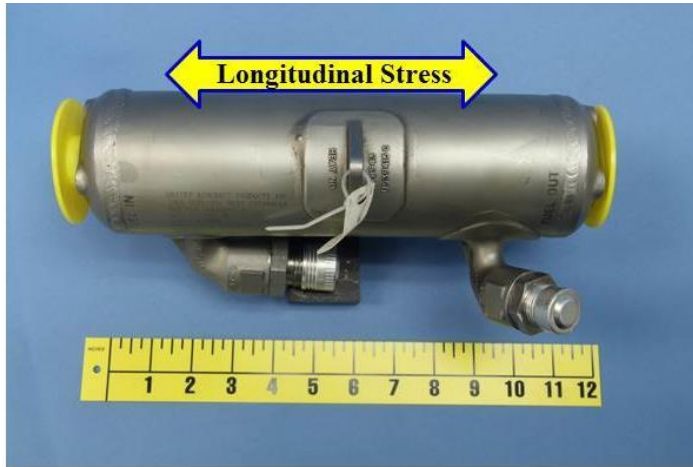
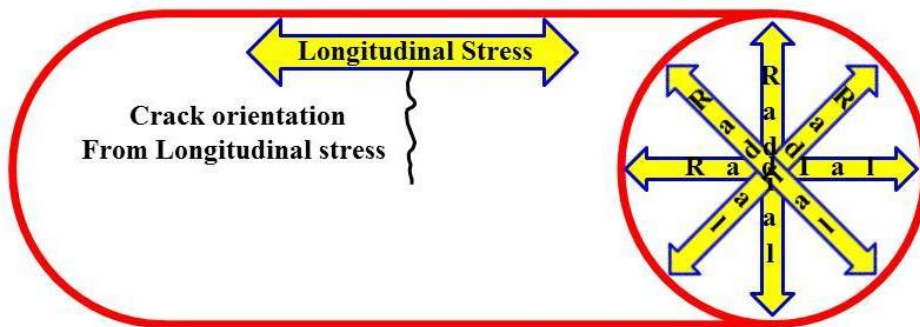
FIGURE 6: STRESS ORIENTATION

housing and propagated radially towards the OD and the crack orientation - circumferential instead of longitudinal - was more consistent with high longitudinal stresses than with hoop (radial) stresses (FIGURE 6). The fracture surfaces of the non through-wall crack also consisted of features consistent with fatigue cracking. However different from the through-wall crack, the non through-wall crack had multiple small OD surface cracks with a larger ID crack; the ID and OD cracks did not link up to produce a through-wall crack (PHOTO 37). The OD cracks appeared to be confined to the weld/braze bead.

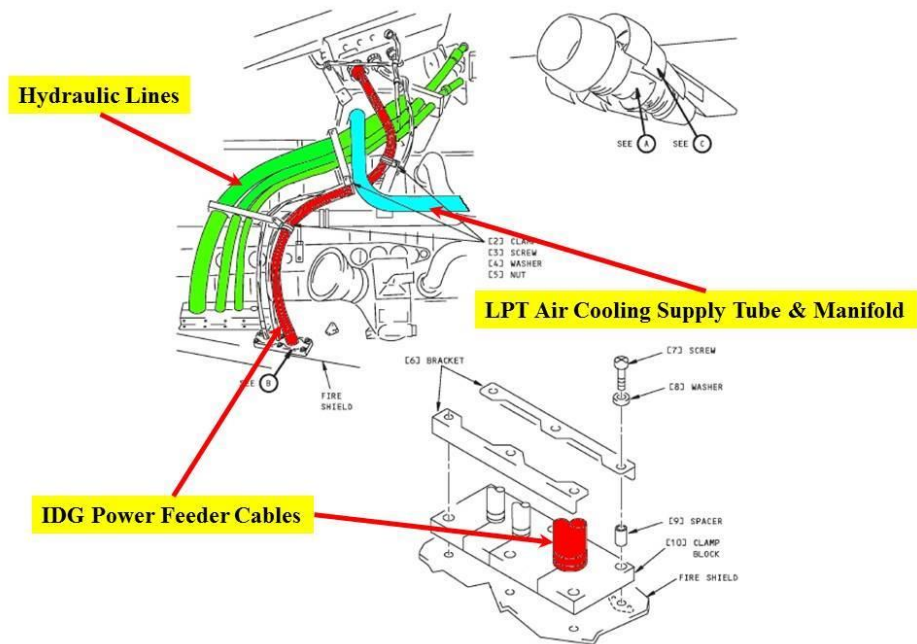
Since the IDG power feeder cables are part of the airplane and remained attached to the pylon when an engine change occurs; the Boeing airplane manuals provide the instructions and illustrations for installing and routing the power feeder cables and it is these manuals that are used when an engine is installed. Review of the various Boeing manuals that address the IDG power feeder cable installation and routing; such as the 767 Aircraft Maintenance Manual (AMM) (CF6-80A Series Engine) Chapter/Subchapter/Section 71-00-02; 767 Powerplant Buildup Manual (PBM) (CF6-80A Series Engine) 71-00-02; and 767 Operator dedicated Task Cards, found they all used essentially the same illustration that depicted: 1) the IDG power feeder cable routed from the pylon to the engine heatshield had a smooth large radius bend and that the cables are routed underneath the LPT air cooling supply tube and manifold (**FIGURE 7**) and 2) the IDG power feeder cable routed beneath the heatshield runs along the cable support bracket with no apparent slack with the forward P-clamp installed up and the aft

FIGURE 7: TYPICAL ILLUSTRATION OF IDG POWER FEEDER CABLE ROUTING ABOVE ENGINE HEATSHIELD IN THE BOEING 767 MANUALS

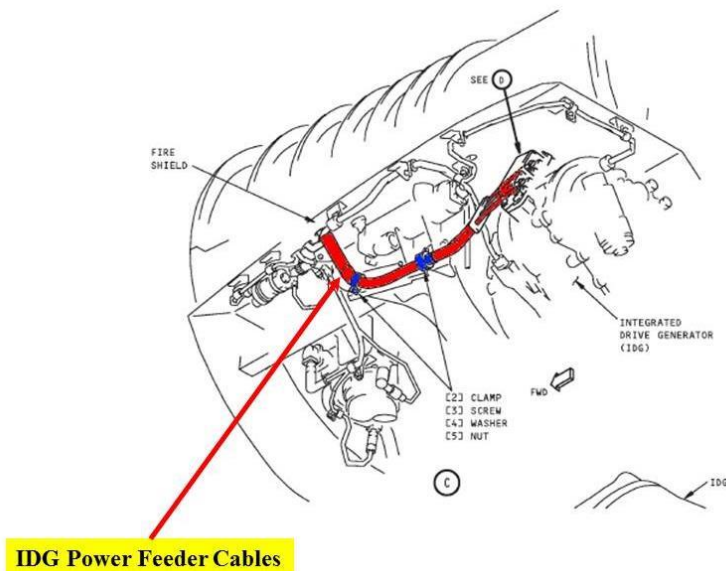
P-clamp installed down (**FIGURE 8**. The Boeing 767 Aircraft Maintenance Manual (CF6-80A Series Engine) Standard Practices Engine Maintenance Procedure Chapter/Subchapter/Section 70-00-00 provides general instructions for installing electrical cables and connectors. The instructions state that:

FIGURE 8: TYPICAL ILLUSTRATION OF IDG POWER FEEDER CABLE ROUTING BELOW ENGINE HEATSHIELD IN THE BOEING 767 MANUALS

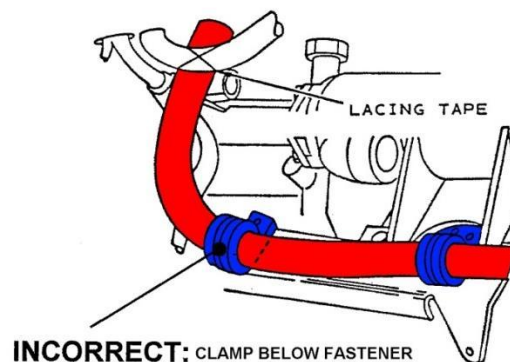
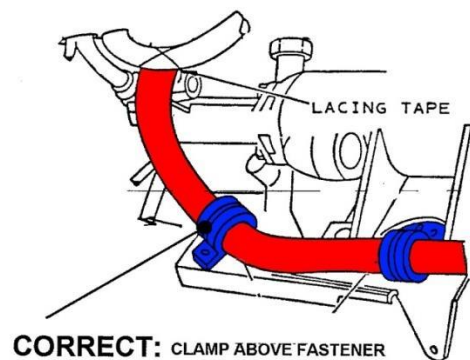
DAL developed their own specific job instruction work card, No. 7100-4450 titled “CF6-80A ENG CHG/Drop ELECTRICAL CONNECTIONS – 300” that provides instructions for connecting the IDG power feeder cables. The job card is a standalone document that provides all the instructions and diagrams needed to perform that task without the need for additional reference material. The job card that was current when the event engine was installed on the incident airplane back in July 2012 provided instructions for the orientation of the P-clamps on the cable bracket (**FIGURE 9**) but did not provide detailed instructions on the amount of slack allowed beneath the engine heatshield nor any guidance on the routing of the power feeder cables from the heatshield to the pylon. Subsequently, based on this event DAL has modified work card No. 7100-4450 to provide additional information on the proper routing of the IDG cable (See Section 9.2 for more details).

FIGURE 9: WORK CARD No. 7100-4450 (VERSION USED IN 2012 ENGINE CHANGE) P-CLAMP ORIENTATION

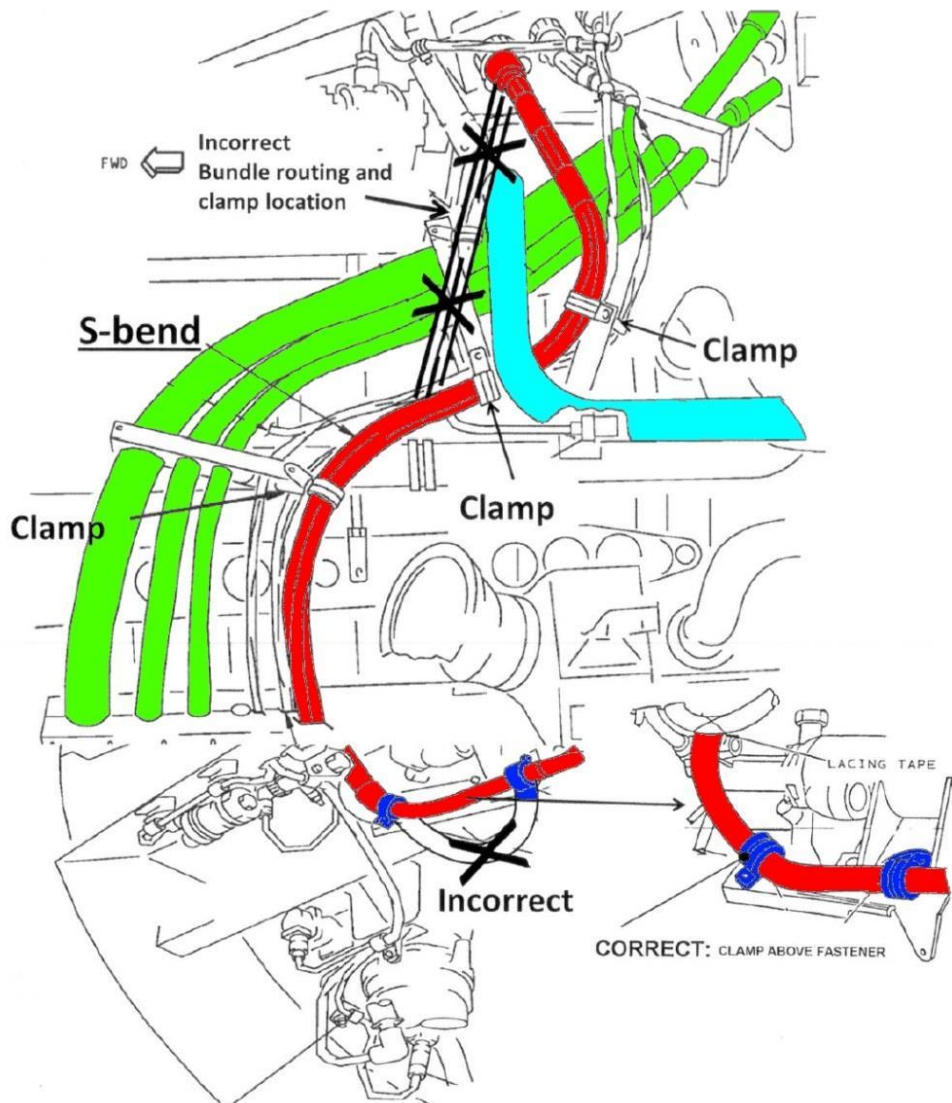
FIGURE 10: REVISED WORK CARD NO. 7100-4450 FOR P-CLAMP ORIENTATION AND CABLE ROUTING

While DAL performed the once-through-the-fleet inspection for chafed and misrouted IDG power feeder cables, they determined that their job instruction work card, No. 7100-4450, could and should provide more specific installation instructions; so on July 25, 2014, DAL issued a revision to No. 7100-4450 that included a CAUTION (see below) and a detailed figure for the proper routing of the power feeder cables both above and below the engine heatshield (**FIGURE 10**). The added CAUTION reads as follows:

Caution: proper generator feeder cable routing and feeder cable clamp orientation is critical to prevent interference with engine components which could cause arcing. Ensure that generator cables do not rub against T/R cowling when closed to prevent chafing of cables.
