NATIONAL TRANSPORTATION SAFETY BOARD Office of Aviation Safety Washington, D.C. 20594

POWERPLANT GROUP CHAIRMAN'S FACTUAL REPORT NTSB No: ENG17IA036

Aircraft: Boeing 757-232, N686DA, Delta Air Lines Flight 1057

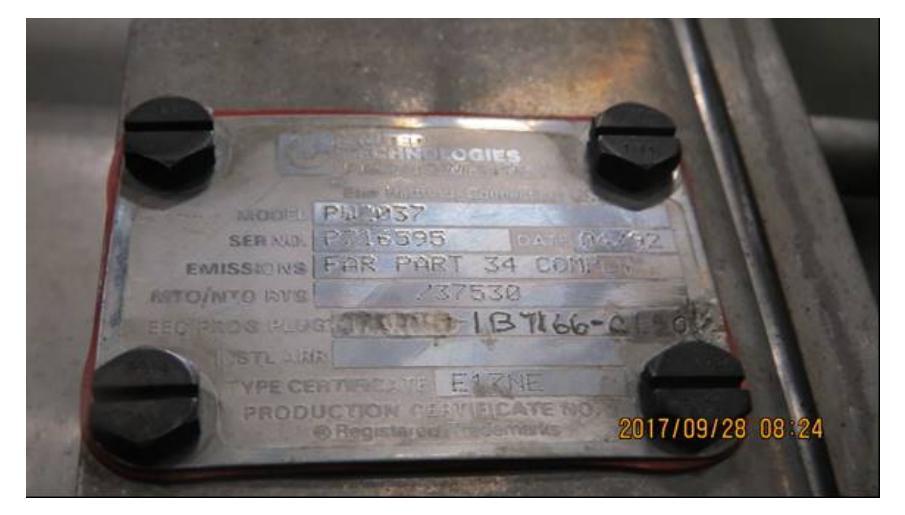
Photo 9- Engine Data Plate

The engine was placed on work pedestals prior to the investigative team's arrival (**Photos 7, 8, and 9**). The engine fan blades were all intact and in good condition. Three consecutive blades (labeled 4, 5, and 6) at the 6 o'clock position were displaced about 1 inch in the aft direction but did not exhibit any impact damage on the blade surfaces. The midspan shrouds of the three consecutive blades at the 6 o'clock position were shingled, and the blade tips were dug into the fan case rub strip (**Photo 10**). The three blades had rub strip material accumulation on the blade tip convex side, consistent with counter clockwise rotation. The fan case rub strip was rubbed/gouged between the 4 and 8 o'clock positions in line with the fan blade trailing edge plane of rotation. The three displaced blades were forcefully released from the rub strip and following release they returned to their normal orientation and the fan/N1 spool could be spun freely by hand.
