**NATIONAL TRANSPORTATION SAFETY BOARD**  
**Office of Aviation Safety**  
**Washington, D.C. 20594**

**POWERPLANT GROUP CHAIRMAN'S FACTUAL REPORT**

**NTSB No: DCA16FA013**

Aircraft: Boeing 767-200ER, N251MY, Dynamic International Airways

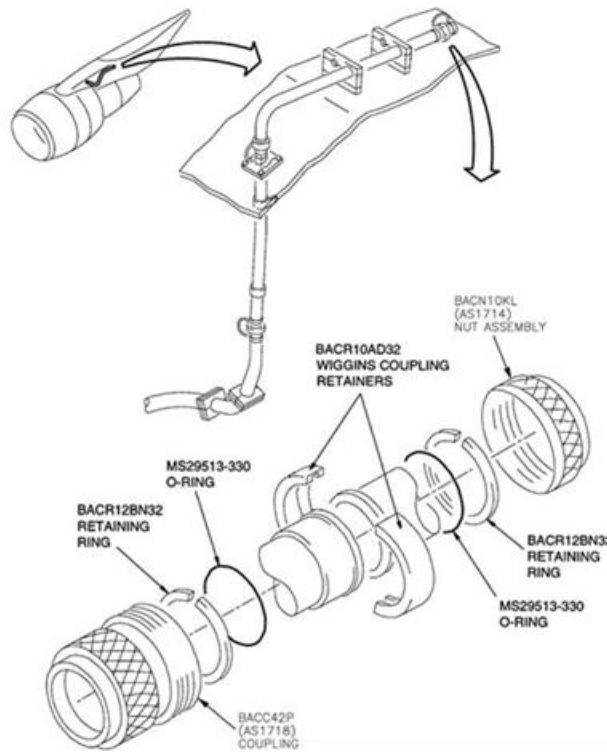
**Figure 2- Full Flex Fuel Coupling Assembly Parts Breakdown**

The left wing leading edge access panel above the left engine was removed to document the aft strut compartment and main fuel supply line (**Photo 10**). The compartment smelled strongly of fuel and light sooting was observed. Between nacelle stations 192 and 234, the fuel supply line features a full flex coupling assembly (**Figure 2**). The coupling body was found disconnected and resting loosely near the wing spar fuel coupling (**Photo 10**). The remaining components of the fuel coupling were located adjacent to the fuel supply tube mating flanges. The aft retaining ring and o-ring were displaced in the aft direction and the nut, forward o-ring and retaining ring were displaced in the forward direction. The retainer halves remained clamped around the mating tube flanges and were free to rotate (**Photo 11**). Lockwire was not present in either the coupling body or nut assembly lockwire holes and the team was unable to locate the lockwire in the surrounding compartments. All lockwire holes in both the coupling body and nut were observed to be intact with no break-through. The forward bonding clamp was present but loose on the fuel supply line. No aft bonding clamp or bonding jumper was present or recovered. An exemplar photo of the fuel coupling in the correct installation configuration from the right engine is shown in (**Photo 12**).
