NATIONAL TRANSPORTATION SAFETY BOARD  
Office of Aviation Safety  
Washington, D.C. 20594

POWERPLANT GROUP CHAIRMAN'S FACTUAL REPORT

NTSB No: DCA15MA029

Aircraft: Embraer Phenom E50P, registration number N100EQ

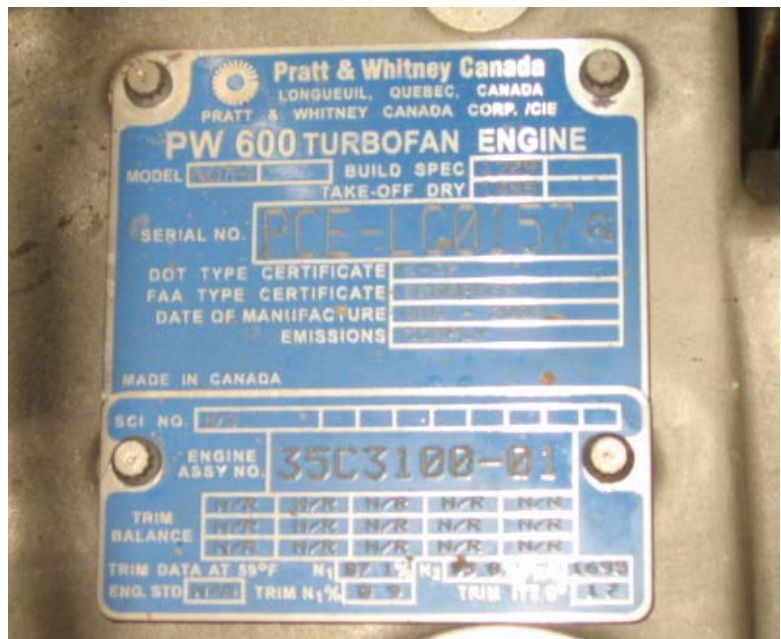
The air inlet port in the inlet nose cowl for the starter generator was free of dirt and debris. With the cowlings removed, examination of the inside of the cowling revealed no thermal distress and the service door (next to the white card labeled “L”) located on the bottom of the cowl was intact, in place, remained latched (**PHOTO 13**). The data plate on the gearbox confirmed the engine to be SN LC0157 (**PHOTO 14**).

**PHOTO 14: ENGINE NO. 1 DATA: SN LC0157**

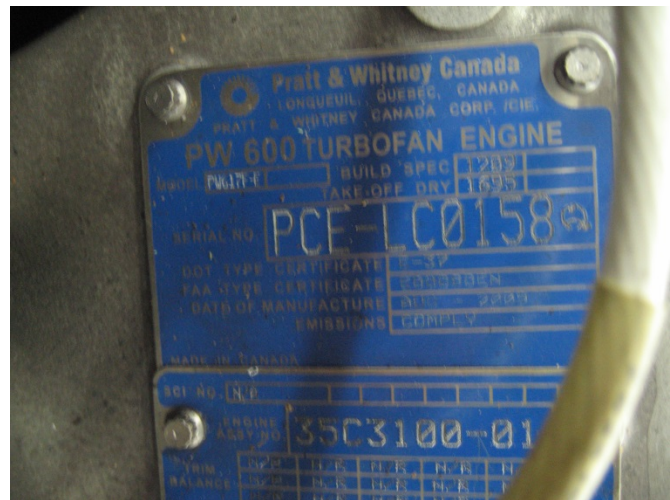
The air inlet port was plugged with dirt; however, the exhaust portion of the inlet port that leads directly to the starter appeared to be clean. With the cowlings removed, the inside of the cowling exhibited thermal distress and some signs of melting (**PHOTO 23**) unlike the No. 1 engine that was free of thermal distress. The service door was distorted but remained latched and in place. The data plate on the gearbox confirmed the engine to be SN LC0158 (**PHOTO 24**).

**PHOTO 24: ENGINE NO. 2 : SN LC0158**
