**NATIONAL TRANSPORTATION SAFETY BOARD
OFFICE OF AVIATION SAFETY
WASHINGTON, D.C. 20594**

**POWERPLANTS GROUP CHAIRMAN'S FACTUAL REPORT
NTSB ID: CEN15FA034**

Location: Wichita, Kansas
Date: October 30, 2014
Time: 0948 Central Daylight Time (CDT)
Aircraft: Raytheon Aircraft Company Super King Air B200, Reg. N52SZ

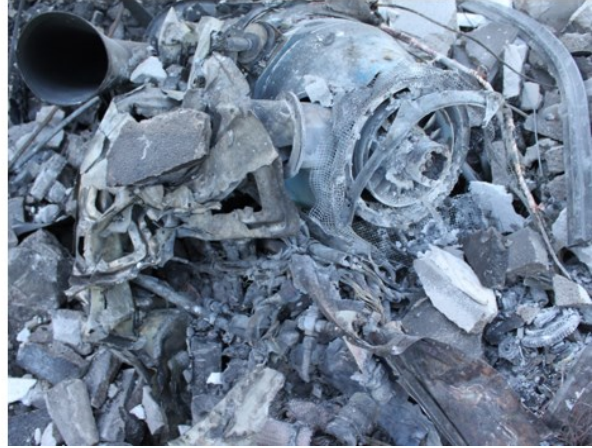
Figure 2. Rear view of left engine as found

An initial point of impact was evident at the northeast corner roofline of the FSI building, a brick structure housing flight simulators. See Figure 1. The left engine and propeller were found inside the building, separated from the airframe and partially buried in rubble just beyond the roofline impact. See Figure 2.

The propeller remained attached to the engine. See Figure 3. The blades were retained in the hub but were loose in their clamps. The outboard ends of two adjacent blades were fractured off.

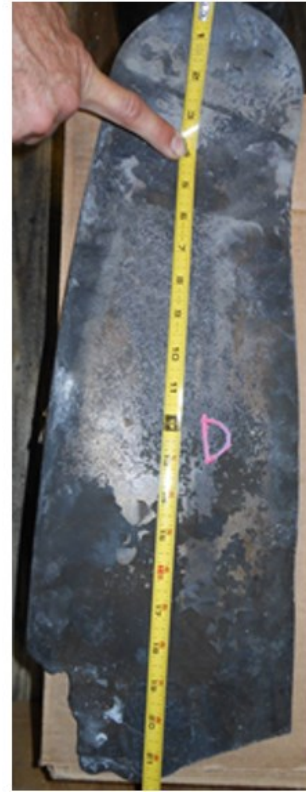
Figure 6. Blade section recovered from roof

An outboard section of propeller blade approximately 11 inches long was found about 200 feet northeast of the initial point of impact. The piece was scraped chordwise and the leading edge (LE) was torn approximately 10 inches from the blade tip. See Figure 5. Another outboard propeller blade section, approximately 23.5 inches long, was recovered from the FSI building roof. See Figure 6.

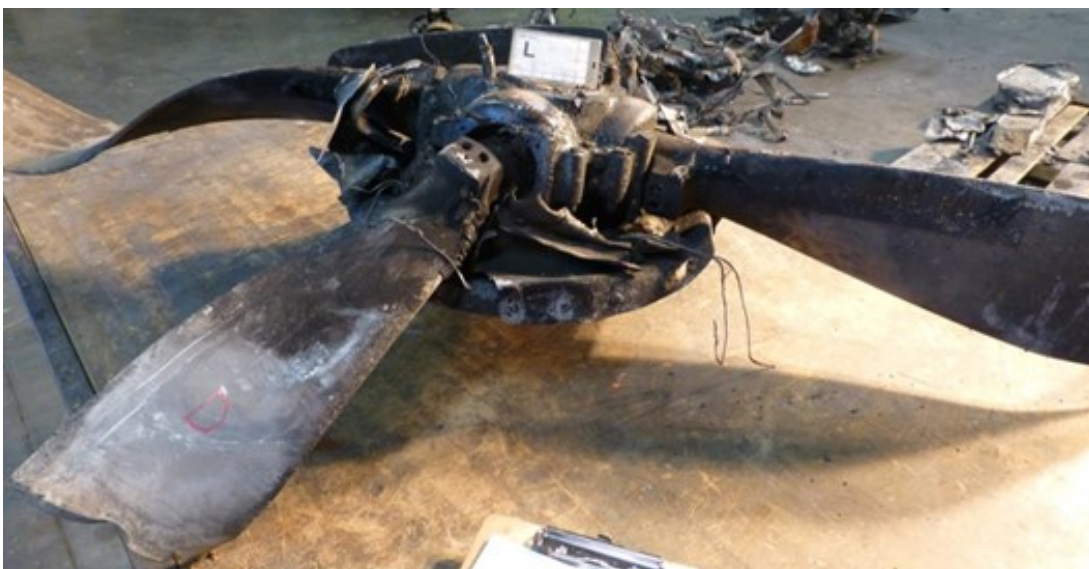
Figure 7. Left propeller S/N HH-1551

The left propeller blades were reference marked A-B-C-D in the direction opposite of rotation.

A disassembly inspection was performed November 2-3, 2014. No evidence of pre-impact failure was found. The parts were further evaluated at Hartzell Propellers Inc, in Piqua, Ohio, September 9-10, 2015.

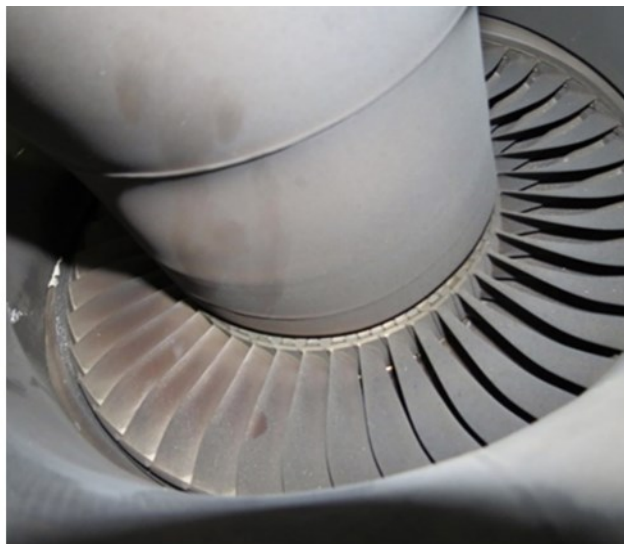
Figure 19. PT rotor viewed through the exhaust

was whole and the connections secured. The fuel nozzle assemblies, transfer tubes and the flow divider remained installed or were recovered from the wreckage debris. No indications of pre-impact fire were found. Viewed through the exhaust, the PT rotor was intact. See Figure 19.

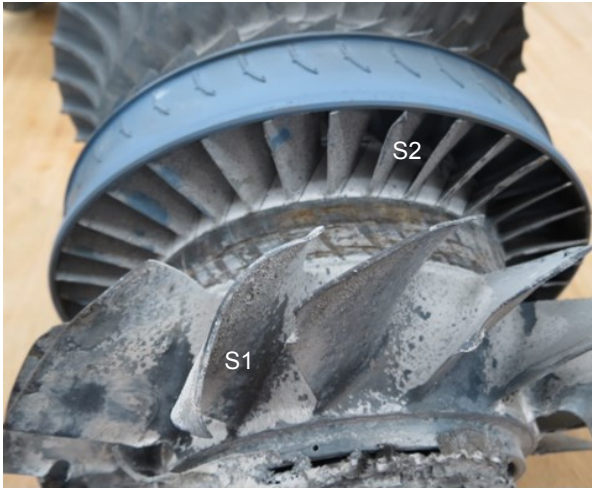
Figure 20. S1 and S2 compressor blades (viewed from forward of engine looking aft)

The compressor rotor turned freely in its housing following removal from the GGC. The stage 1 (S1) compressor blades were dented and torn, with random leading edge (LE) curling. The blade

tips were rubbed with associated burring. The S1 compressor spacer was lightly rubbed 360°. The stage 2 (S2) blade LEs were lightly dented and the blade tips were rubbed and burred. See Figure 20. The stage 3 (S3) compressor blades were lightly impact damaged and the blade tips were rubbed and burred. See Figure 21. The S2 and S3 spacers were undamaged.

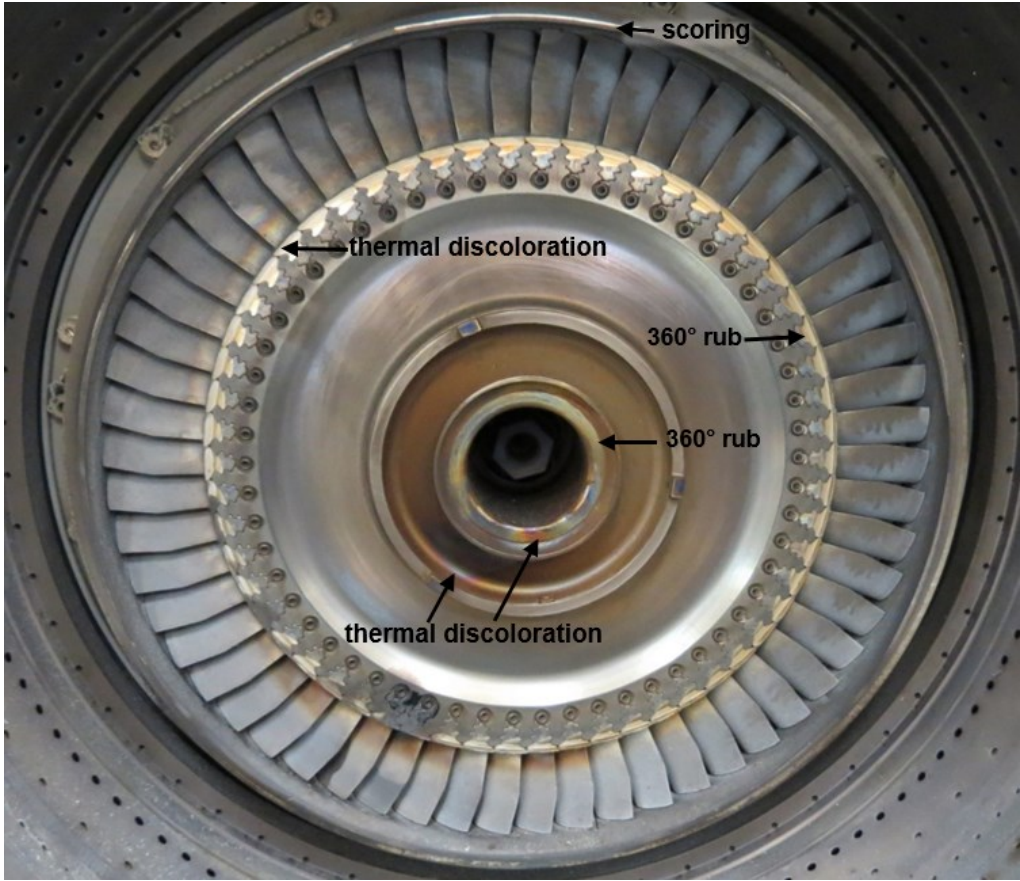
Figure 25. CT disk assembly downstream side

The downstream side of the CT disk assembly was circumferentially scored along the fir trees and the hub. The disk hub spigot was deformed and thermally discolored. There was discoloration along the blade roots. See Figure 25.

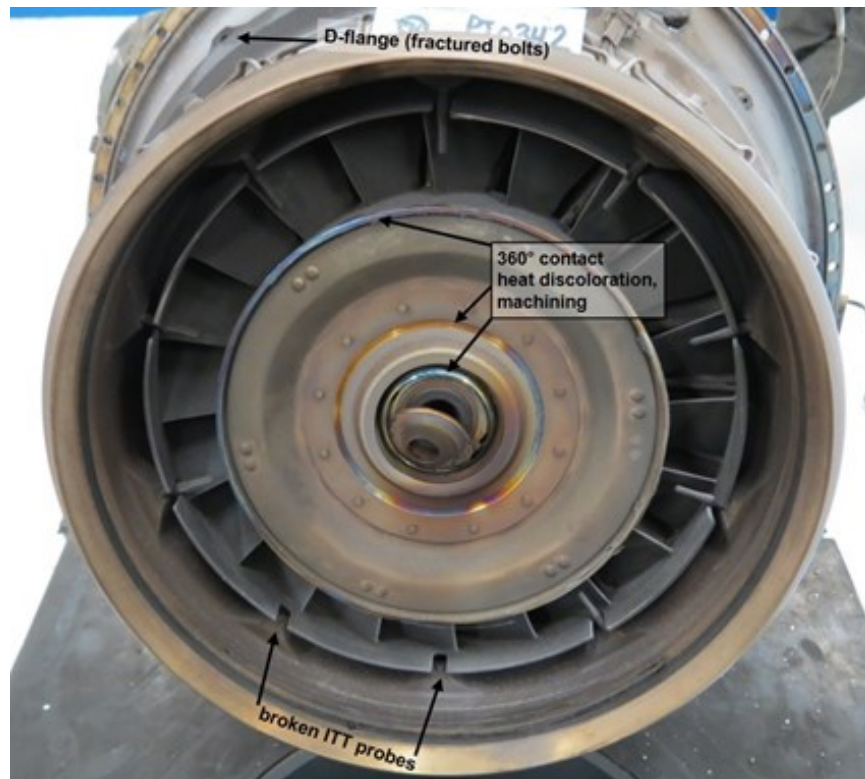
Figure 29. PT S2 vane ring assembly, upstream face

The upstream side of the S1 PT vane ring exhibited 360° scoring and thermal discoloration on three surfaces, including machining separation of the center of the baffle. See Figure 29. The downstream side of the vane ring exhibited a 190° arc of rotational damage and thermal discoloration on the inside baffle and rotational scoring along the outside baffle. There were two axial cracks in the vane ring inner drum. See Figure 30.

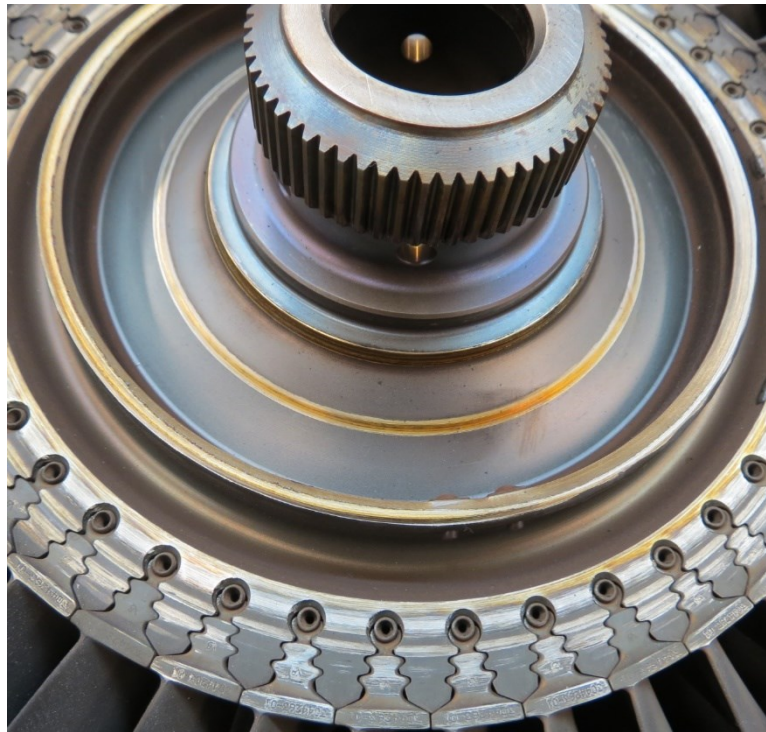
Figure 32. PT S2 disk assembly, downstream face

The upstream surface of the PT S2 disk assembly was circumferentially scored. The downstream surface exhibited circumferential rub at the fir tree area, the balance rim, and on the disk hub spigot. See Figure 32. The blade shroud knife edges exhibited slightly more rub than is typical for in-service operation.

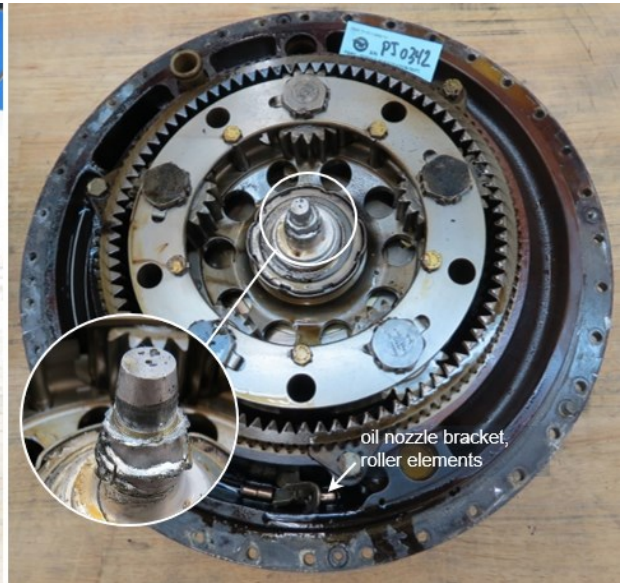
Figure 38. S2 reduction gear carrier

All of the No. 4 bearing OR retaining bolt heads were broken off, including those retaining the 3/4 bearing oil nozzle retaining bracket; the 3/4 bearing oil nozzle retaining bracket and bearing roller elements were found loose in the RGB rear housing. See Figure 38. The 3/4 bearing oil nozzle assembly was bent 90° and was fractured at its supply end. The aft surface of the 3/4 bearing housing was deformed and ovalized, and was intermittently scored.

The RGB S2 planet gears, carrier assembly, ring gear and bearings were inspected as assembled. No gear distress was found. The No. 4 bearing oil nozzle exhibited machining damage and displaced material. The gear retention plug heads were slightly worn on the inboard sides consistent with contact by the S2 planetary housing during operation. See Figure 38. Inspection of the aft side of the No. 5 bearing found no obvious damage. The front gearbox assembly was not disassembled and the condition of the No. 6 bearing, the propeller oil transfer sleeve, and the propeller control system drive train was not assessed.

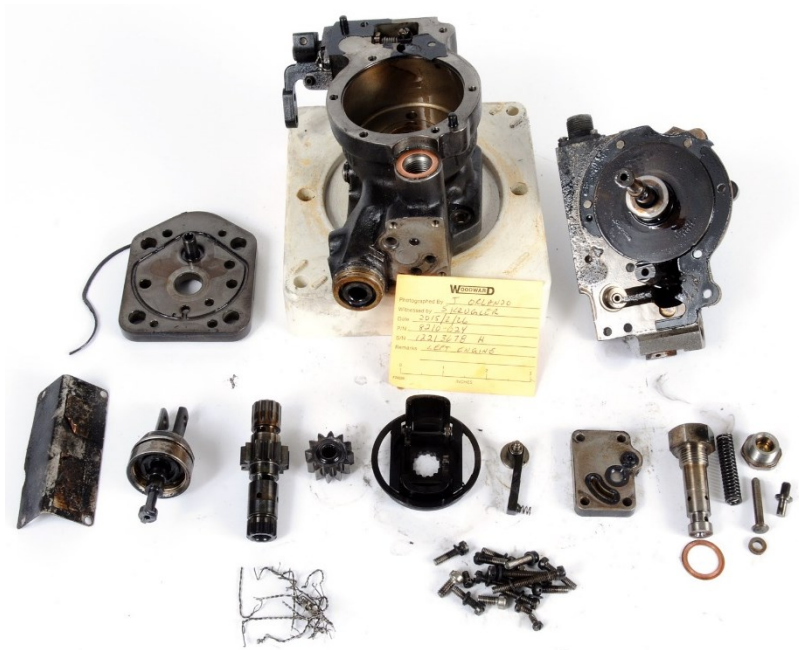
Figure 39. CSU components

As-received inspection of CSU P/N 8210-024, S/N 1223678 found it capable of functional test. The unit operated normally on production acceptance test, meeting all requirements except several speed settings that were slightly out of production specification. The discrepancies were accounted for by typical field rigging adjustments and post-crash fire damage. A teardown inspection was

then performed. No evidence of pre-impact failure was found. See Figure 39.

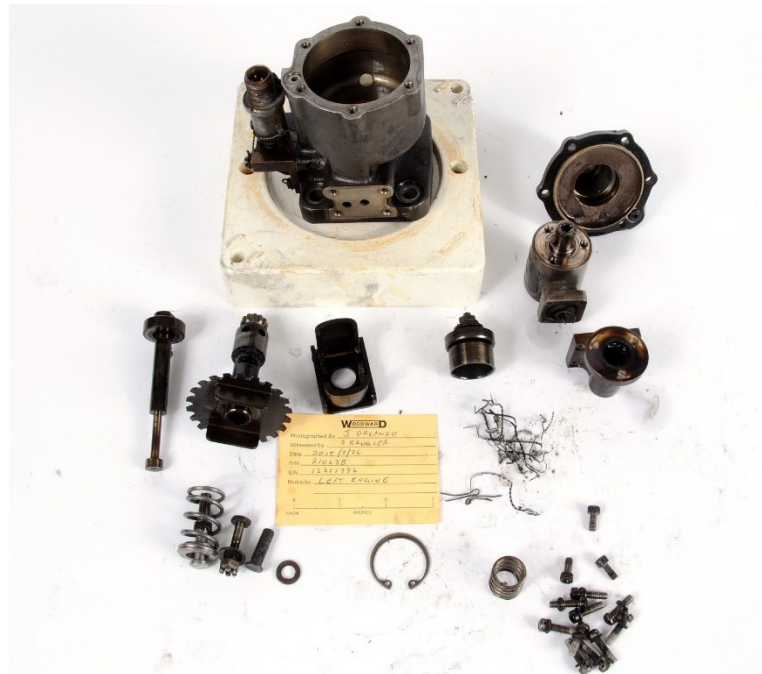
Figure 40. Raytheon overspeed governor components

Raytheon overspeed governor P/N 210638, S/N 12211796 was initially installed on a test bench but functional test was stopped due to unusual noise. Disassembly found that the plunger and driveshaft were seized together as a result of corrosion. The corrosion and mechanical damage were consistent with post-crash fire and the fire extinguishing effort. No evidence of pre-impact failure was found. See Figure 40.

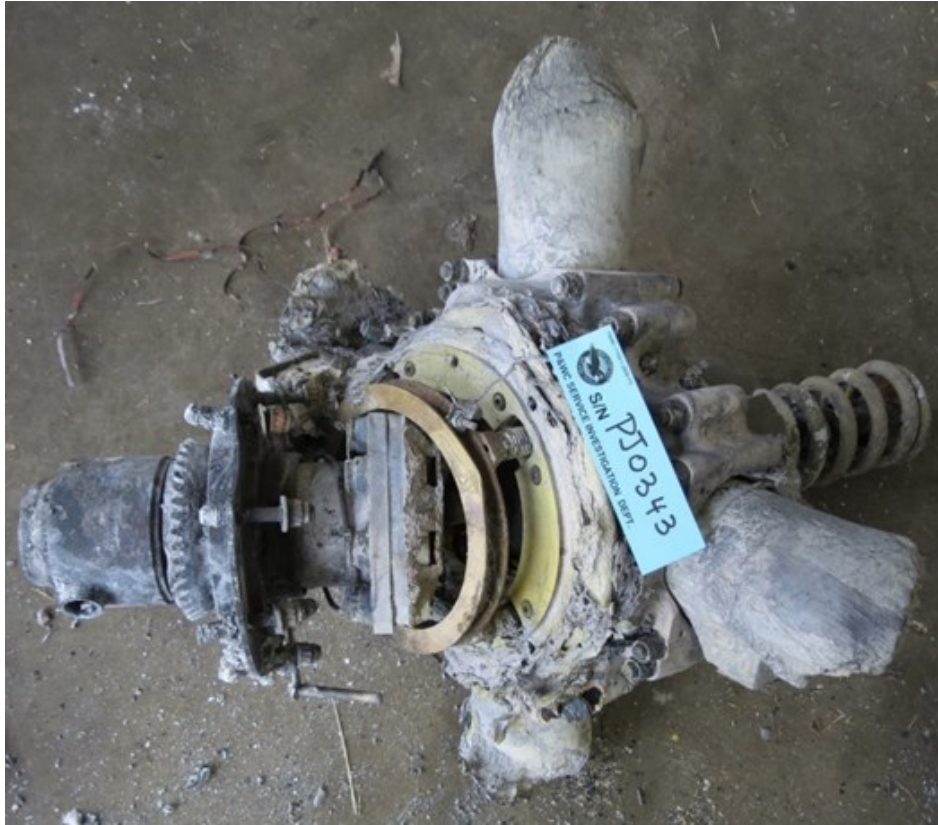
Figure 40. Propeller S/N HH-3523

The right propeller blades and the pitch change mechanism were largely consumed by fire. See Figure 40.

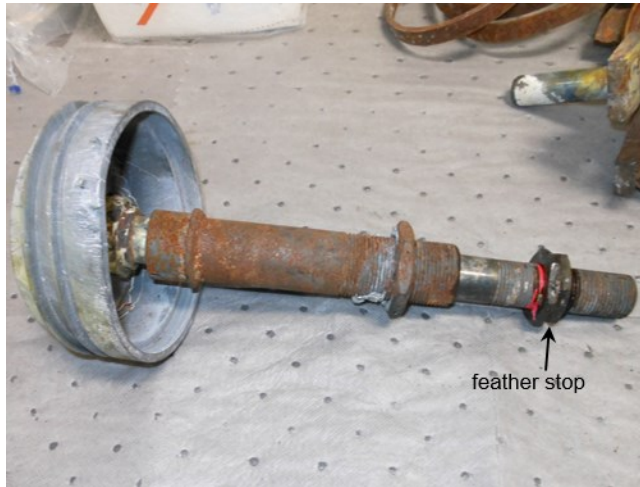
Figure 41. Piston and pitch change rod

The piston was melted/thermally deformed. See Figure 41.

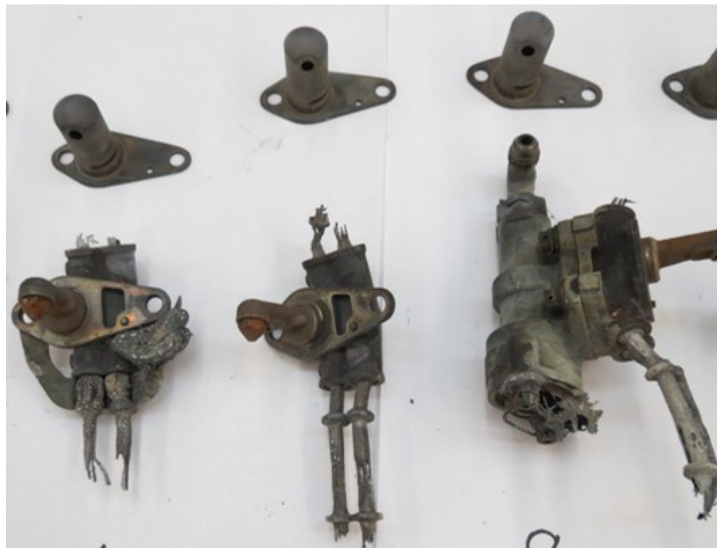
Figure 49. Fuel system components

The fuel pump and FCU were thermally destroyed. The integrity of the fuel line between the FCU and the fire seal mount ring assembly could not be assessed due to thermal and mechanical

damage. The fuel line from the aft fire seal mount ring to the fuel flow divider fuel line was continuous with the safeties intact. The fuel manifolds were coated with debris but were undamaged. The transfer tubes were thermally damaged and could not be assessed. All of the fuel nozzles and the flow divider were recovered. There were no indications of pre-impact fire. See Figure 49. Viewed through the exhaust, the PT rotor was intact. See Figure 50.

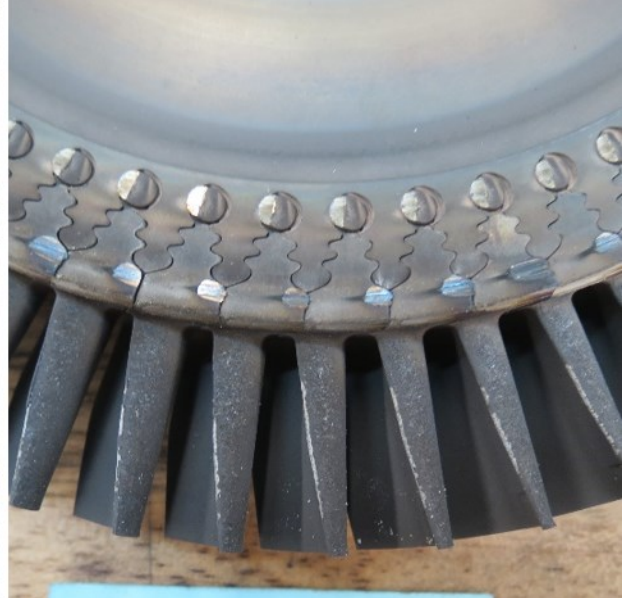
Figure 55. CT disk assembly upstream side

The upstream side of the CT disk assembly exhibited 360° circumferential rub along the blade platforms and retention rivets. See Figure 56. A light circumferential rub was observed on the disk hub downstream side.

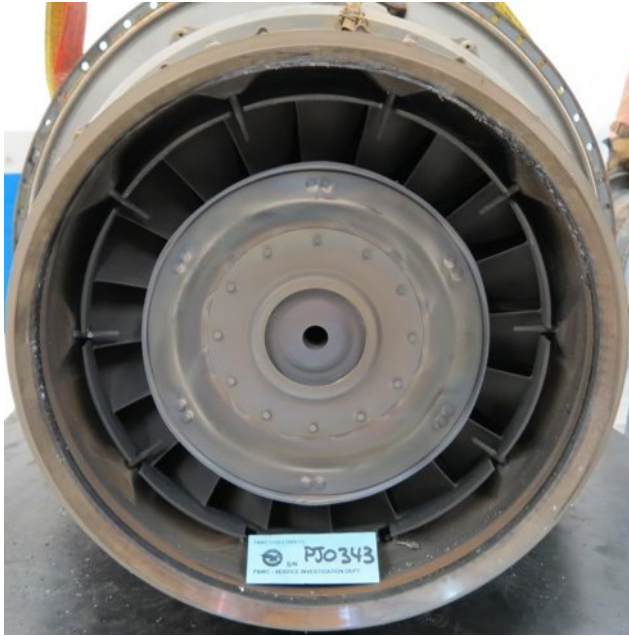
Figure 56. PT S1 vane ring

There was a very light circumferential rub on the upstream side of the S1 PT vane ring baffle. See Figure 58.

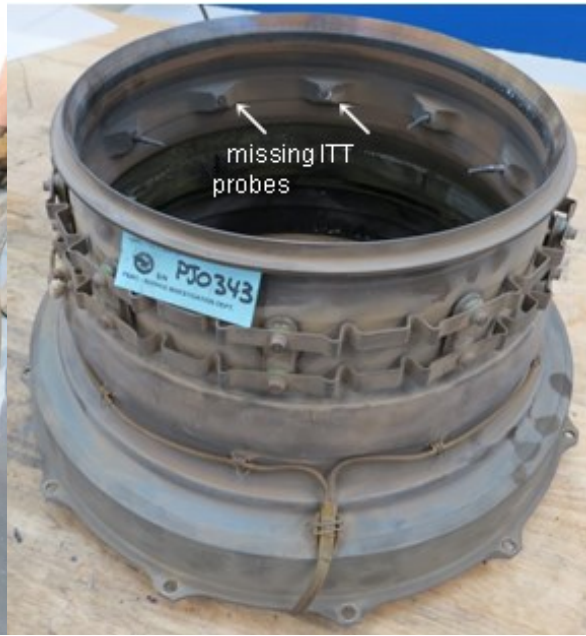
Figure 57. PT housing

The PT housing was intact. See Figure 57.
