NATIONAL TRANSPORTATION SAFETY BOARD
Office of Aviation Safety
Washington, D.C. 20594

POWERPLANT GROUP CHAIRMAN'S FACTUAL REPORT

NTSB No: CEN14LA239

Aircraft: Cessna 525C, Registration Number N718MV

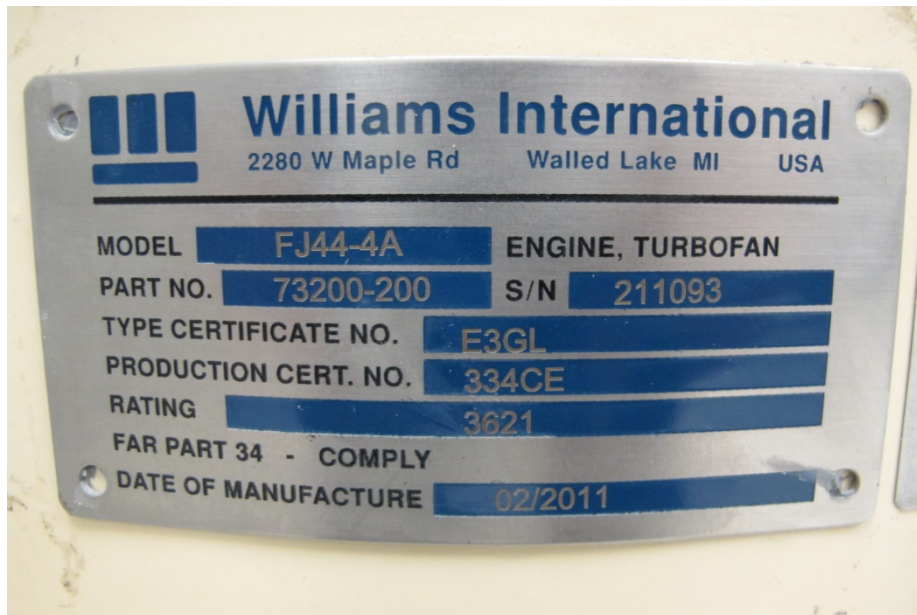
Photo 2- Engine Data Plate

The engine was shipped to the Williams International facility in Commerce Township, MI for inspection and partial disassembly (**Photos 1 and 2**). A visual examination of the engine was conducted beginning at the inlet.

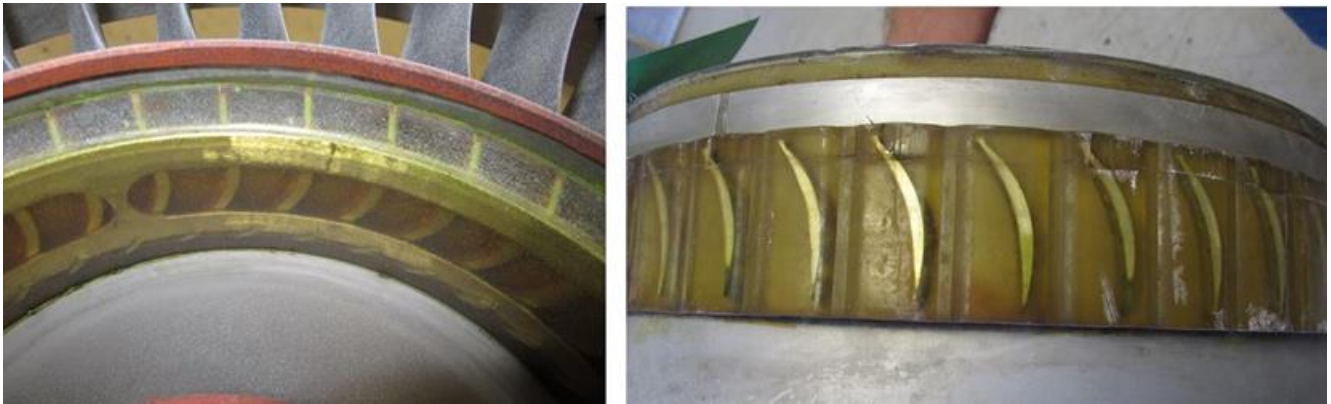
Photo 10- Castable Polyurethane Elastomer on Representative Fan Stator Assembly

In order to better examine the thermal damage to the fan stator assembly, the fan and fan case and stator assembly were removed. As noted earlier, the fan stator had green residue seeping from vane connection points along the inner and outer shrouds (**Photo 9**). The stator vanes are secured in the case with a castable polyurethane elastomer. The elastomer is green and melts when exposed to temperatures above 140-150°F. A representative stator assembly with focus on the elastomer is shown in (**Photo 10**). The outer diameter of the fan stator is manufactured out of aluminum and exhibited bulging in multiple locations consistent with thermal exposure.
