**NATIONAL TRANSPORTATION SAFETY BOARD**  
**Office of Aviation Safety**  
**Washington, D.C. 20594**

**POWERPLANT GROUP CHAIRMAN'S FACTUAL REPORT**

**NTSB No: DCA15FA185**

Aircraft: British Airways, Boeing 777-236ER, registration number G-VIIO, flight number 2276

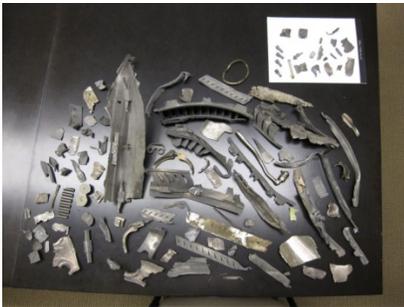
**PHOTO 3: METALLIC DEBRIS  
COLLECTED FROM RUNWAY  
07L**

According to witnesses statements by airport personnel, video tape evidence, and flight data recorder (FDR) data, the accident flight started its takeoff roll on runway 07L at the intersection of taxiway A8 and runway 07L. The airplane then experienced a No. 1 engine failure and subsequent fire about 1,030 feet after the takeoff roll start, and came to a full stop about 1,927 feet from the start of takeoff roll (**FIGURE 4**)<sup>7</sup>. After the event and prior to the arrival of the investigative team, airport personnel walked runway 07L and the grassy area about 50 feet on either side of the runway to recover any engine/airplane debris. Several boxes/bags of debris were collected. According to airport personal cleaning runway 07L, the first metallic part was found on the south right runway edge line at about the 1,000 foot threshold marker and no other metallic debris was found until about the 3,000 foot mark. At the 3,000 foot mark, the vast majority of the metallic debris was collected (**PHOTO 3**). Between the 3,000 foot mark and where the airplane was stopped (about 4,500 foot mark), only soft material was recovered consistent with honeycomb and cowling type material. The debris was examined by the investigative team and pieces of cowling, HPC stator vanes segments, HPC blade dovetails and platforms, and several pieces of the HPC stage 8-10 spool along (**PHOTOS 4 and 5**, and **FIGURE 5**) with various pieces of case and manifold (plumbing) were recovered.

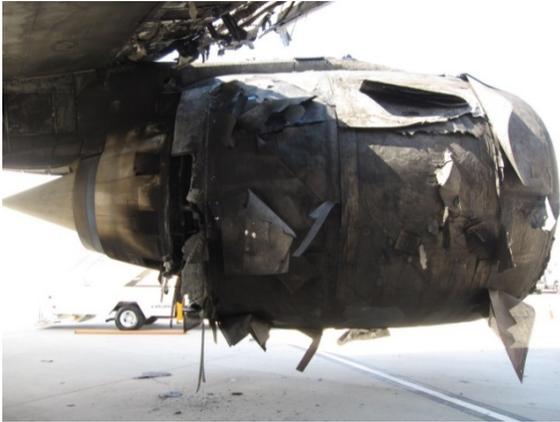
In general, the right side of the engine exhibited far more thermal/fire distress than the left side (**PHOTOS 6 and 7**).

**PHOTO 6: RIGHT SIDE OF ENGINE**

Thermal distress/fire damage was only noted on the right side of the engine strut - the left side was in good condition and no soot patterns were noted (See **PHOTOS 6** and **7**). The right side of the engine strut was burned, charred and on some of the panels the epoxy binder was missing and the composite plies were loose (**PHOTOS 23** and **24**). No burn through holes were noted. All the access panels were CLOSED and latched except for the pressure/relief and fire detector access panel which was partially OPEN, melted, and the latch missing (**PHOTO 24**).

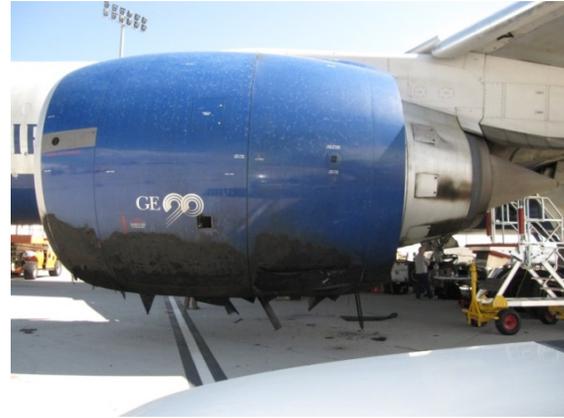
**PHOTO 7: LEFT SIDE OF ENGINE**

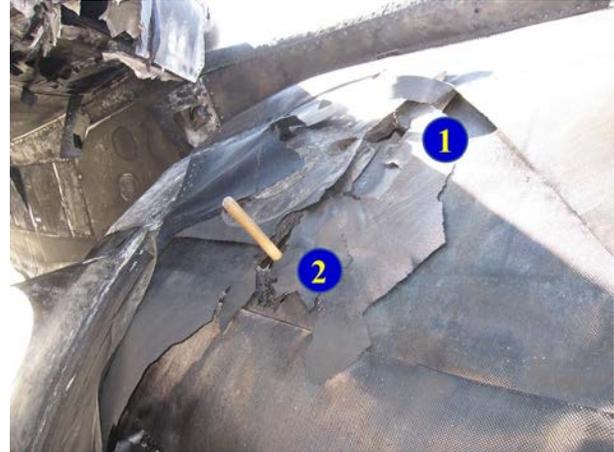
The TR exhibited the most thermal distress of any of the nacelle components. The right TR translating sleeve was heavily thermally damaged/burned (charred and loose composite sheets with almost all of the epoxy binder missing) and two confirmed penetration holes: 1) located at 1:30 o'clock position and 49 inches forward of the rear flange measuring 3 x 4 inches, 2) located at 2:00 o'clock position and 44 inches forward of the rear flange measuring 5.5 x 3 inches. The distance between the centers of the penetration holes was about 14 inches. Broomstick handles were placed in the penetration holes to provide a general fragment exit direction (**PHOTOS 9-12**). The trailing edge of the translating

**PHOTO 10: RIGHT TR THRU-HOLES – FORWARD LOOKING AFT - EXIT ANGLE FROM HOLE 2**

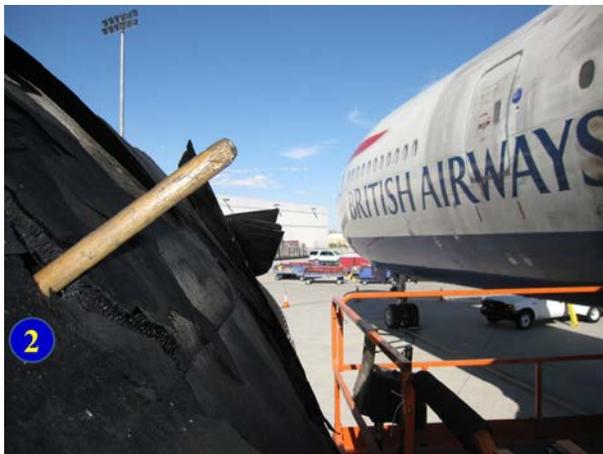
**PHOTO 11: RIGHT TR THRU-HOLE – AFT LOOKING FORWARD -EXIT ANGLE FROM HOLE 2**

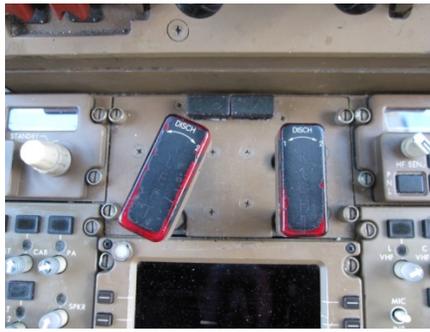
Examination of the cockpit revealed that both thrust levers (throttles) were against the aft stops, both fuel control<sup>10</sup> cutoffs knobs were in the down and CUTOFF position (**PHOTO 16**) and the No. 1 engine fire handle was pulled and twisted to the right in the direction of the No. 2 bottle discharge position (**PHOTOS 17** and **18**). The No. 2 engine fire handle was found not pulled and straight.

**PHOTO 17: ENGINE FIRE SUPPRESSION HANDLE POSITIONS FOR BOTH ENGINES**

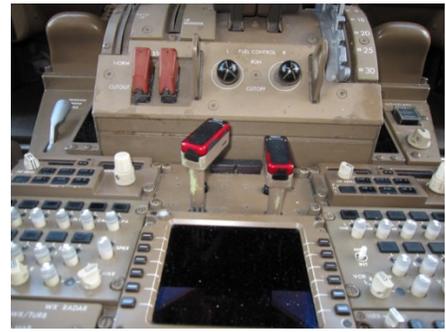
**PHOTO 18: No. 1 ENGINE FIRE SUPPRESSION HANDLE PULL AND TWISTED TO THE RIGHT**

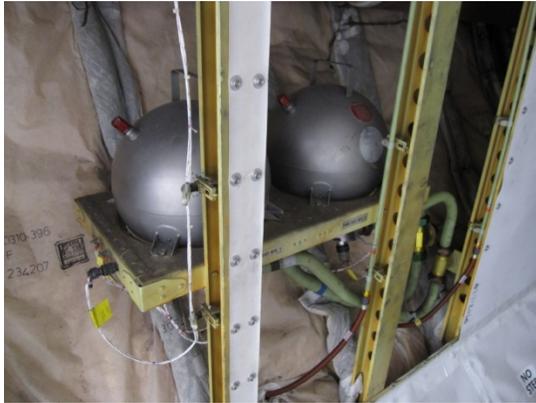
There are two fire suppression bottles for the engines – bottle 1 and bottle 2 – and the bottles are shared by both engines. Each fire suppression bottle has a dedicated discharge port for each engine. The engine fire suppression bottles are located in the forward right cargo bay (**PHOTO 19**). A continuity check was conducted to determine if the fire suppression bottles were discharged by checking the pressure switch for each of the two fire suppression bottles. The electric connector was disconnected from the pressure switch and continuity was confirmed from pins 1 and 3 on each of the fire suppression bottles; this is consistent with low or no pressure in the bottles. When the fire suppression bottles are under normal pressure, the pressure switch is in the OPEN position; when low or no pressure, the switch is in the CLOSED position. After the continuity check was completed, both engine fire suppression bottles were removed to examine the detonation devices to see if they had been discharged. Visual examination of the discharge ports of each bottle revealed that the detonation device in one of the discharge ports in each bottle was missing the percussion cap which is consistent with the bottle being discharged (**PHOTOS 20** and **21**). The part number for both engine fire suppression bottles are Boeing PN 34600042-1, manufacturer (Pacific Scientific) PN 5303W001-1 with the forward most bottle SN 14986F1 and the rearmost SN 20644F1. According to the manufacturer's specification, the empty

**PHOTO 19: ENGINE FIRE SUPPRESSION BOTTLES  
INSTALLED IN THE CARGO BAY**

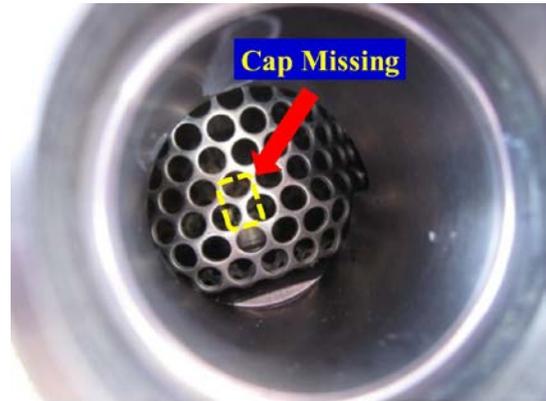
**PHOTO 20: DETONATION DEVICE WITH THE  
PERCUSSION CAP MISSING**

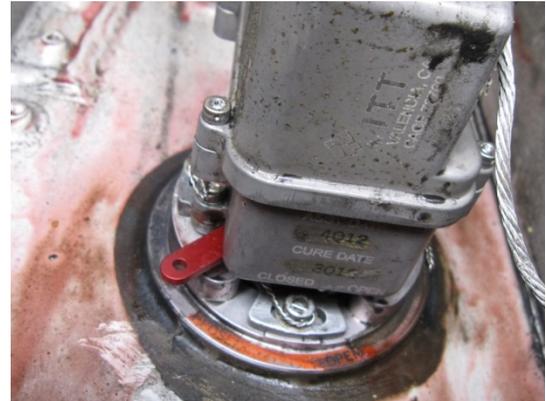
weight of the fire suppression bottle is 16.4 pounds. The No. 1 fire suppression bottle weighed about 15 pounds and the No. 2 weighed about 16 pounds with the scale reading in whole pound increments. The left wing (No. 1 engine) spar valve actuator was accessed through the bottom of the left wing and visually the actuator was in the CLOSED position (**PHOTO 22**).

**PHOTO 22: LEFT WING (NO. 1 ENGINE) REAR  
SPAR ACTUATOR IN CLOSED POSITION**

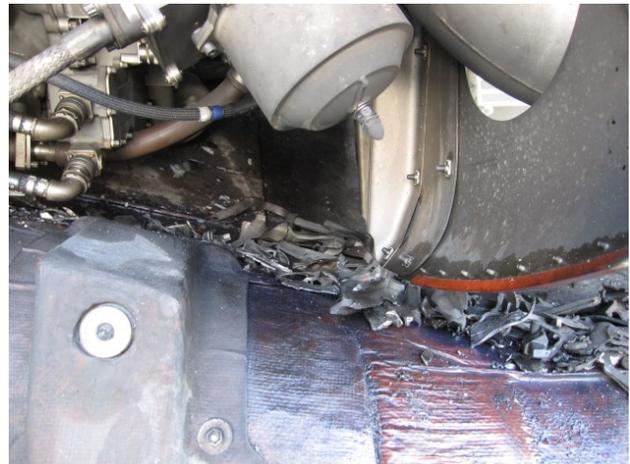
With the fan cowls removed, visually the fan case appeared in good condition and was free of soot and the full authority digital engine control (FADEC) appeared in good condition. The left TR was removed first, followed by the right TR. Debris was collected from within the TR (**PHOTO 25**), from the ground beneath the engine as the TRs were removed, as loose pieces became dislodged after removing hardware from the engine to facilitate shipping, and as the engine was removed from the airplane. All loose metallic debris was examined and pieces consistent with the HPC stage 8-10 spool, such as pieces of the forward rabbeted flange, seal teeth sections, and circumferential blade slot sections were shipped to the NTSB metallurgical laboratory in Washington DC for failure and material analysis.

**PHOTO 25: UNDERCOWL ENGINE DEBRIS**

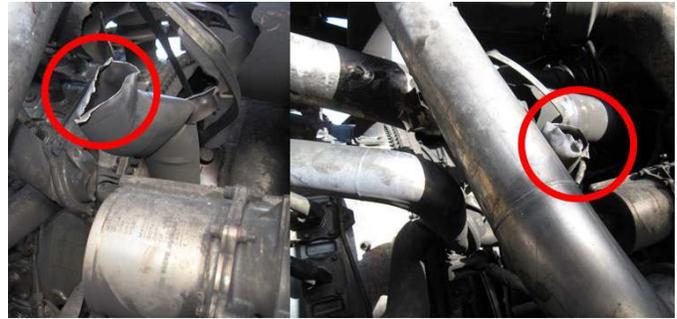
The right engine thrust link, located at about the 1:00 o'clock position was severed in-plane with the HPC aft extension case (**PHOTO 26**). Several bleed ducts from the 2:00 – 3:00 o'clock position were severed in-plane with the HPC aft extension case (**PHOTO 27**). The HPC stage 10 bleed duct was disconnected from the HPC aft extension case – the tube and case were intact, all the attachment bolts were fractured (**PHOTO 28**). The main fuel supply line was intact; however, the inlet elbow of the main fuel pump (MFP) housing was fractured; the fuel supply line was completely separated from the pump and pieces of the elbow remained attached to the main fuel supply line (**PHOTO 29**).

**PHOTO 27: EXAMPLES OF SEVERED DUCTING**

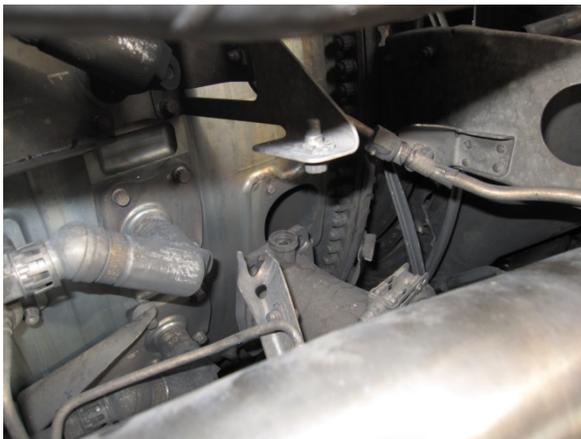
**PHOTO 28: HPC STAGE 10 BLEED DUCT SEPARATION**

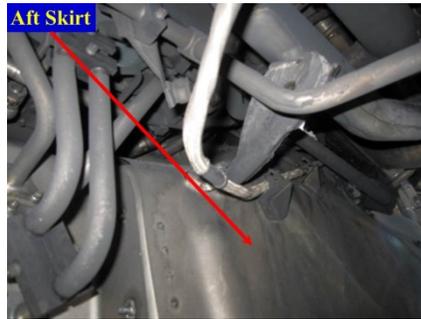
The engine heatshield exhibited numerous exit penetration holes centered about the 5:00 o'clock position in-line with the breach in the HPC aft extension case (**PHOTO 32**). The engine heatshield aft skirt was pierced by a section of what appears to be part of the HPC aft extension case flange (**PHOTOS 33 and 34**).

**PHOTO 33: ENGINE HEATSHIELD AFT SKIRT – FRONT SIDE**

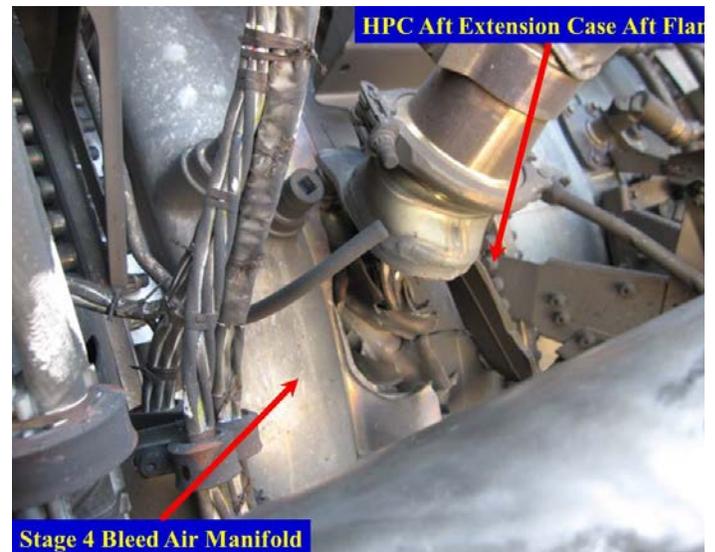
The HPC aft extension case was breached circumferentially from about the 11:30 – 5:00 o'clock position (58 inches circumferentially) (**PHOTOS 37 and 39**) and axially from the stage 4 bleed manifold to the rear flange. The case skin was missing but in those areas where it remained, the case skin was torn and pushed outwards. A breach of the HPC aft extension case was also located at about the 9:30 o'clock position, coincident with a HPC stage 7 bleed port (**PHOTO 40**), and the case skin was torn, pushed outwards, and pieces of compressor debris were wedged in the tear. The tear measured about 10 inches circumferentially x 2.5 inches axially.

**PHOTO 40: HPC AFT EXTENSION CASE BREACH AT 9:30 O'CLOCK POSITION**

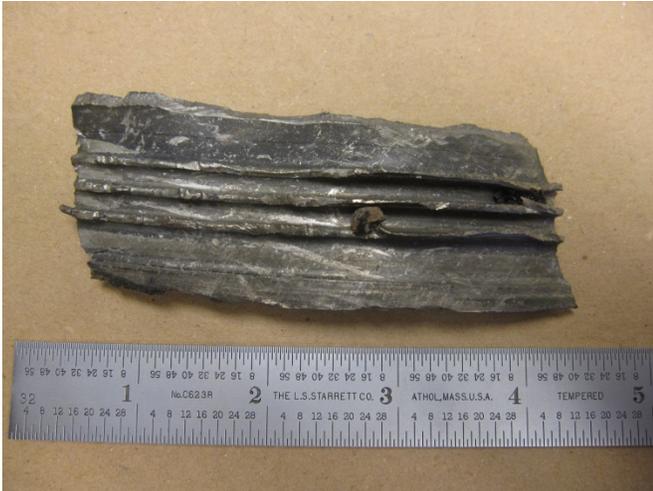
A preliminary trajectory analysis was performed by GE and Boeing using FDR data, video of the event, and witness statements from airport personnel to determine a search area for engine debris that departed the engine (**FIGURE 7**). On September 15, 2015, a group comprised of persons from GE, Boeing, BA, and the NTSB walked from the intersection of taxiway A8 to taxiway A6 along the south edge of runway 07L and from taxiway A7 to the airport perimeter south fence. Two pieces consistent with the HPC stage 8-10 spool with seal teeth were recovered on the south east corner of the intersection of taxiway A7 and runway 07L (**PHOTOS 43** and **44**). A HPC stage 8 blade platform was also recovered in the center of taxiway A7, just north of runway 07R.

**PHOTO 43: RECOVERED HPC STAGE 8-10 SPOOL FRAGMENT FROM INTERSECTION OF TAXIWAY A7 AND RUNWAY 07L**

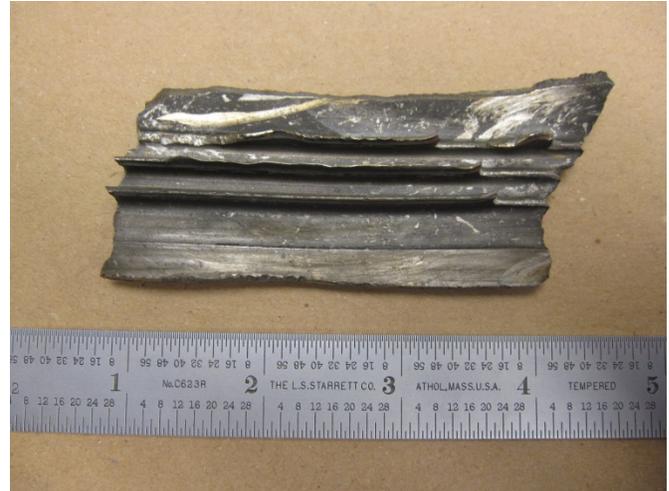
**PHOTO 44: RECOVERED HPC STAGE 8-10 SPOOL FRAGMENT FROM INTERSECTION OF TAXIWAY A7 AND RUNWAY 07L**

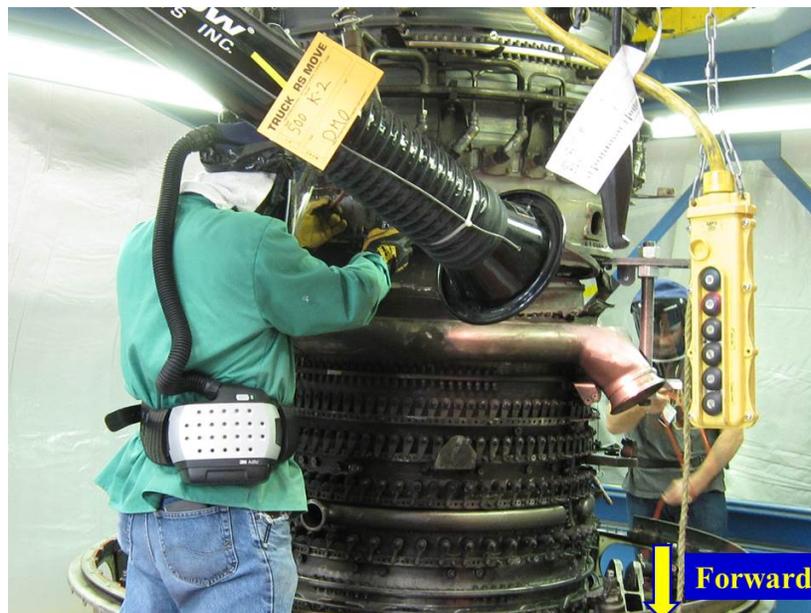
With the fan module removed, the engine was rotated vertically on its nose to facilitate the cutting of the HPC aft extension case. A hand held grinder was used to cut through the HPC aft extension case that remained intact, essentially cutting from the 5:00 to 11:30 o'clock position (**PHOTO 49**).

**PHOTO 49: CUTTING OF THE HPC AFT EXTENSION CASE TO REMOVE HPC STAGE 8-10 SPOOL PIECES**

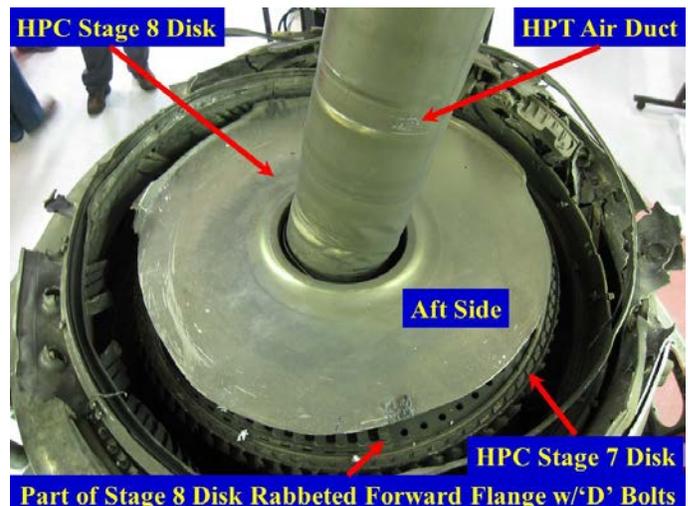
After cutting through the HPC aft extension case, the back end of the engine was lifted off and the HPC stage 9 and 10 disks remained with the back portion (**PHOTO 50**). The HPC stage 8 disk remained with the forward end along with the HPT air duct. The HPC stage 8 disk was fully detached from the stage 7 disk, and the HPT air duct was loose within the bore (**PHOTO 51**). The stage 8 disk was fractured circumferentially about 200° around just at the transition radius of the web to the blade circumferential dovetail slot rim. About 37 inches of the dovetail slot rim remained attached to the disk (**PHOTO 52**).<sup>13</sup>

**PHOTO 51: HPC STAGE 8 DISK LOOSE & SITTING ON THE IMPELLER TUBE ASSEMBLY & THE HPT AIR DUCT LOOSE WITHIN THE DISK BORES**

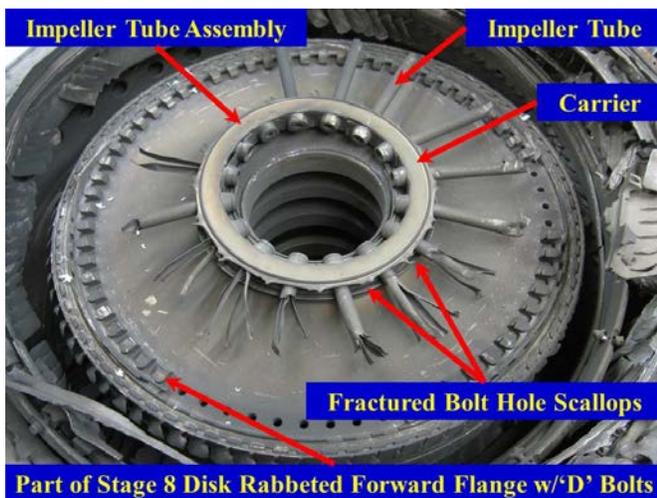
With the HPC stage 8 disk removed, the impeller tube assembly was exposed. The impeller tube assembly was fractured and detached from the front side of the stage 8 disk, and the carrier was ovalized; no longer round. The attachment flange on the impeller tube assembly carrier was partially present with all the bolt hole scallops pulled through and fractured. Some of the impeller tubes were fractured at the carrier, some were fairly intact, and some were splayed open (PHOTO 53). The mating attachment flange on the stage 8 disk forward side was completely fractured and missing (PHOTO 54).

**PHOTO 53: DAMAGED IMPELLER TUBE ASSEMBLY**

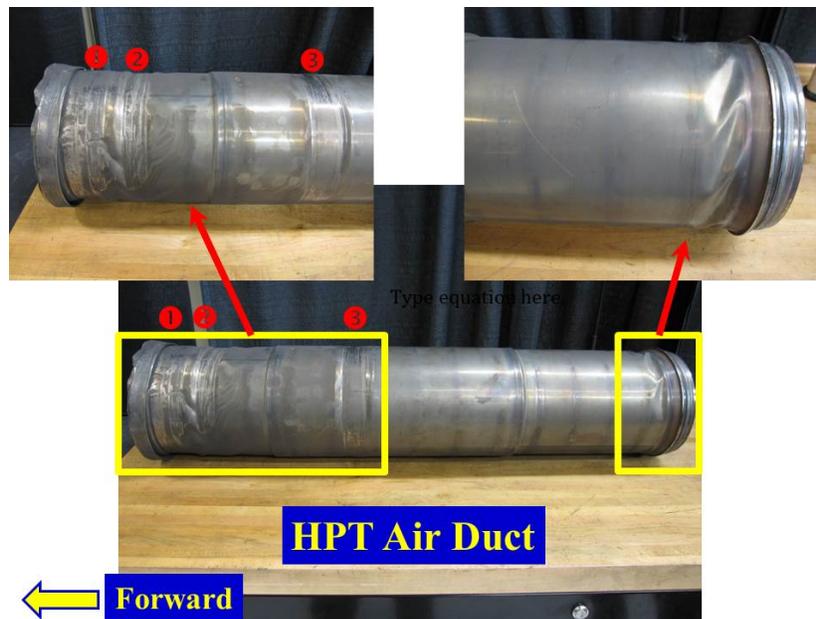
The HPT air duct was twisted and distorted (consistent with torsional buckling) at both ends of the duct. The forward portion of the air duct exhibited three separate, about 180° circumferential, rub marks/contact marks and the locations of those marks were consistent with contact with the stage 8 (1), 9 (2) and the CDP seal (3) bores (PHOTO 57). The forward seal land that mates with the seal on the stage 7 disk was damaged and exhibited circumferential rubs.

**PHOTO 57: HPT AIR DUCT DAMAGE – TWISTING AND PARTIAL CIRCUMFERENTIAL SCORING**

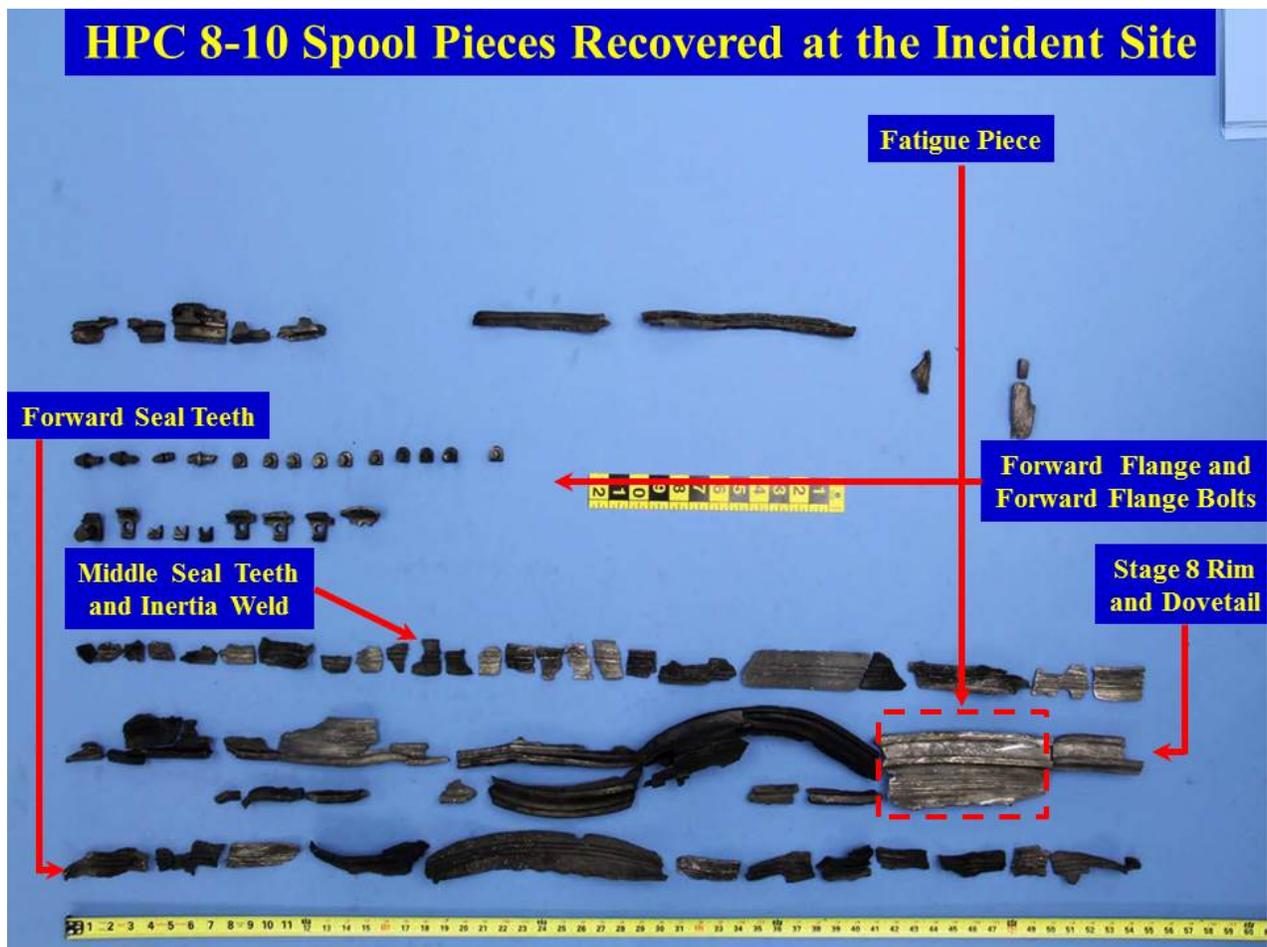
All the HPC stage 8-10 spool pieces that were recovered on-site were shipped to the NTSB Material Laboratory in Washington DC for further examination. A group comprised of members from GE, FAA, and the NTSB convened at the NTSB Material Laboratory on September 14, 2015 to commence examination of the hardware and completed their work on September 15, 2015. For complete details of the metallurgical findings, see Materials Laboratory Factual Report No. 15-131, dated January 15, 2016. After aligning the recovered pieces of the stage 8 disk, it was determined that just less than 50% percent of the stage 8 outer rim had been accounted for (**PHOTO 58**).

**PHOTO 58: HPC STAGE 8-10 SPOOL PIECES RECOVERED ON-SITE. PIECE WITH FATIGUE HIGHLIGHTED**

Examination of all the stage 8 fragments revealed a piece (See **PHOTO 58** and **PHOTO 4 -** leftmost piece) with a tinted/discolored flat-fracture region oriented in the circumferential plane located approximately 0.9 inch inboard of the blade slot bottom at the thinnest part of the web (web thickness in this area conformed to print dimensions of 0.118 inches) (**PHOTOS 59** and **60**). Detailed examination of the flat fracture region indicated that the fracture initiated along the aft face of the disk and initially progressed in an intergranular mode before gradually transitioning to a transgranular mode consistent

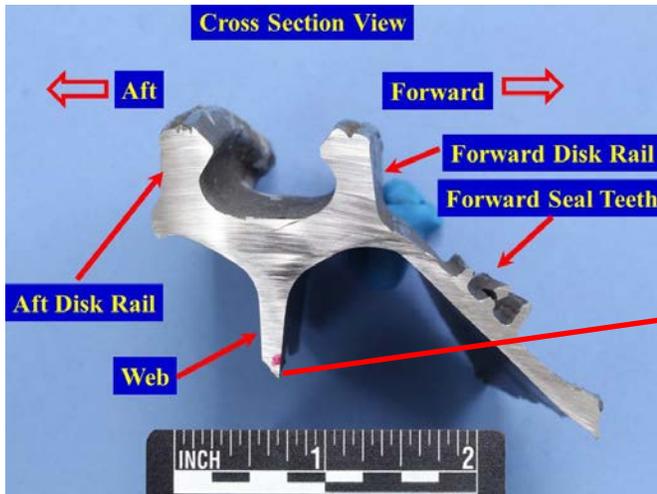
PHOTO 59: CROSS-SECTION - GENERAL LOCATION OF CRACK

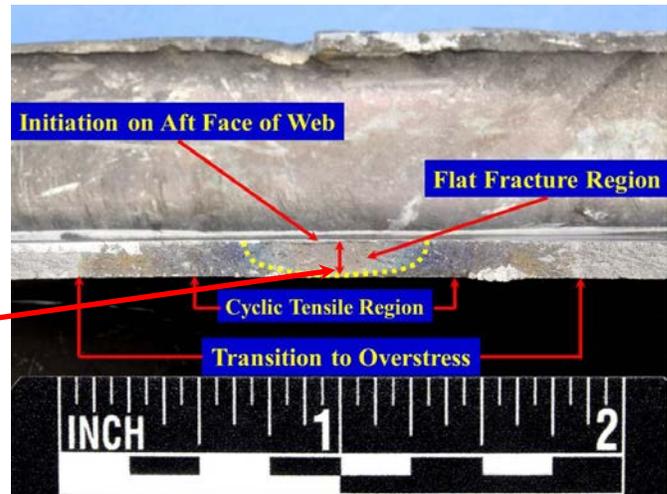
with low-cycle fatigue (LCF) (PHOTO 61).<sup>14</sup> As the crack continued to progress in LCF, the flat-fracture region transitioned to a tinted/discolored slanted-fracture region (see the region labelled cyclic tensile in PHOTO 60). Taken together, the tinted/discolored regions extended through the web in the forward/aft direction (approximately 0.118 inch) and approximately 1.7 inch in the circumferential direction. Outside of this region, the appearance of the fracture surface was consistent with a tensile overstress fracture.

PHOTO 60: FRACTURE ORIGIN AT HIGHER MAGNIFICATION

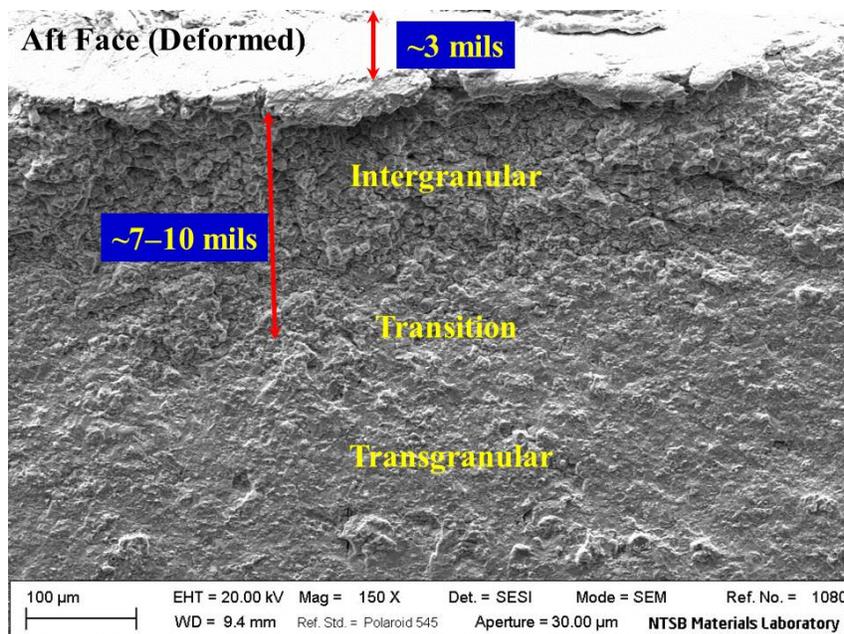
PHOTO 61: SCANNING ELECTRON MICROSCOPE IMAGE OF FRACTURE SURFACE

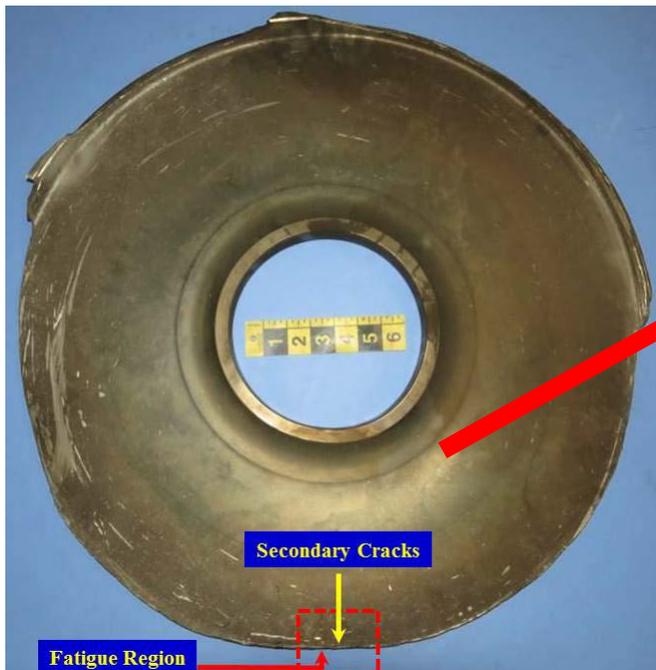
at the fracture origin on both fracture halves at the aft surface (fracture origin) and according to GE was consistent with post-fracture, event-related impact damage.

**PHOTO 62: STAGE 8 DISK SHOWING FATIGUE REGION AND SECONDARY CRACK LOCATIONS**

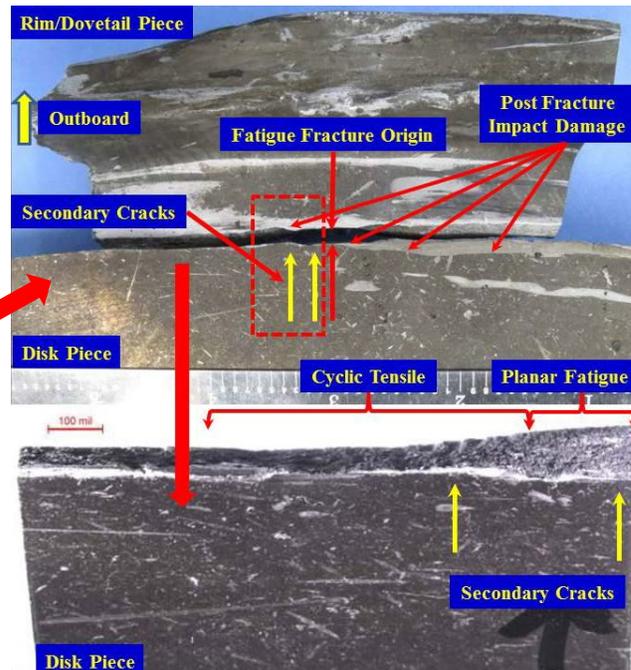
**PHOTO 63: STAGE 8 DISK AND MATCHING RECOVERED RIM/DOVETAIL SECTION SHOWING FATIGUE REGION AND SECONDARY CRACK LOCATIONS**

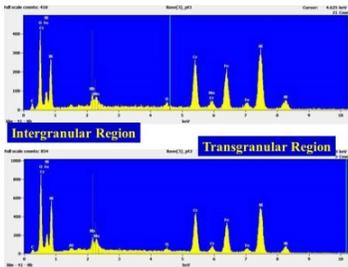
Metallographic mounts adjacent to the origin area (excluding the post-fracture surface damage) showed no microstructural anomalies. A SEM energy dispersive spectroscopy (EDS) of the fracture surface revealed only elements consistent with the specified material - Inconel<sup>®</sup> 718DA<sup>17</sup> (PHOTO 64). Etching confirmed that the grain structure was as specified and also that no heat affected zones were present (PHOTO 65). Micro-hardness traverses on the forward and aft sides of the disk revealed that the material had the proper hardness on both sides, between 46-48 on the Rockwell Hardness “C” Scale (HRC) (PHOTO 66). Further analysis of the intergranular region using techniques such as high high-resolution SEM and transmission electron microscopy (TEM)<sup>18</sup> did not reveal any detrimental species at the grain boundaries, only base metal oxides.

**PHOTO 64: MATERIAL COMPOSITION**

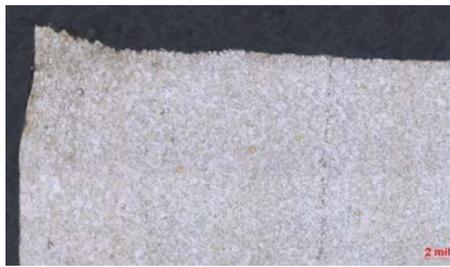
**PHOTO 65: ETCHED AND POLISHED FRACTURE SHOWING PROPER MICROSTRUCTURE**

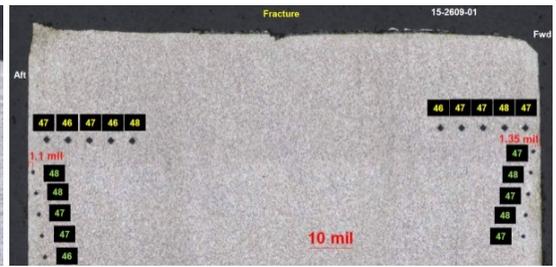
**PHOTO 66: MICRO-HARDNESS MEASUREMENTS AT VARIOUS LOCATIONS**

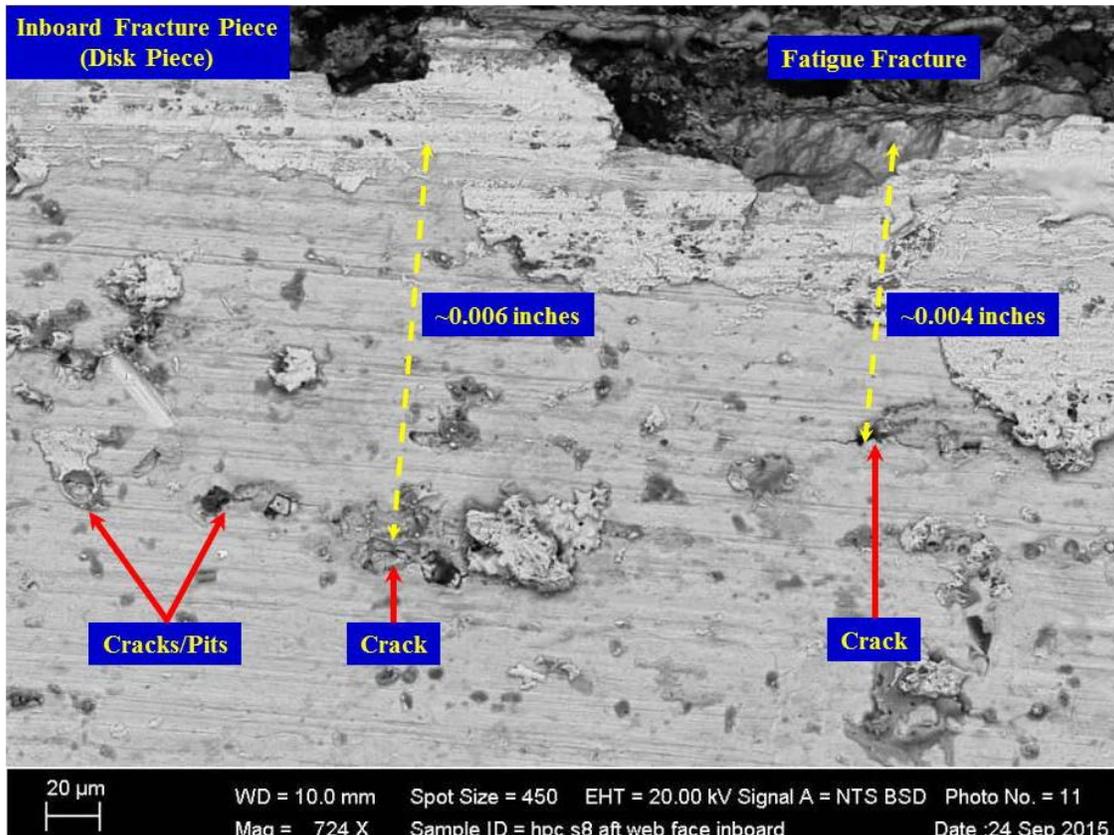
Multiple secondary circumferential cracks were found on the aft face of the web within 0.016 inches radially of and circumferentially adjacent to the fatigue region. The secondary cracks measured up to approximately 0.003 inches circumferentially by 0.0005 inches deep and initiated in a combination of intergranular/transgranular modes at the base of oxidized/etched carbides with no surface/microstructural anomalies (**PHOTO 67**). According to GE, based on the level of oxidation and circumferential orientation, the cracks were consistent with pre-existing fatigue cracks and were not event-related. Furthermore, since the secondary cracks were only localized in the area near the fracture origin, this indicates a locally high stress area. No damage or microstructural anomalies were found at the secondary cracks; similar to what was found on the primary fracture. No secondary cracks were found on the diametrically opposed side of the aft web in the same radial plane or on the forward face (with one exception at/near the slant fracture).

**PHOTO 67: SECONDARY CRACKING FOUND IN STAGE 8 DISK PIECE**

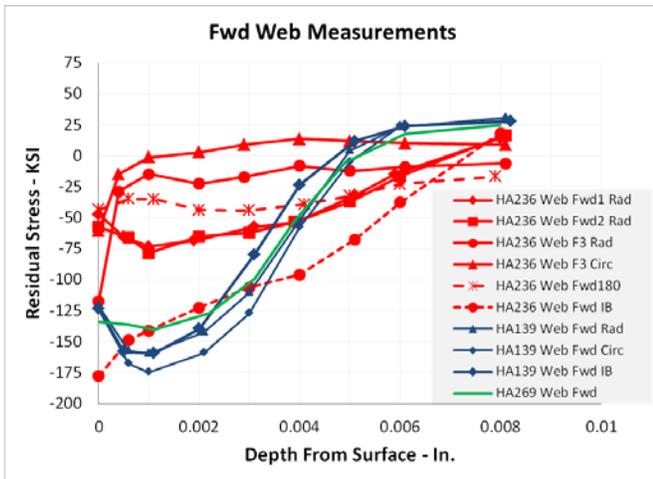
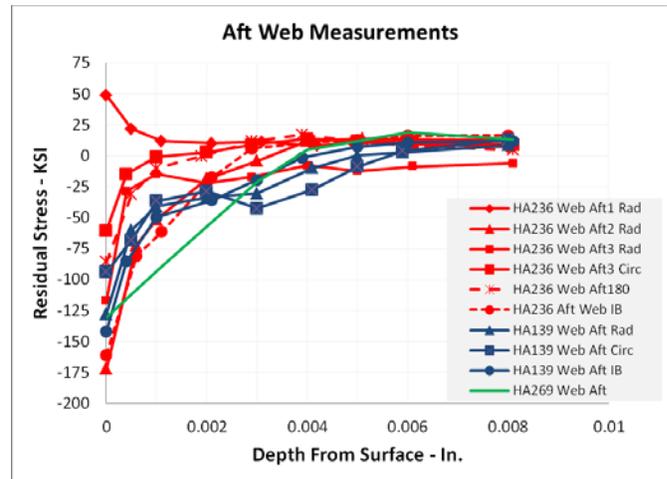
Examination of both the forward and aft face of the stage 8 web near the fracture radius found a visible difference in the shot peening appearance, with the forward web face having more pronounced peening dimples than the web aft face (**PHOTO 68**). Since no anomalies were noted at the fracture initial site, residual stress measurements were taken to determine the effect that the variation of the peening may have on the part. The measurements were taken on the event disk on both the forward and aft faces of the web at the fracture origin and at the opposite side where the dove tail slot was still in place. Measurements were also taken on two out-of-service HPC stage 8-10 spools of similar vintage (sister spools) for comparison. According to GE, the results showed that on the forward web, the sister spools' compressive profile conformed to expectations for a well peened surface. However, the forward web on the event disk was less compressive near the fracture surface but approached the expected profile further inboard radially (**FIGURE 10**). For the outer aft web, all the disks – the event and sister spools – showed compressive profiles that did not conform to expectations with a well peened surface but according to GE the profiles and surface variation were consistent for as-turned surfaces with little or no peening (See **APPENDIX C** in GE laboratory report for details) (**FIGURE 11**). Along with residual stress measurements, GE performed two additional measurements/tests; LCF testing and strain (grain distortion) measurements. LCF testing was conducted on specimens of the event stage 8 disk and comparison disks. All but one of the fatigue samples conformed to the GE average life curve for the specified material (See **APPENDIX D** in GE laboratory report for details). One sample from the event disk fell between the average life curve and the minimum life design curve. Strain measurements of the event web material near the fracture origin or the secondary cracks were taken to determine if there was any additional work that may have been pre-existing beyond the normal machining and peening inducted stresses. According to GE, the uniform level of strain on the aft face was less than on the forward side but was consistent with the difference in the peening observed on each side of the web (See **APPENDIX D** in GE laboratory report for details).

**FIGURE 10: FORWARD WEB RESIDUAL STRESS**

**FIGURE 11: AFT WEB RESIDUAL STRESS**

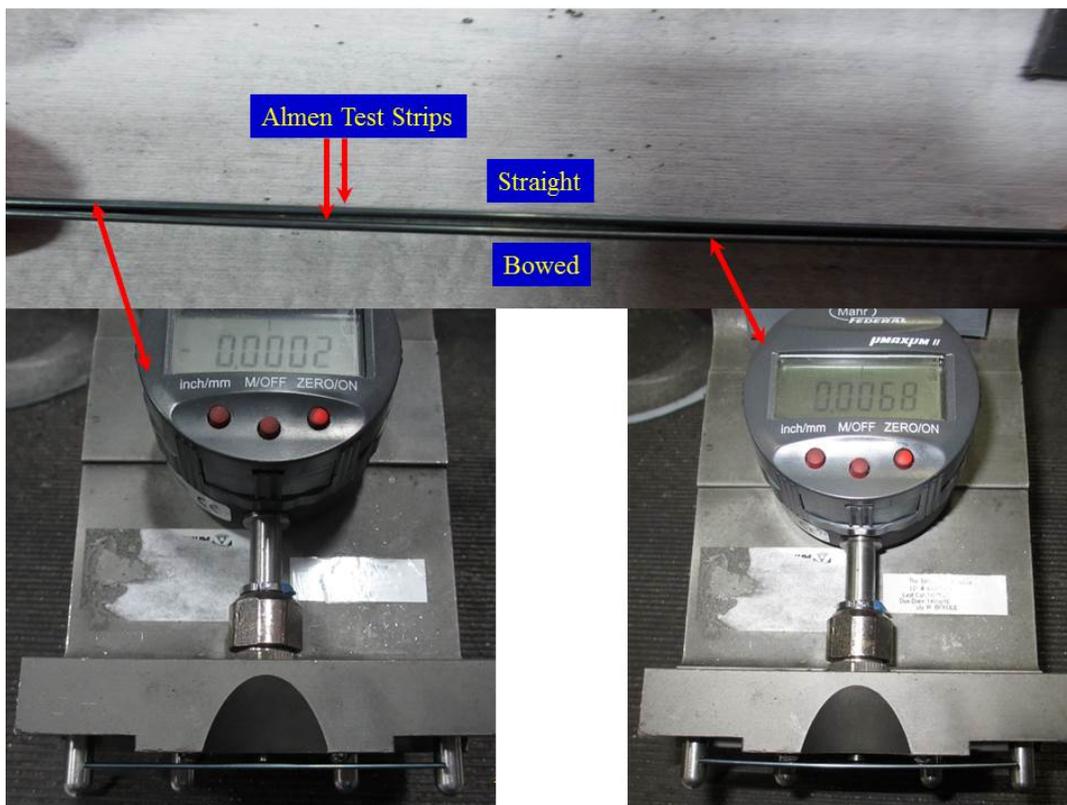
For the event 'M80' spool, surface coverage (% saturation), peening intensity, peening locations, and required intensity verification locations are all called out on the part drawing. The intensity is specified as 0.005-0.008 inches using the 'A' strip (PHOTO 69) and the intensity must be verified at the beginning and end of each run of a lot of parts and every eight hours of continuous running on a given set-up. Almen test strips are placed at designated locations on a scrapped part to verify intensity of the shot peening at those key areas. Review of the Almen test strip locations for the 'M80' part showed that the test strips were located on the forward (No. 21) and aft (No. 31) surfaces of the stage 8 disk web as well as on the ID surface underneath the middle seal teeth (No. 40B). No Almen test strips were located in the area of the fatigue fracture on the event 'M80' spool which was in the stage 8 disk web about 1 inch below the stage 8 blade slot. A review of the 'M90' Almen test strip locations revealed: 1) there was a significantly greater number of test strip locations than what was on the event 'M80' and 2) no test strips locations for 'M90' spool are in the same vicinity of the fatigue fracture found on the event 'M80' spool. Currently GE has added the Almen test strip for the 'M90' spool in the vicinity of the event 'M80' fracture location.

**PHOTO 69: EXEMPLAR ALMEN STRIP TEST FOR THE 'M90' SPOOL**

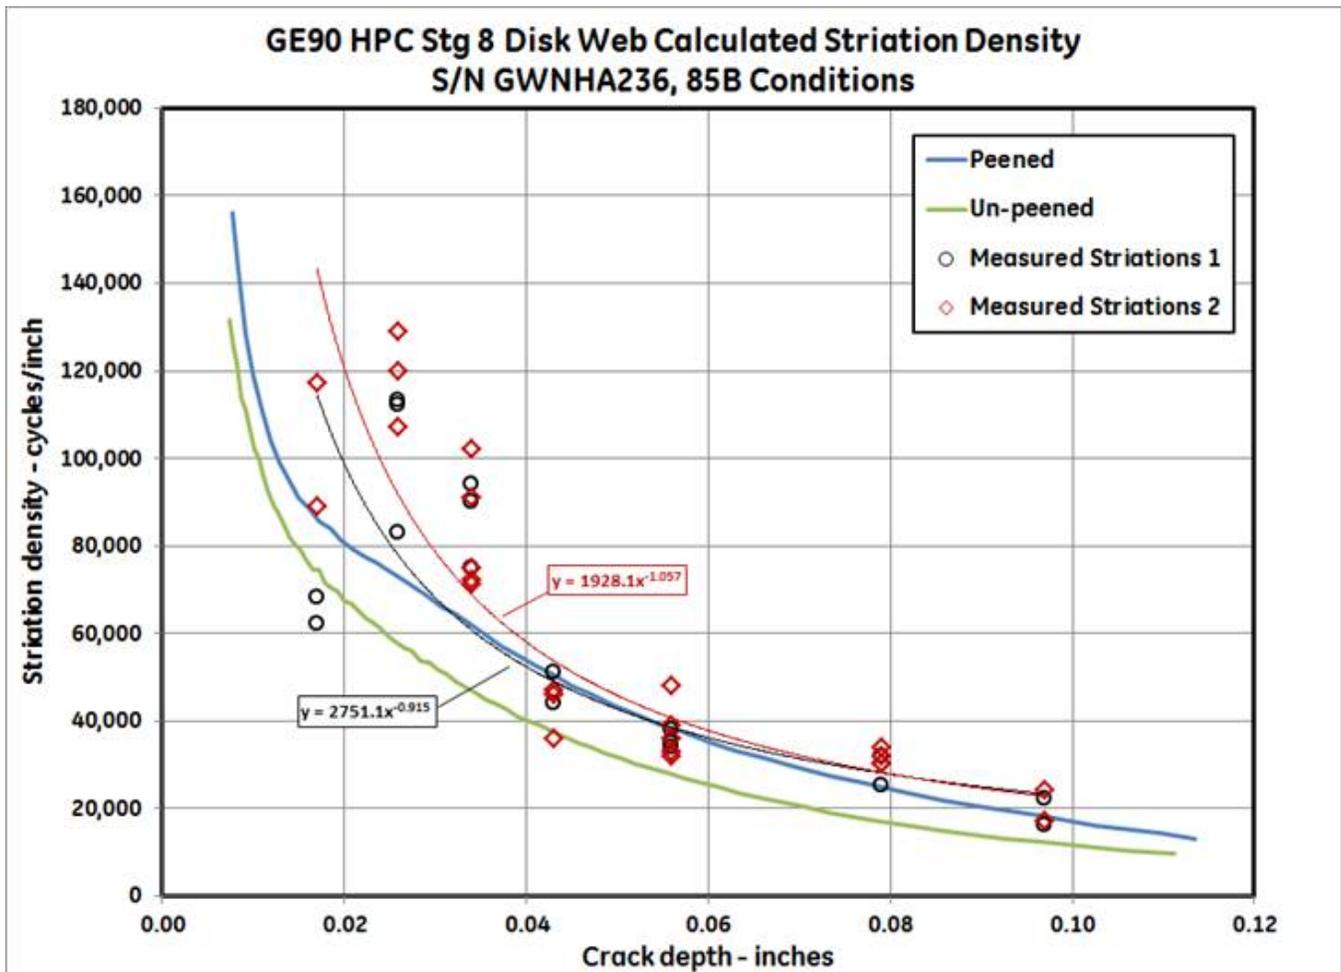
GE performed stress and lifing analysis on the event spool using standard LCF curves for minimum/average material thickness and properties at the GE-90-85B rating; this included all the MRB dimensions (‘oil canning’), BA specific operational mission (taxing time, takeoff thrust rating, shutdown, core speeds and temperatures, ambient takeoff temperature, etc.), and shutdown stresses, etc. Based on the analysis, the fracture location (stage 8 web) on the event spool has a calculated LCF life about 1.5 times (1.5x) ( $29,800/20,800 = 1.4$ ) greater than the event spool limiting feature (stage 8 disk-to-forward rabbeted flange transition radius) at the minimum material properties and about 9x ( $187,400/20,800 = 9$ ) at the average material properties. Based on the striation count analysis that the NTSB and GE performed, the crack initiated at roughly 6,000 CSN which is 5x ( $29,800/6,000=5$ ) less than the predicted value for the failure location under the worst conditions (highest stresses and temperatures and minimum material properties); the GE analysis could not close the gap between the predicted LCF crack initiation and the estimated actual event crack initiation. It should be noted that all the predictive calculations that GE performed could not close on the event crack location at the number of cycles that was thought to have initiated the crack; however, the striation density curves that were developed for the event spool match well with the analytical predictive crack propagation rate ([FIGURE 12](#)).

**FIGURE 12: STRIATION DENSITY CURVE**
