NATIONAL TRANSPORTATION SAFETY BOARD  
WASHINGTON, DC

PRATT & WHITNEY RESEARCH REPORT  
704297-2440

PRATT & WHITNEY AIRCRAFT GROUP  
Commercial Products Division

REQUESTED BY	P.E. Rowe		DEPARTMENT	Engineering	
SEND REPORTS TO	P.S. Hopper, H.L. Lemasters, R.J. Milkay, J.B. Moore, A.W. Oberg, P.E. Rowe, H.C. Schatta R.J. Bergenholtz, J.J. Carino, W.E. Cockerille, R.F. Conway, T.G. Figlioli, R.H. Haines.				
PART NAME	Hub - Front Compressor Front		MATERIAL	PWA 1215 (6A1-4V) Titanium-base Alloy	
PART NUMBER	749701C		HEAT CODE	WENS-2028	SERIAL NO. 5A5786
ENGINE TYPE	JT8D-7B	NO.	P-654892	MFG. Forging: Wyman-Gordon Machining: PWA - North Haven	
PART TIME	12,634 Hours/9,360 Cycles		OPERATED BY Pan Am (PA)

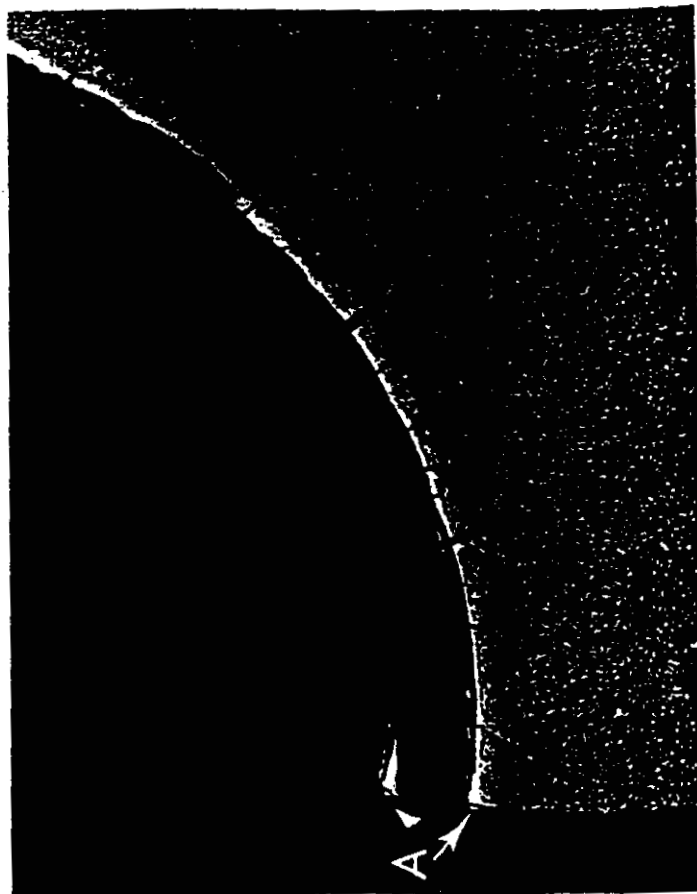
PHOTOMICROGRAPHS OF PLANAR SECTION (SECTION B-B SHOWN IN FIGURE 6)  
THROUGH GROOVE IN TIE ROD HOLE AT FATIGUE ORIGIN (ARROW A - LEFT)  
SHOWING DEFORMED AND WORK AFFECTED MICROSTRUCTURE (BRACKETS - RIGHT)  
AND MULTIPLE AXIAL CRACKS (ARROWS - LEFT AND RIGHT) SUGGESTIVE OF  
ABUSIVE MACHINING.
