**DOCKET NO.: SA-515  
EXHIBIT NO. 8J**

**NATIONAL TRANSPORTATION SAFETY BOARD  
WASHINGTON, D.C.**

**JTSD-200 SERIES FAN HUB INDUSTRY MEETING**

# JT8D-200 FAN HUB INDUSTRY MEETING AGENDA

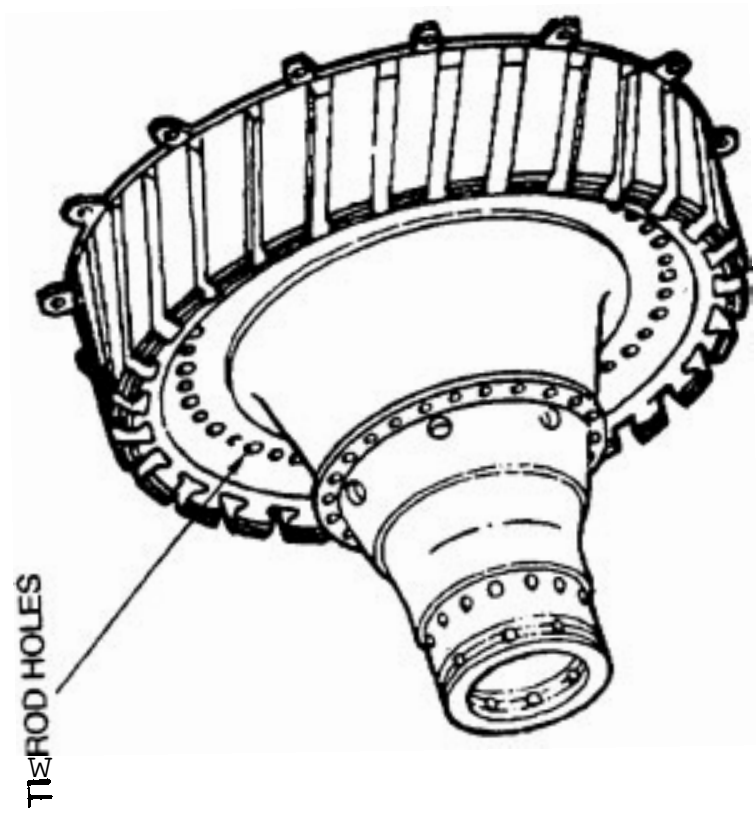
# JT8D-200 1 3/4" S. P. W. GE FOUN HUB

- Low cycle fatigue
- Originated from a localized area of work hardened / deformed material
  - Located 1/2 inch inboard of the aft face in the tierrod hole
- Striation count shows crack had been present for 12,000 to 13,000 cycles

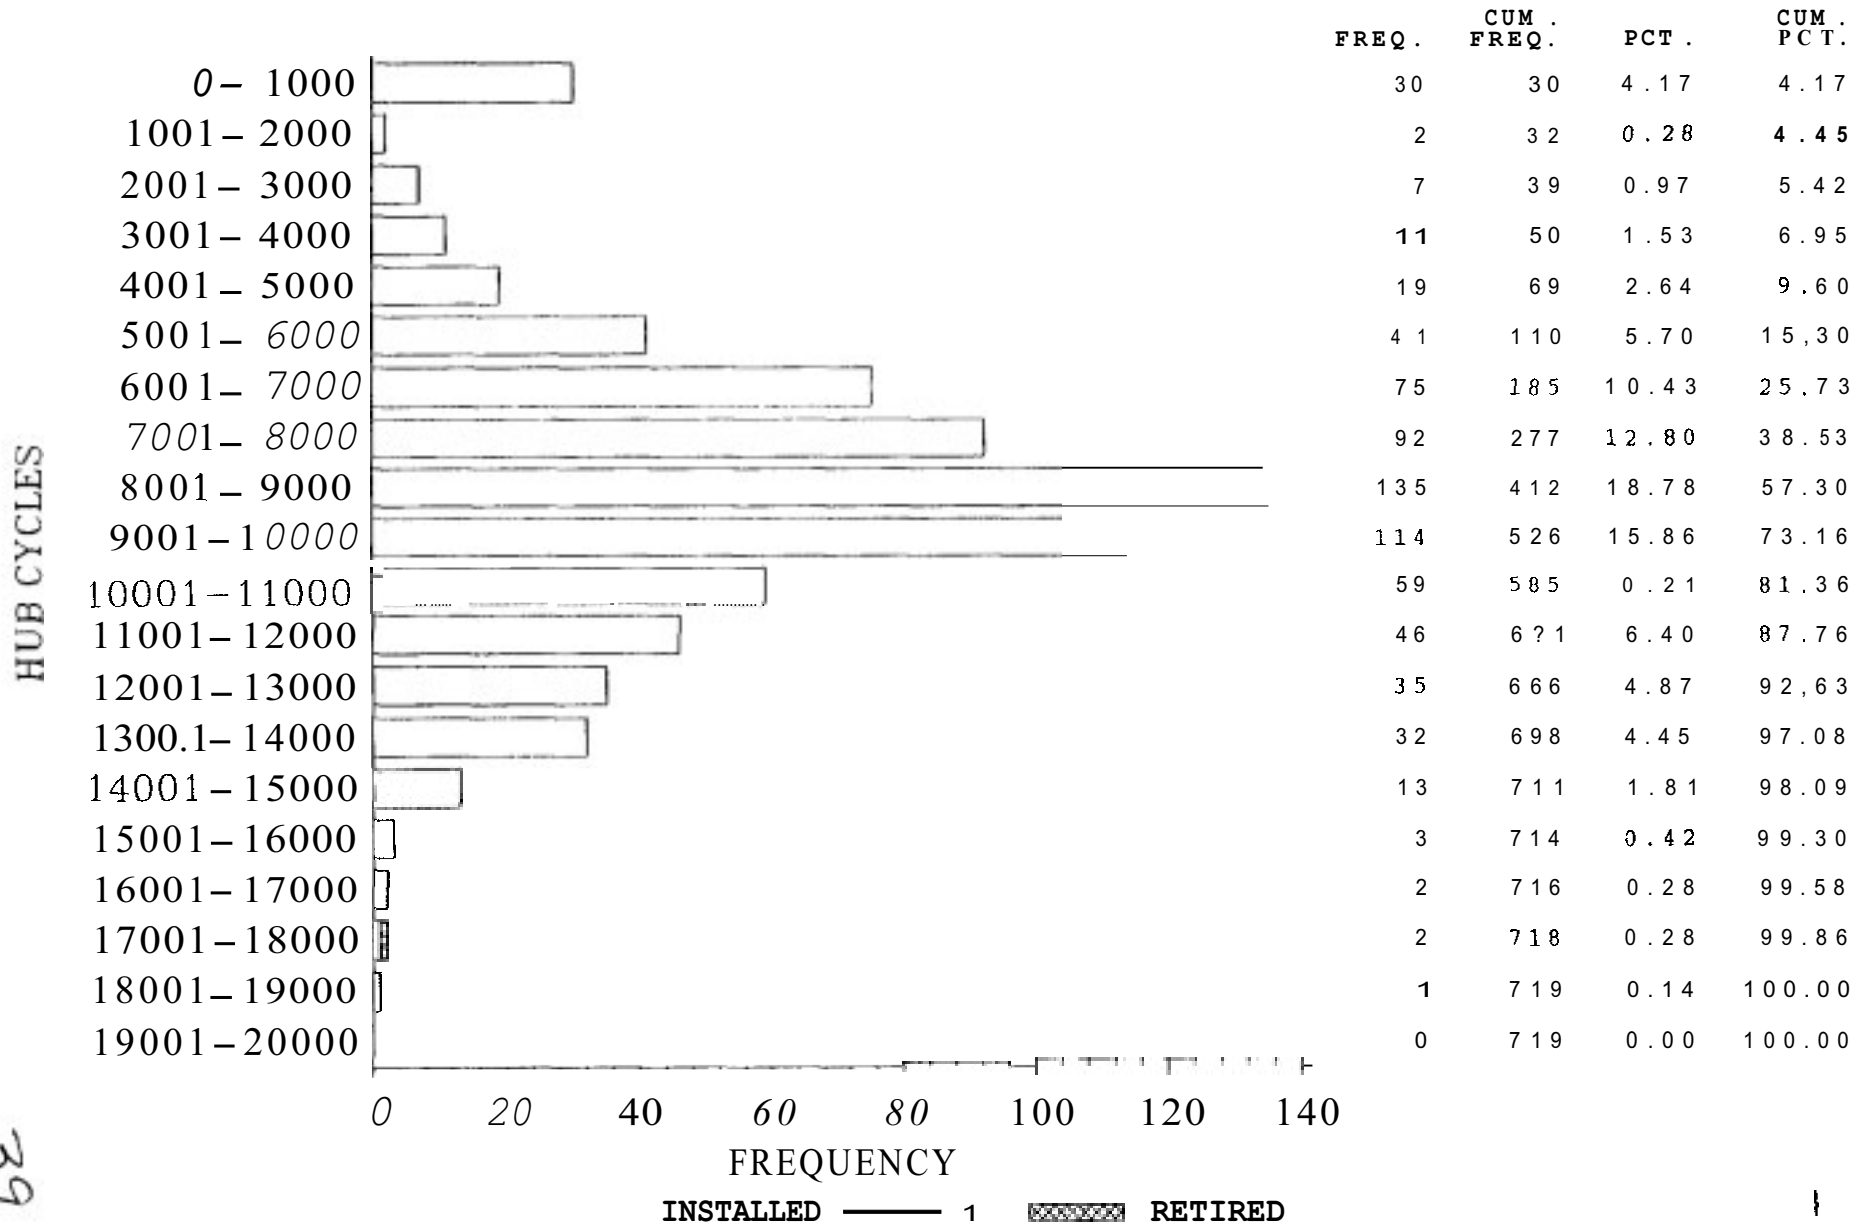
# JT8D-200 FAN HUB EST. CYCLES HISTOGRAM

## FAN HUBS MANUFACTURED WITH COOLANT CHANNEL DRILL

(AS OF 6/30/96)
