**NATIONAL TRANSPORTATION SAFETY BOARD**

**POWERPLANTS GROUP CHAIRMAN'S FACTUAL REPORT**

NTSB ID No.: ENG08IA038

Location: McCarran International Airport, Las Vegas, Nevada  
Date: August 6, 2008  
Time: 15:40 Pacific daylight time  
Aircraft: Boeing 757-232, N666DN, Delta Air Lines, Flight 624

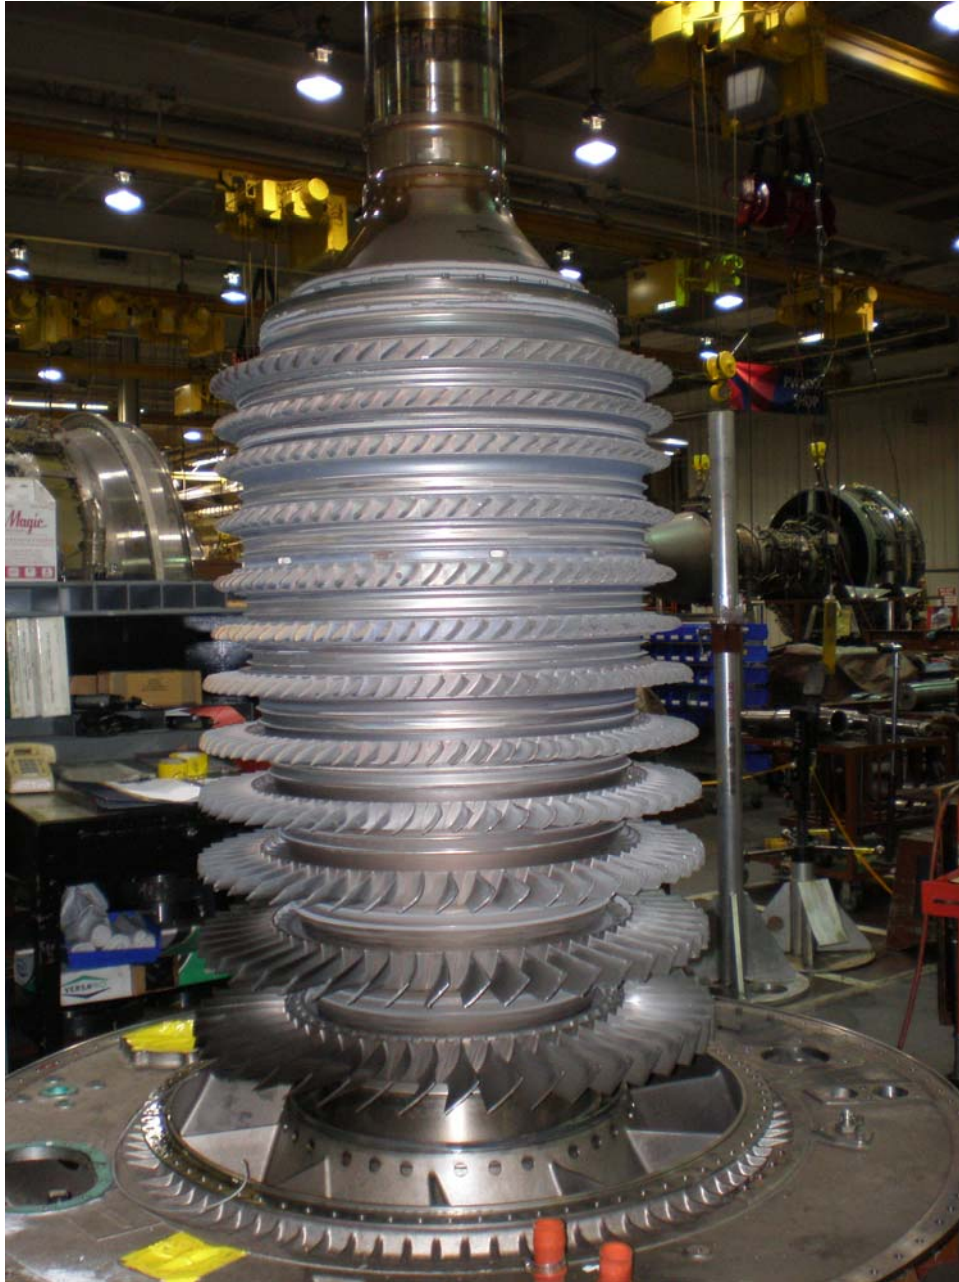
The HPC rotor was intact and all of the HPC blades were in place in the rotor. (Photo 17)

Photo 17: HPC rotor showing all of the blades were in place

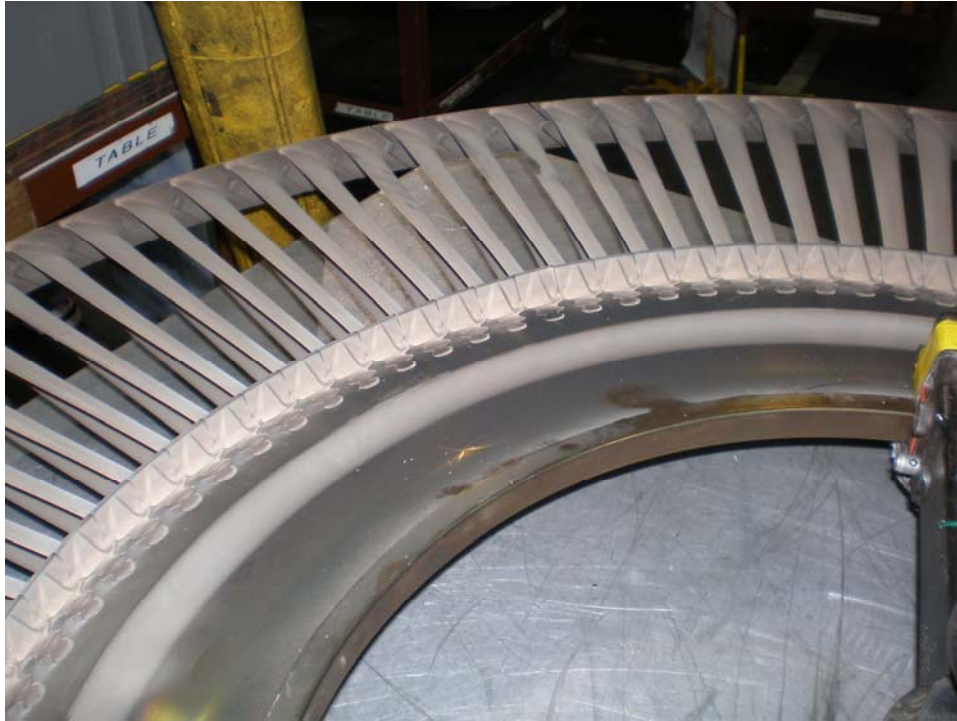
Photo 25: 5th stage turbine blades
