**NATIONAL TRANSPORTATION SAFETY BOARD
OFFICE OF AVIATION SAFETY
WASHINGTON, D.C. 20594**

Powerplant Group Chairman's Engine Factual Report

NTSB ID No.: DCA-07-MA-310

Aircraft: American Airlines McDonnell Douglas DC-9-82 (MD-82), N454AA, Flight 1400

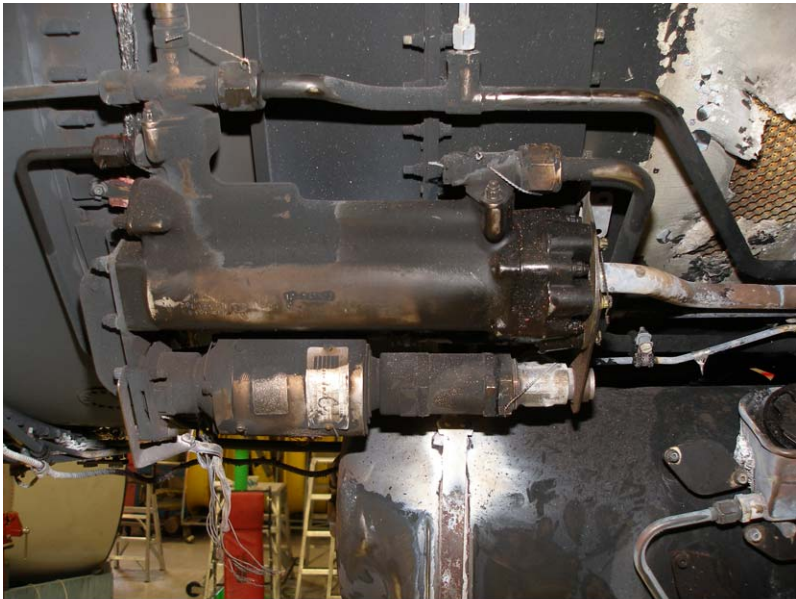
The housing of the alternating current (AC) generator exhibited a hole approximately 9-inches circumferential by about 2-inches axial on the left-hand side of the engine (Figure 21). The edges of the hole were melted and heat distressed. The coils

Figure 21 – AC generator housing breach

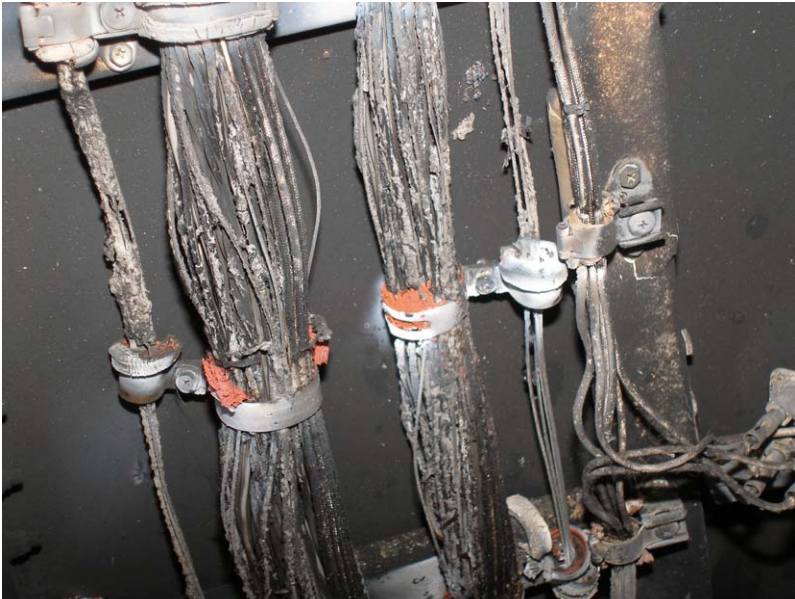
From the pylon connectors, the wiring harness routes vertically upwards until it reaches the top of the engine where it is fastened to a bracket. One wire bundle from the upper bracket attachment point then routes directly downward along the right side of the engine and at the 4 o'clock position it then turns forward and becomes distributed to the lower junction box and the Line Replaceable Units (LRUs) on the forward lower right engine area. All these lower wires were missing their insulation sleeves and were bare. A second wire bundle from the upper attachment point runs forward along the top of the engine. Near the front of the engine this bundle then becomes distributed into smaller bundles, which are then routed towards the bottom of the engine on the left side. There the smaller bundles are further distributed until single wires are visible and connect to their various plugs and connectors. Those bundles, which contained fewer than 20 wires near the bottom of the engine exhibited the most heat distress and were missing their insulation sheaths (Figure 24). Several connectors were missing, leaving loose bare wire ends.

Figure 24 – Wiring harness & connector damage details

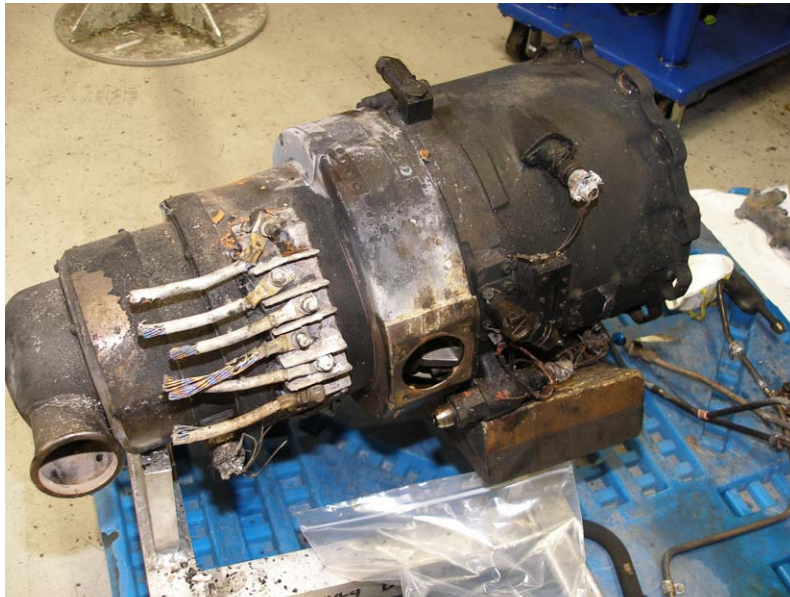
The external generator housing was dry and coated with a white deposit on the left-hand side (Figure 34). The remainder of the housing was coated with a sooty deposit. The 2-inches portion of the housing surrounding the field wires was melted from approximately 7 o'clock position to the 11 o'clock position. This axial location corresponded to the plane of the starter exhaust deflector. The exposed internal copper colored field wires appeared to be undamaged.

Figure 34 – CSD and AC generator
