**NATIONAL TRANSPORTATION SAFETY BOARD  
OFFICE OF AVIATION SAFETY  
WASHINGTON, D.C. 20594**

**POWERPLANTS GROUP CHAIRMAN'S FACTUAL REPORT**

**NTSB ID No.: ANC-06-FA-018**

Location: Ketchikan, Alaska  
Date: January 25, 2006  
Time: 1250 Alaska Standard Time  
Aircraft: Aero Vodochody L-39MS Registration N104XX

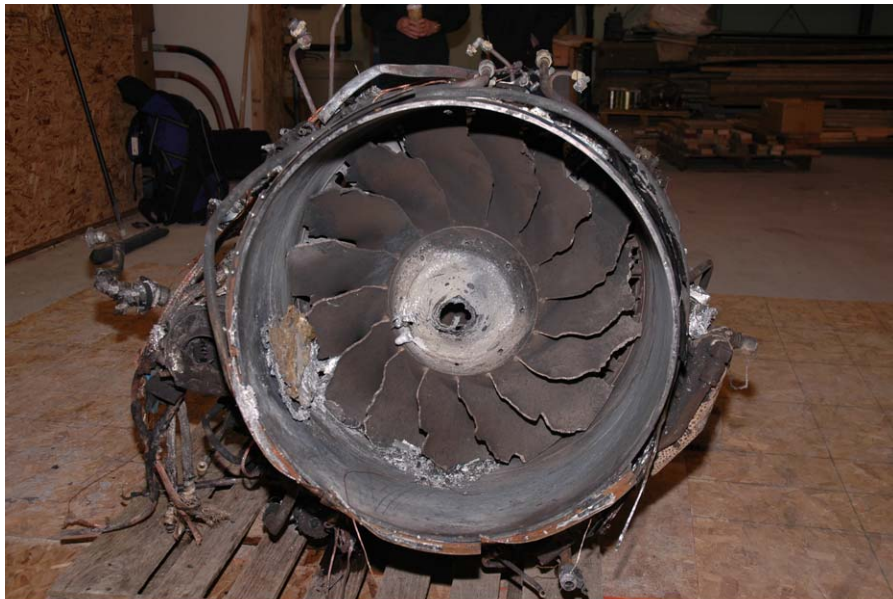
Figure 8 – Povazske Stroguarne DV-2 engine – Front looking aft

The engine was on its left-hand side on top of a palette (Figure 7, Figure 8, Figure 9 & Figure 10). The external surfaces of the engine, accessory gearbox and external accessories were coated with soot (Figure 11). The right side of the engine sustained considerable damage consistent with an external fire. The outer bypass duct, between the fan case aft flange and in front of the rear bearing housing, was burned and melted on the right side of the engine (Figure 12). There was no evidence of an in-flight fire. The engine core was generally intact from the inlet case to the fan exhaust duct. A 1-foot long segment of the aircraft exhaust duct was still attached to the aft exhaust flange. Approximately half the circumference of this duct was buckled. The fan containment ring portion of the fan inlet consists of the metal cylinder of the housing wrapped with black fibrous material around the outside (Figure 13). This fibrous material was burned on the right side of the engine. The insulation on the electrical wires on the right side of the engine was melted. The right corner of the accessory gearbox was fractured but the gearbox was otherwise intact.
