**NATIONAL TRANSPORTATION SAFETY BOARD
OFFICE OF AVIATION SAFETY
WASHINGTON, D.C. 20594**

POWERPLANTS GROUP CHAIRMAN'S FACTUAL REPORT

NTSB ID No.: ERA15FA221

Location: West Columbia, South Carolina
Date: May 23, 2015
Time: 0921 Eastern Daylight Time
Aircraft: BR Legend LLC, Turbine Legend, N42BR

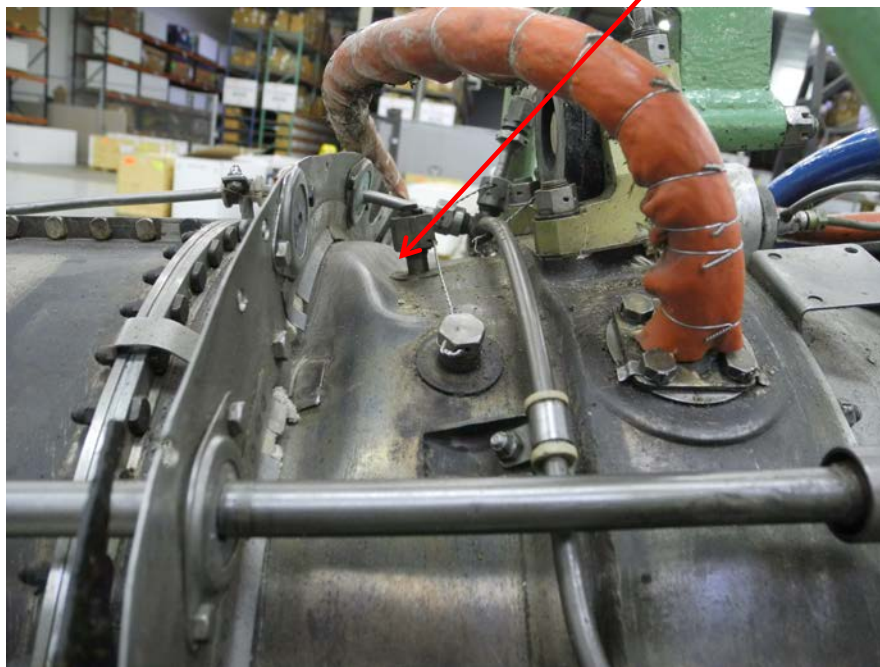
The accessory gearbox (AGB) was intact, attached, and appeared to be undamaged. The oil fill and check hardware was present and undamaged (Figure 10), however the fill port was not secure. The fuel pump and fuel control unit (FCU) (Figure 11) were still attached to the AGB and appeared to be undamaged. All the tube fittings and connections to and from the FCU and fuel pump were undamaged and secure.

Figure 10 – Oil Fill and Check Hardware

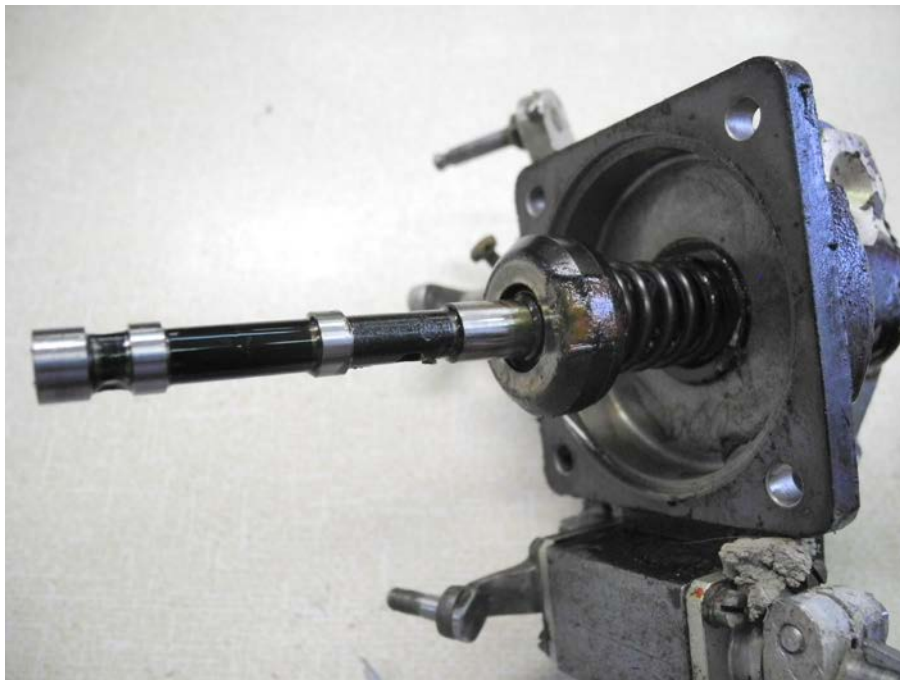
The propeller governor was externally impact damaged and could not be functionally tested. The internal cavities and components were all oil wetted and evidence of water ingress was found. The involute gear teeth and the side sealing faces of gear pump were undamaged as were the brass side seals (Figure 59). The rotating main shaft with the pilot valve, the speeder spring (Figure 60) and the flyweights (Figure 61) were mildly corroded, consistent with water contact; however, they were otherwise undamaged and free to operate. The beta valve was undamaged and free to rotate.

Figure 61 – PCU Flyweights – Undamaged and Free to Operate

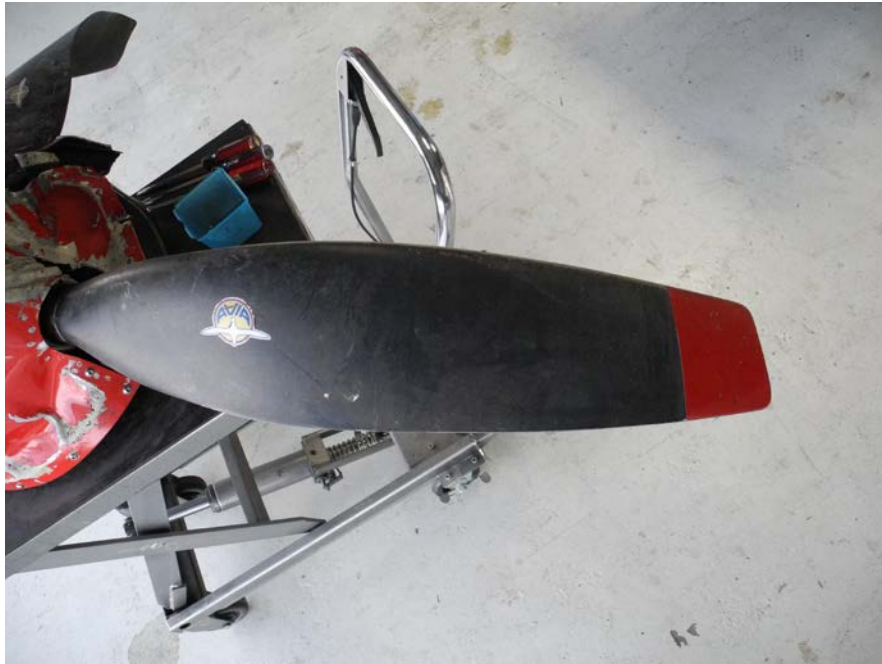
The propeller was retained until January 17, 2017, when it was transported to the Turbine Power Tech facility in Deland, Florida where it was dis-assembled and examined. The propeller was intact (Figure 63); however, the overspeed governor cover was missing. The spinner was present, however, it was battered, torn and crushed over the hub and counterweights. All 3 blades were bent aftwards in the form of a large radius and with only a minor amount of twist. The leading edges were all undamaged and the front, low pressure surfaces, exhibited no rotation score marks (Figure 64). The counterweights were all in their forward position, which is associated with a flat or fine blade pitch (Figure 65). The counterweight clamp locating keys were all in location and undamaged (Figure 66), confirming that the clamps were in their original location and had not rotated from their indexing position. All the blades were unscrewed from the blade bushings with normal effort and all threads were undamaged (Figure 67).

Figure 65 – Propeller – Front View – Depicting Counterweight Position During Impact

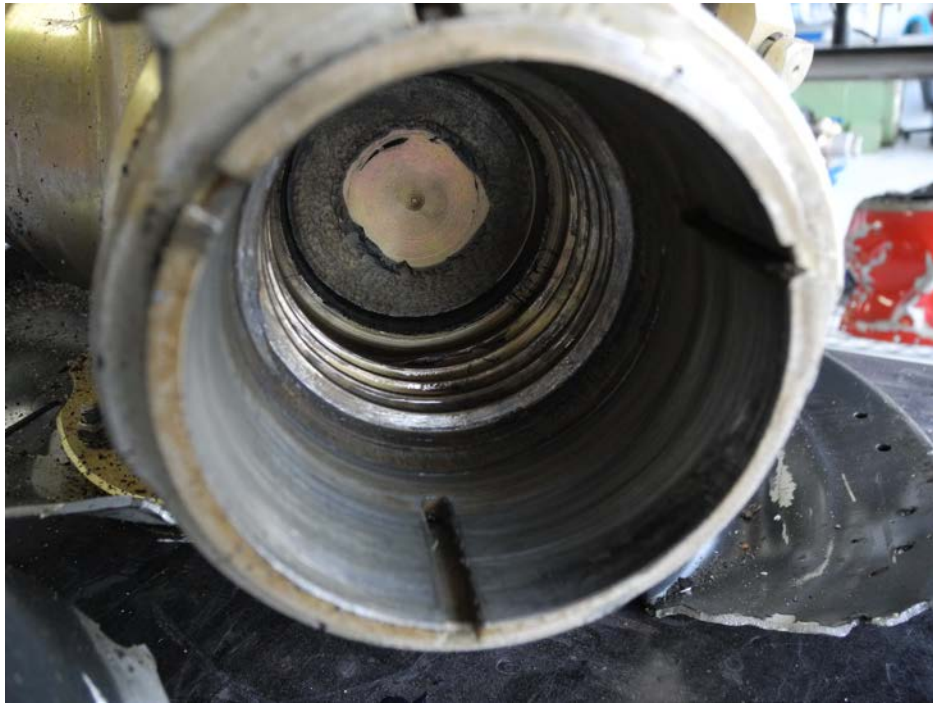
The cylinder was removed with normal effort and the internal bore was found undamaged (Figure 68). The piston and elastomer piston ring were also undamaged (Figure 69). The sliding fork and tube assembly operated smoothly (Figure 70); however, each of the three lower fork flanges exhibited one impact mark, consistent with contact against the crank flange of the blade bushings (Figure 71) during a propeller strike or impact.

Figure 68 – Cylinder - Undamaged
