NATIONAL TRANSPORTATION SAFETY BOARD
Office of Aviation Safety
Washington, D.C. 20594

POWERPLANTS GROUP CHAIRMAN'S FACTUAL REPORT

NTSB ID No.: WPR17FA179

Location: Rio Linda, California
Date: August 3, 2017
Time: 1503 Pacific Daylight Time
Aircraft: Michaelian, Lancair IV-TP, N420M

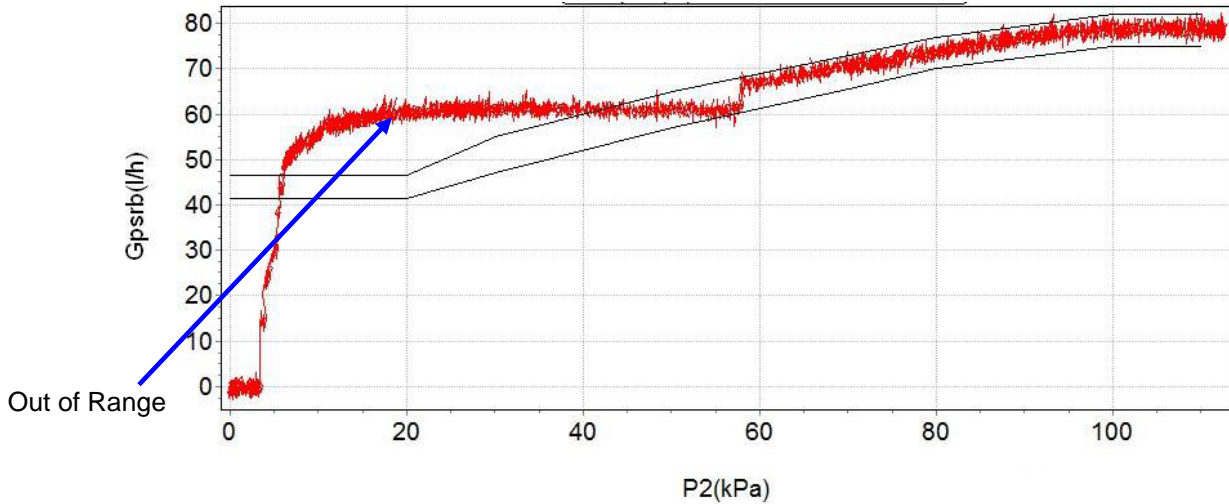
Graph 1 – Starting Performance

During the start FTP (Graph 1), the fuel flow response at the P2 (compressor discharge) pressures between 8 and 50 Kilo Pascals (KPa) is higher than nominal, which could be reflected as higher start temperature, however this is not a consideration during engine operation after start or during flight.

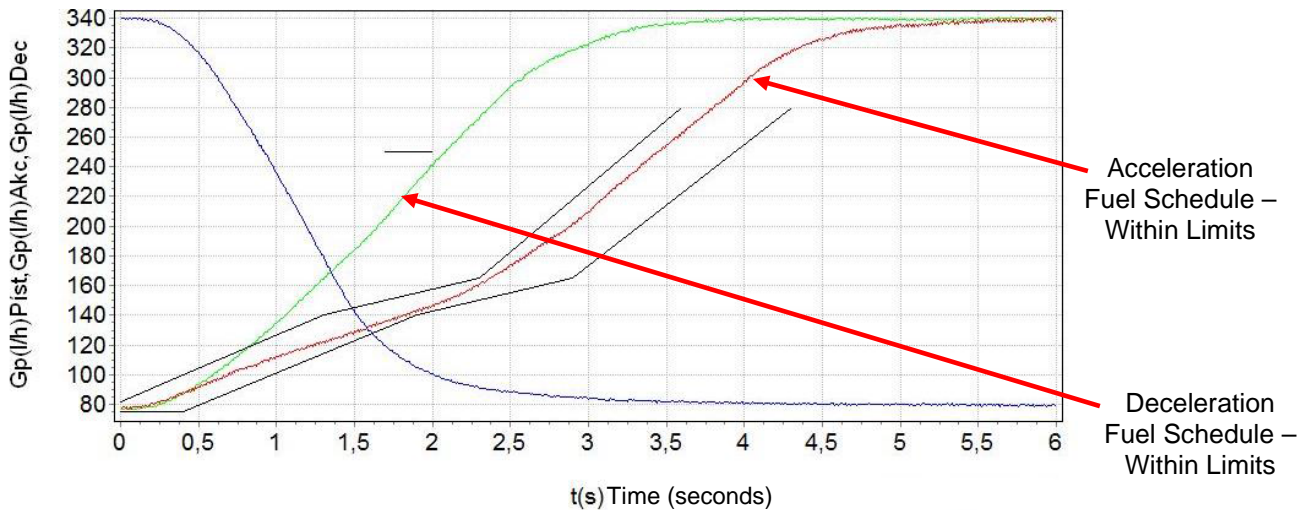
Graph 2 - Acceleration & Deceleration Performance

The acceleration and deceleration characteristic (Graph 2) of an FCU determines how fast the fuel flow changes in response to the power lever being moved quickly to a new power setting. Too fast a response could lead to a flameout. The acceleration (red) response of the FCU is within limits (black). The deceleration (blue) time was approximately 2 seconds, longer than the minimum requirement of 0.5 seconds and acceptable performance.

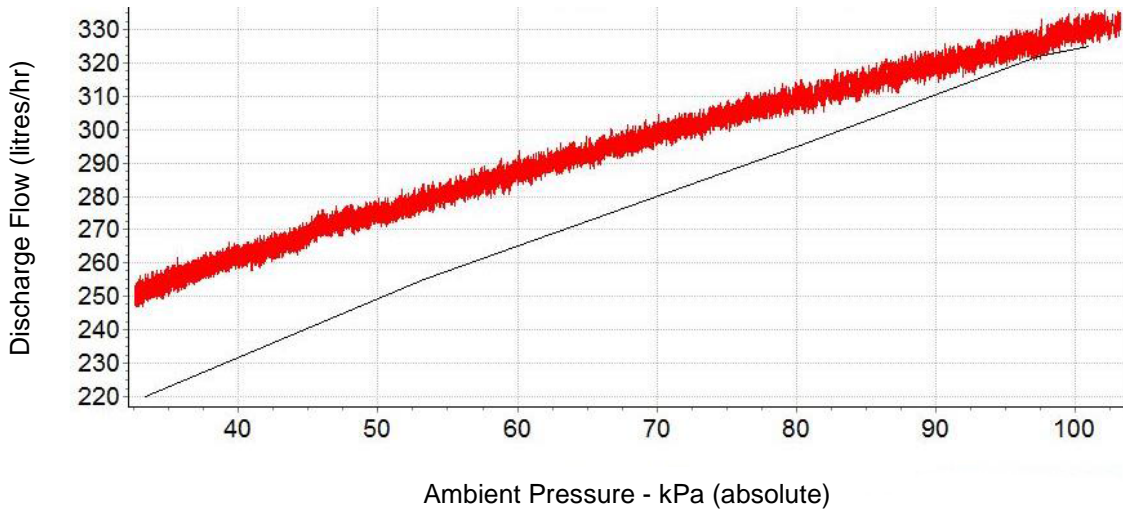
Graph 3 - Altitude Characteristic

The required fuel flow at altitude (Graph 3) is above the required limit and exhibits low hysteresis and acceptable behavior.

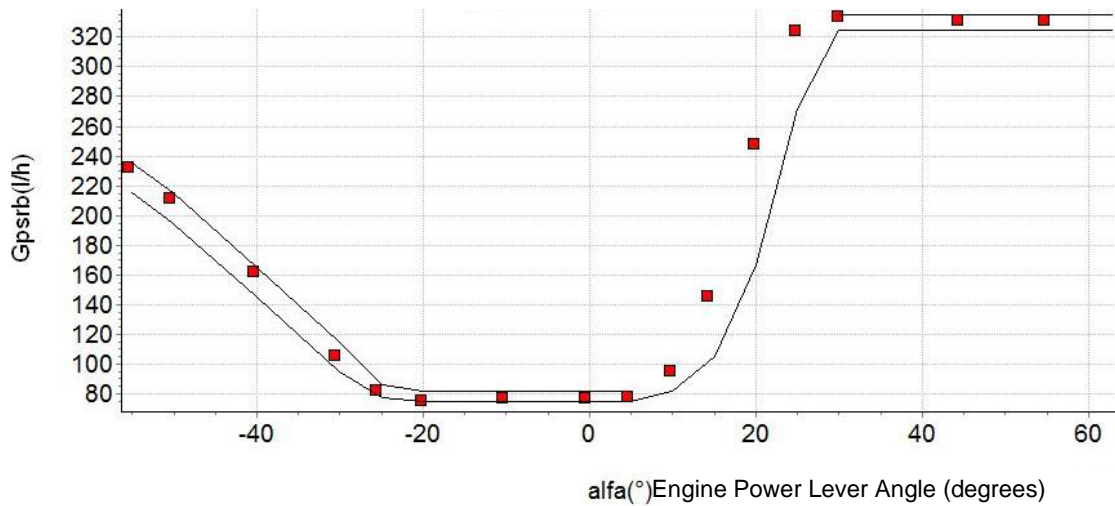
Graph 4 - Fuel Flow vs. EPL Position

This test measured the fuel flow at engine power lever (EPL) positions (Graph 4). The required fuel flow rate for all static conditions were within limits along the entire range, including reverse. The maximum fuel flow was achieved.

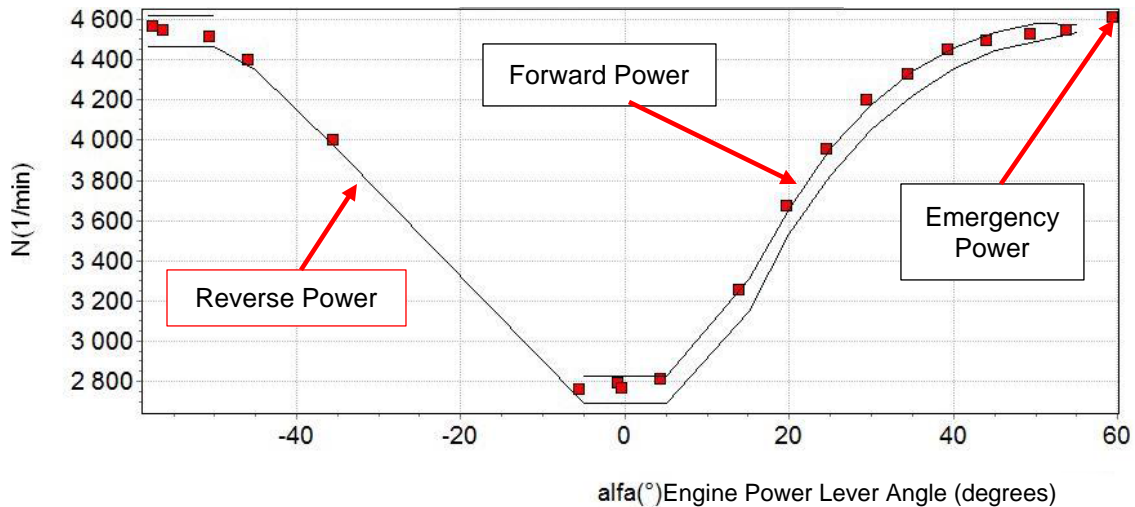
Graph 5 - Flyweight Governor Performance

In this test, the EOR is set to 103% of gas generator speed, removing the influence of the hydromechanical section of the FCU and testing the performance of the governor (Graph 5). Three points are very slightly outside of limits, consistent with the unauthorized disassembly of the power lever.

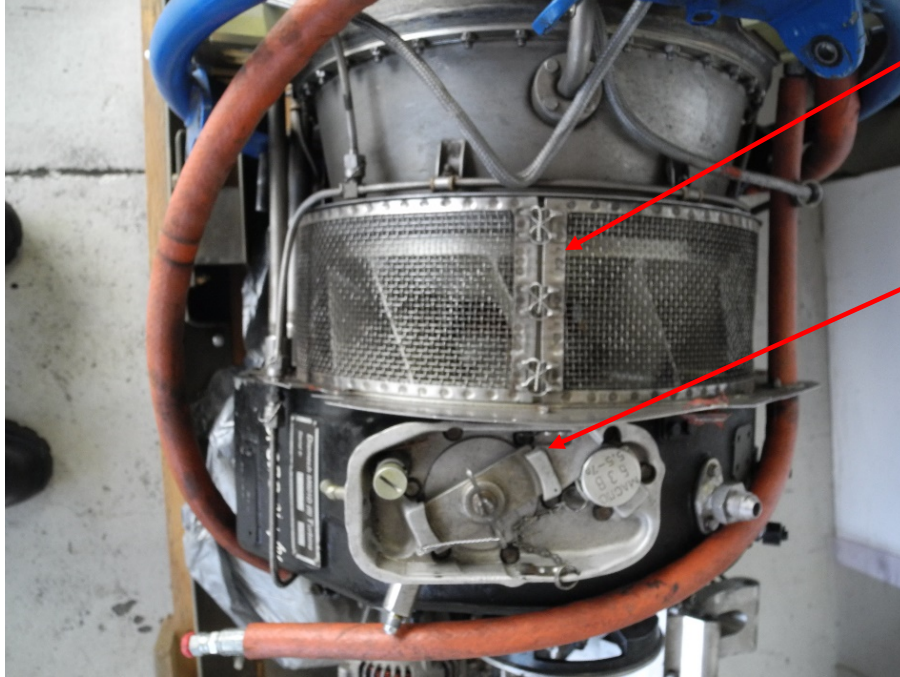
The accessory gearbox (AGB) was intact, attached and appeared to be undamaged. The oil fill port and check hardware were present and undamaged (Photo 5). The fuel pump and fuel control unit (FCU) were still attached to the AGB and appeared to be undamaged (Photo 6). All the tube fittings and connections to and from the FCU and fuel pump were undamaged and secure. An input spline was rotated by hand on the AGB and the 1st stage gas generator compressor blades rotated in unison, indicating mechanical integrity of the AGB.

Inlet Screen
and Engine Air
Inlet

Oil Fill and
Check
Hardware

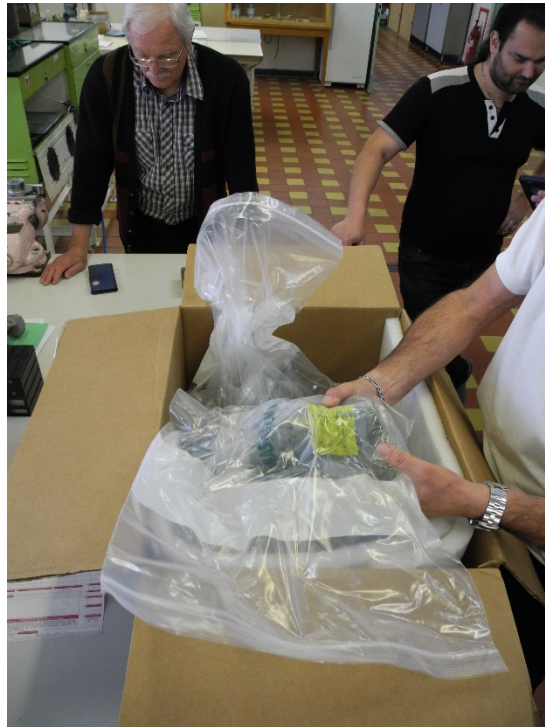
The FCU was received in a cardboard box (Photo 12) which was opened in the presence of the NTSB. A receiving inspection revealed that the FCU was generally intact (Photo 13); however, the ball-and-spring stop mechanism of the cutoff & EOR lever on the lower aft outer quadrant was deformed and not functioning (Photo 14). Internal fuel pressure against the cutoff valve causes a small torque (approximately 11 inch-pounds) on the cutoff shaft, which constantly twists the shut-off lever towards the off position. Normal friction in the airframe control cables and levers is greater than the internal torque and the cockpit cutoff lever normally stays in place. To prevent an inadvertent cutoff due to vibration, the external ball-and-spring mechanism acts as a detent stop. Because there were no discernable impact marks, it was unknown if this deformation existed before the accident.

Photo 13 - FCU - As-Received

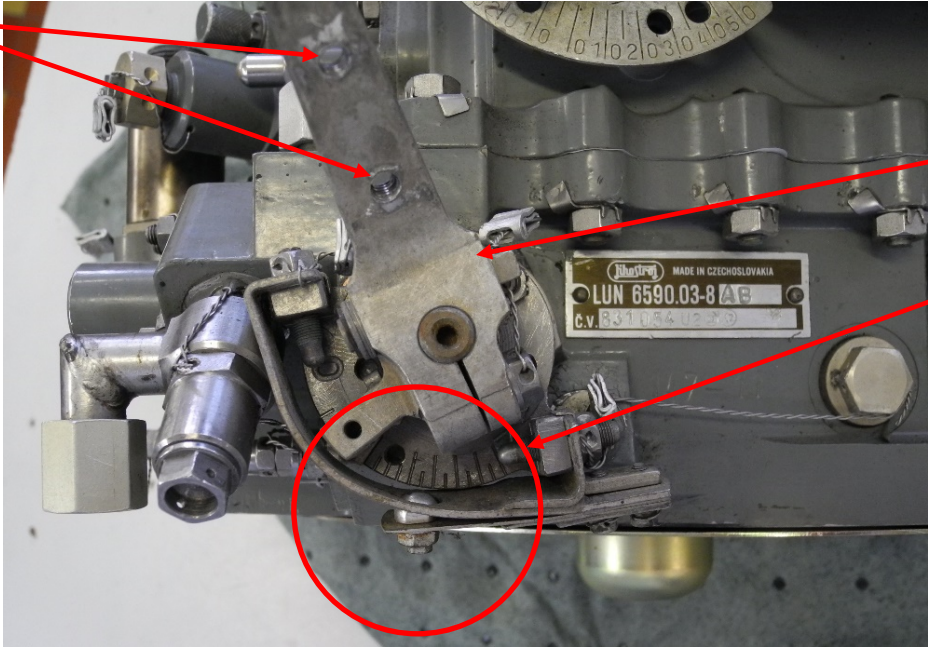
Both the engine power lever (EPL) and the cutoff & EOR lever could be rotated with no unusual internal resistance. The fuel cutoff & EOR lever was bent and it had two non-original tapped holes (Photo 14). The EPL was intact and undamaged (Photo 15); however, the witness cap of the spring-loaded detent of emergency maximum power was

Non-Original Tapped Holes

Fuel Cutoff & EOR Lever

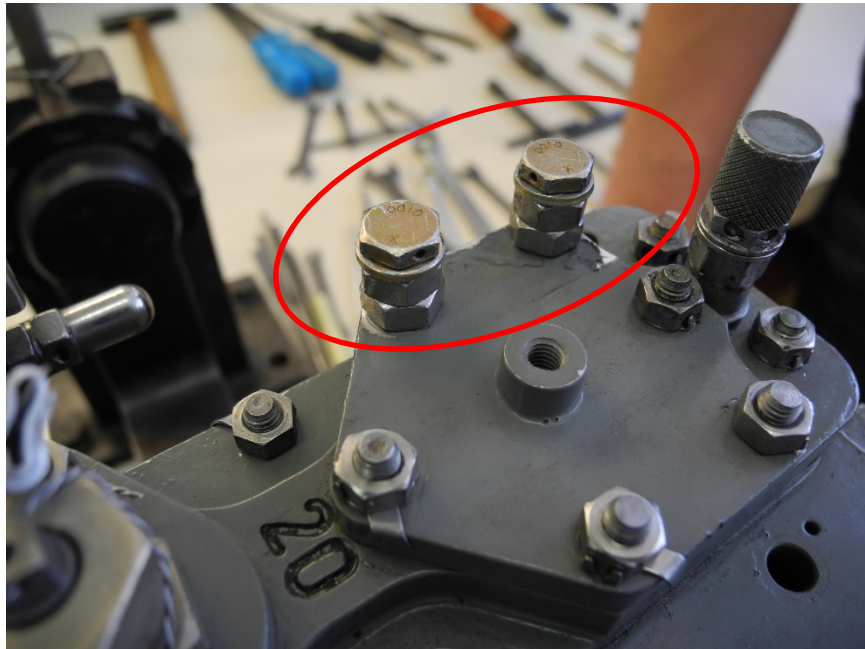
Non-standard fasteners were observed on the fuel-in flange and the #20 adjuster cover plate (Photo 18). During manufacture or overhaul, Jihostroj lock-wires all the adjuster screws of the FCU and then places a unique lead security crimped seal on the lock wire to identify modifications to the original settings. The following adjusters did not have the original crimped seal: The adjusting screws No. 33 – main metering plunger sleeve position (Photo 19), No. 40 – adjustment for start maximum fuel flow, No. 41 – adjustment for start fuel flow acceleration, and No. 50 – adjustment for minimum fuel flow during start (Photo 20).

Photo 19 - Lock Wire at adjustment Screw 33

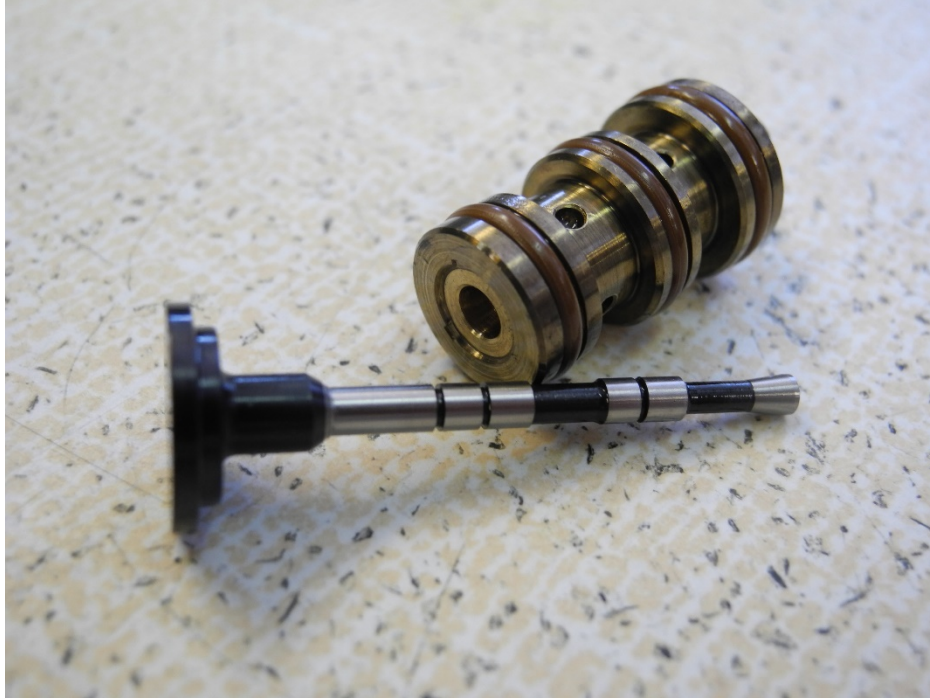
The emergency metering valve assembly was removed from the FCU and examined and found to be intact and undamaged (Photo 26). The pressure regulating valve of the EOR circuit was removed from the FCU housing (Photo 27) and minor corrosion was observed on the active spool outer surface; however, the spool moved freely in its sleeve. The fuel cutoff valve was removed from the FCU housing, examined

Photo 26 - Emergency Metering Valve Assembly

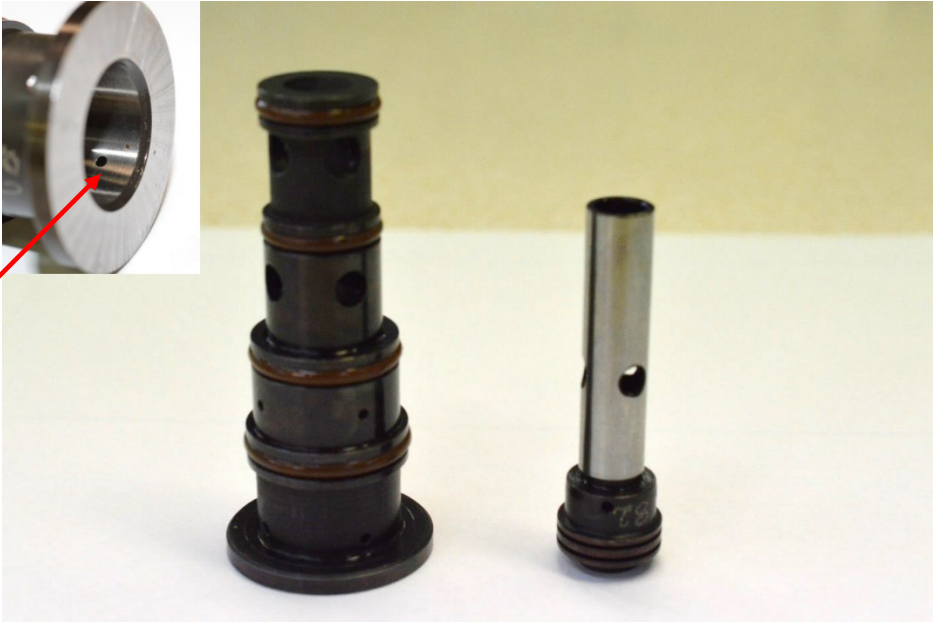
and found to be intact, however a small amount of corrosion was observed on the internal sleeve, but it did not affect the operation of the valve, which moved freely in the sleeve (Photo 28). According to the manufacturer, the corrosion observed in this valve is not common, but is consistent with the component being stored for an extended time without proper preservation. It could also be caused by the presence of water in fuel. The emergency circuit solenoid valve was removed (Photo 29) and functionally tested, passing the minimum switching voltage of 17 volts (V) and drop-off voltage of 15 V.

Minor Corrosion

Photo 29 - Emergency Circuit Solenoid

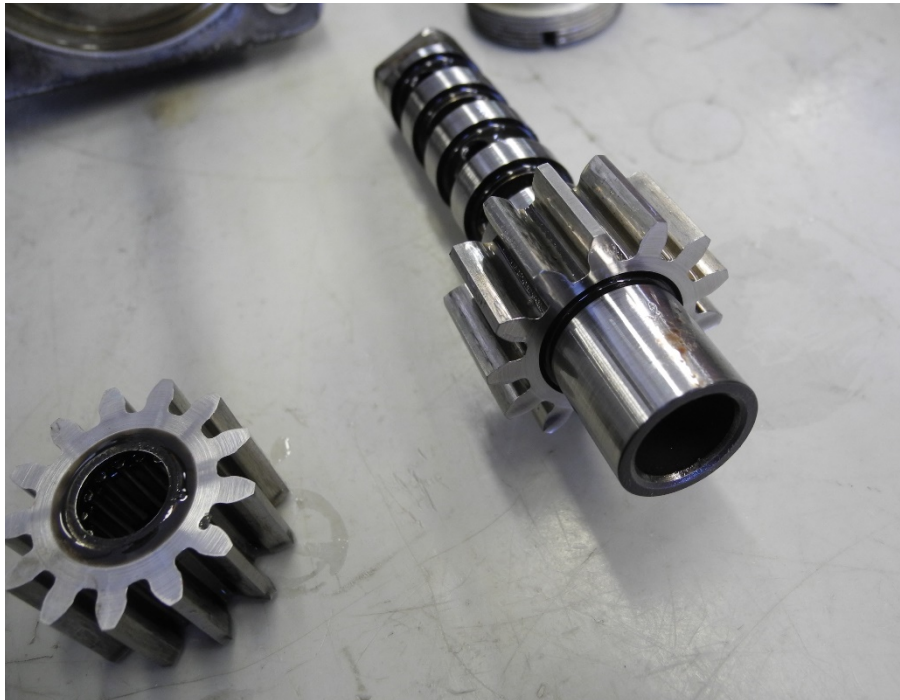
All the internal cavities and components were oil wetted. The pump involute gear teeth (Photo 42) and the side sealing faces of gear pump were undamaged as were the brass side seals. The rotating main shaft with the pilot valve, the speeder spring (Photo 43) and the flyweights (Photo 44) were oil wetted, undamaged and free to operate. The beta valve was undamaged and free to rotate.

Photo 43 - Rotating Main Shaft, Pilot Valve and Speeder Spring

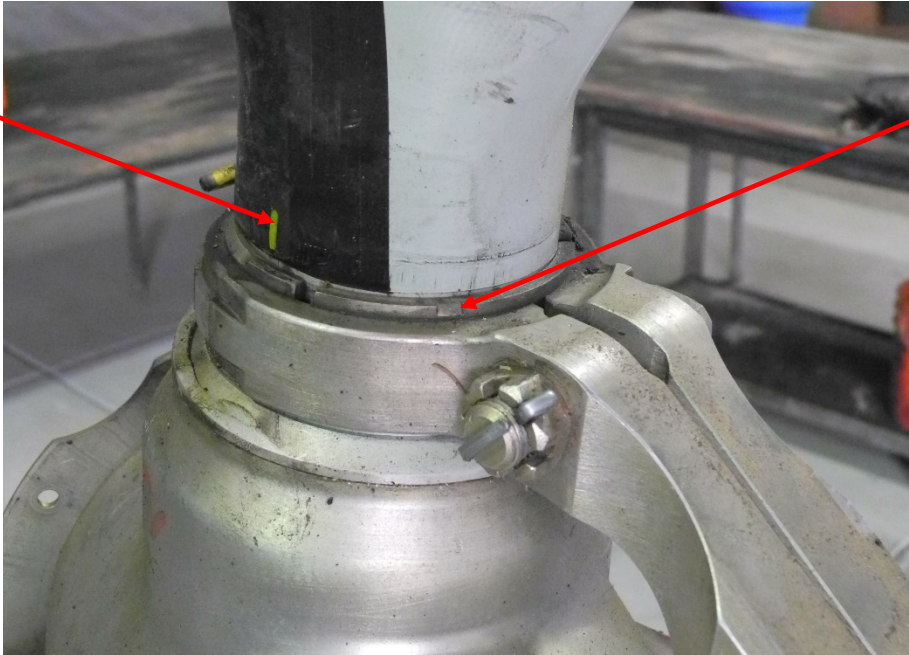
The original blade location in the bushing can be determined by observing a factory scribed mark on beveled surface on the lip of the blade bushing and a factory scribe mark on the blade. These two scribe marks are in alignment during assembly. Blade #1 was rotated in its bushing by approximately 1 inch along the circumference (Photo 49). Blade #2 was rotated in its bushing by approximately 1- 3/4 inch along the circumference (Photo 50). Blade #3 was aligned to the original location (Photo 51).

Photo 51 - Blade #3 – Alignment Scribe Marks - Aligned

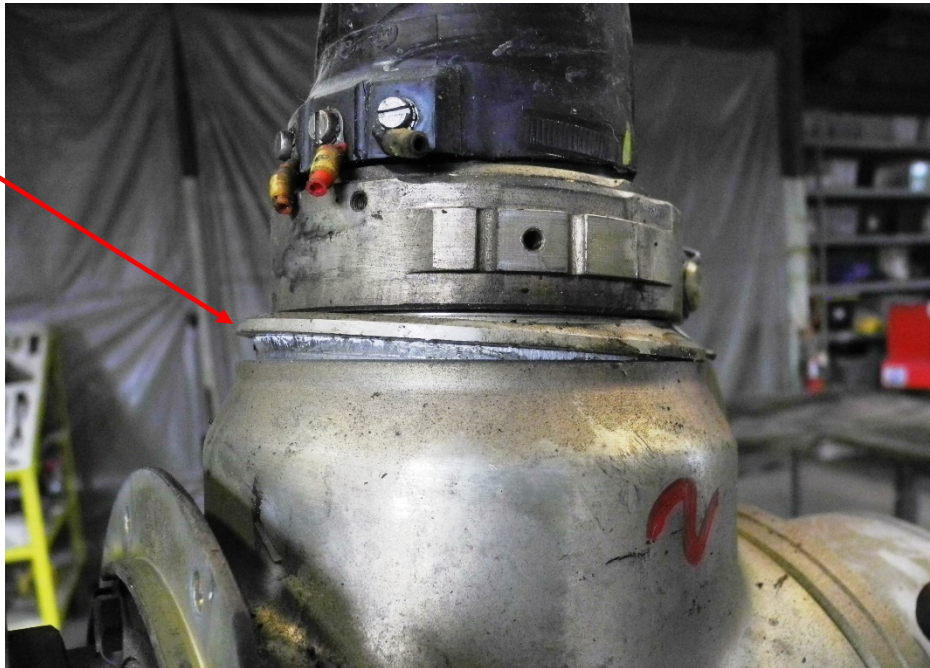
Photo 53 - Bearing Ring of Blade #3 - Undamaged

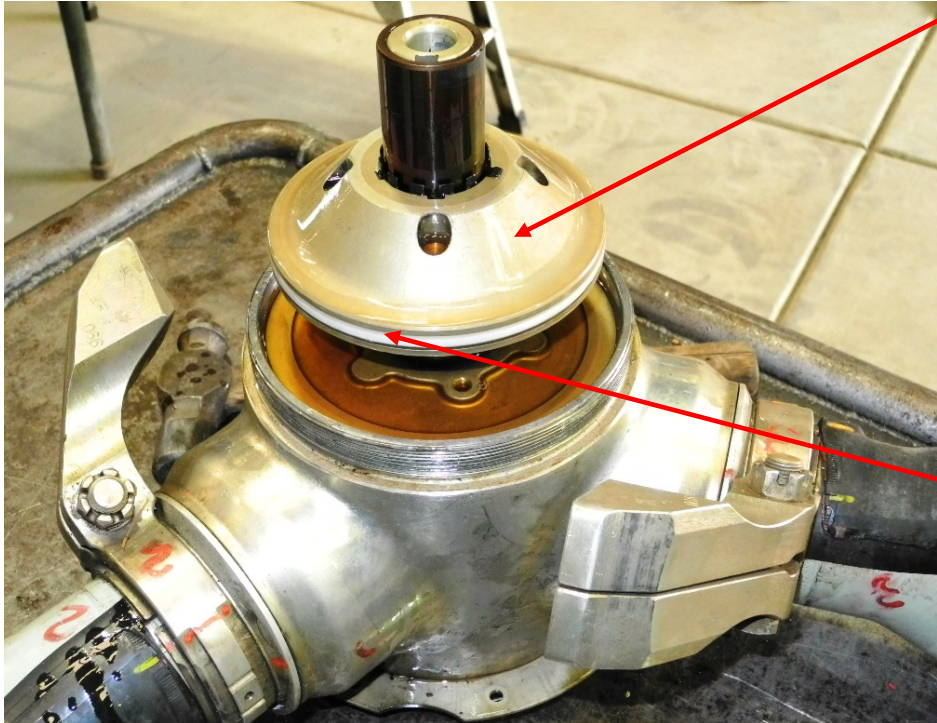
The cylinder mounting nut was still retained by the locking screw ([Photo 58](#)) and once removed, the nut was unscrewed from the hub with normal torque. The cylinder inner surface was undamaged, with only slight witness marks visible ([Photo 59](#)). The piston and elastomeric piston ring were undamaged ([Photo 60](#) & [Photo 61](#)).

Photo 61 - Piston & Elastomeric Ring - Undamaged

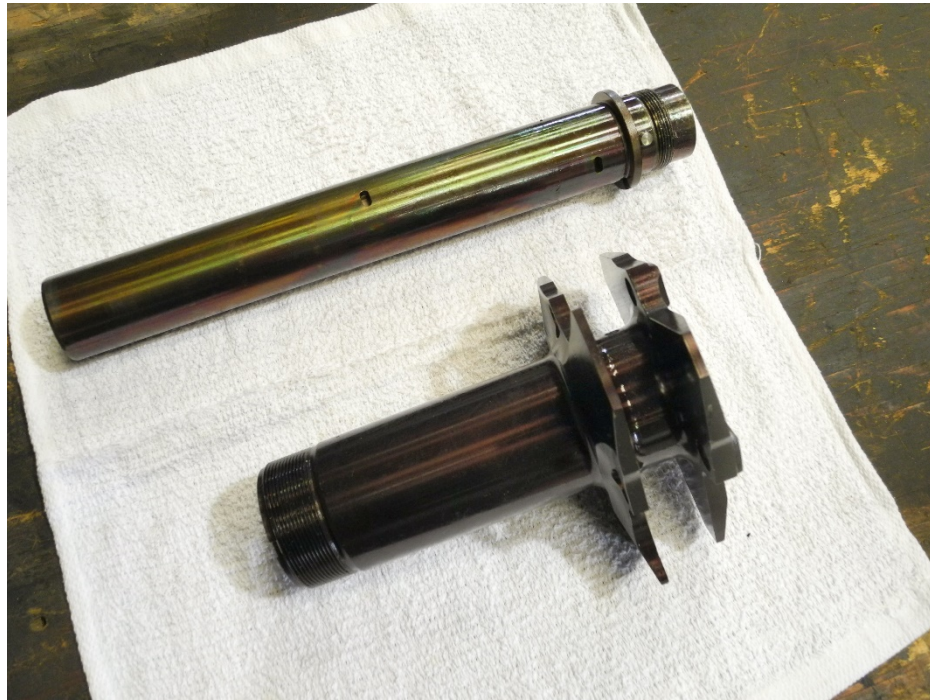
The center tube ([Photo 62](#)) and its secondary pitch lock components were undamaged ([Photo 63](#)), however the front O-ring of the aft spacer of the slide valve assembly was sheared, consistent with an incorrect installation practice ([Photo 64](#)). According to the manufacturer, if the O-ring is missing, then the propeller would not achieve maximum reverse position. The O-ring damage observed would not influence the forward mode of the propeller.

Photo 63 - Secondary Pitch Lock Components - Intact

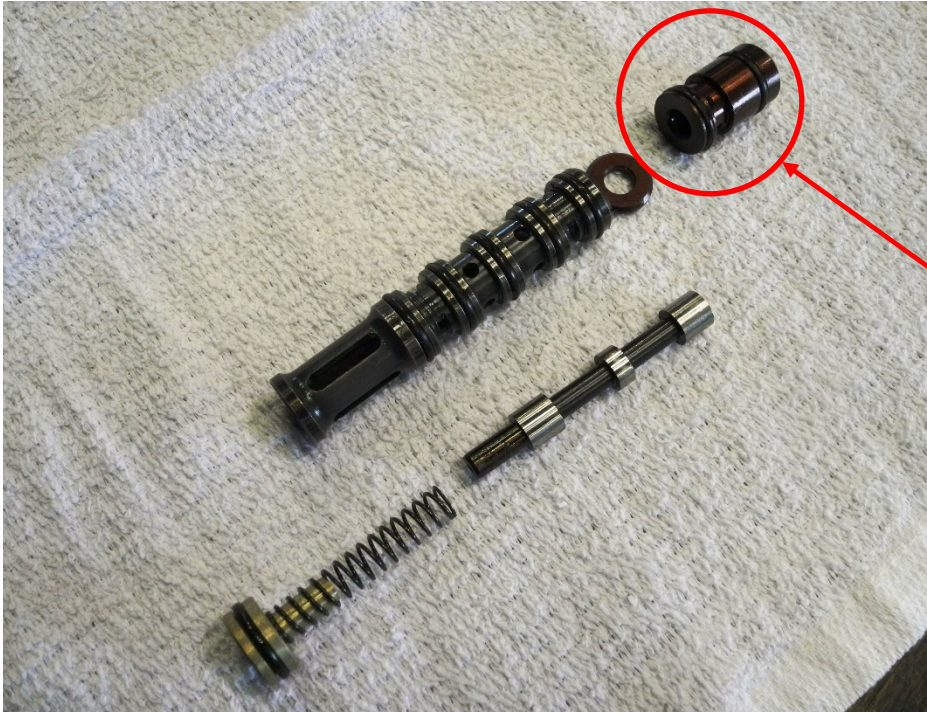
Photo 64 - Aft Spacer of the Pitch Lock Components
