**NATIONAL TRANSPORTATION SAFETY BOARD**  
**Office of Aviation Safety**  
**Washington, D.C. 20594**

**POWERPLANT GROUP CHAIRMAN'S FACTUAL REPORT**

**NTSB No: ENG14IA001**

Aircraft: Spirit Airlines Airbus A319, Registration No. N516NK, Flight 165

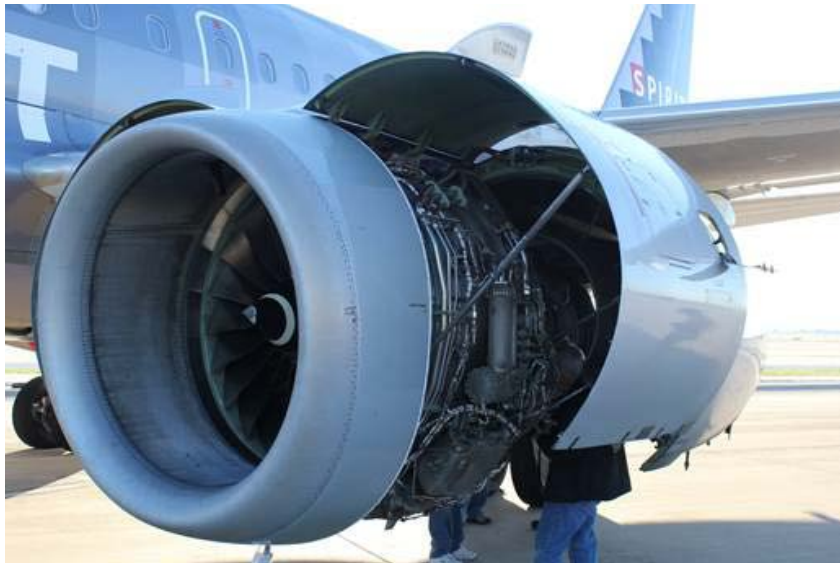
**Photo 1- No. 1 Engine**

The investigative team arrived at DFW on October 16, 2013 to document the condition of the aircraft and No. 1 engine. The aircraft was quarantined on the tarmac in front of the NKS maintenance hangar. Prior to the team's arrival, the engine cowls had been raised and the engine borescope and magnetic chip detector plugs had been removed by NKS maintenance crews (**Photo 1**). The master magnetic chip detector plug located in the oil tank had accumulated a significant amount of metal shavings and debris (**Photo 2**).

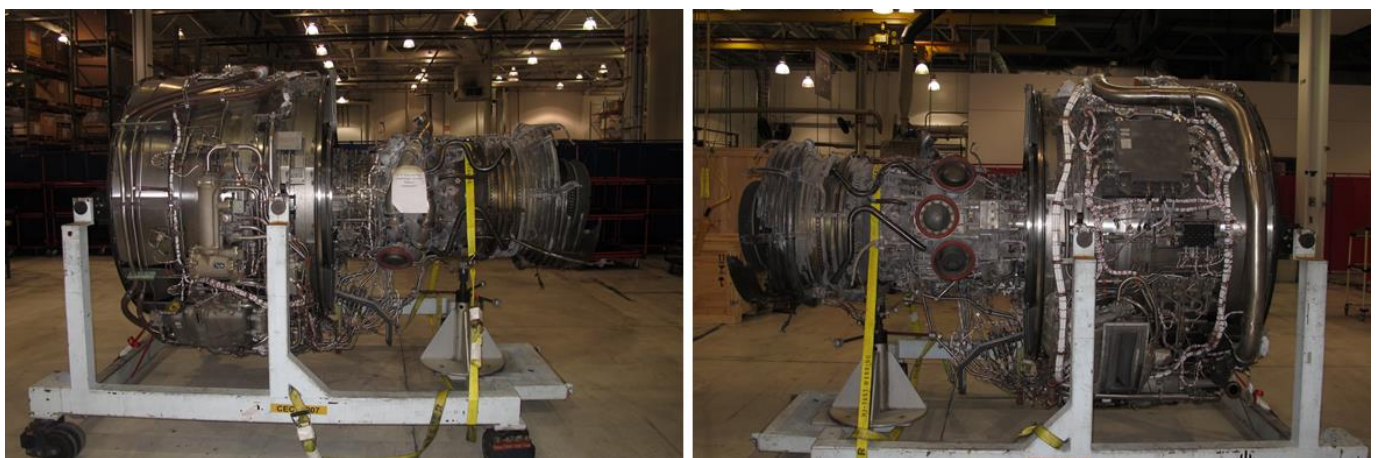
**Photo 18- Engine- As Received (L) Left Side (R) Right Side**

Extensive damage to the aft engine mount, LPT case, and turbine exhaust prohibited shipment in a standard shipping container. NKS and IAE created a modified container to ship the engine to the P&W Columbus, GA facility (**Photo 18**). The turbine exhaust case and common nozzle assembly were shipped in a separate crate (**Photo 19**).

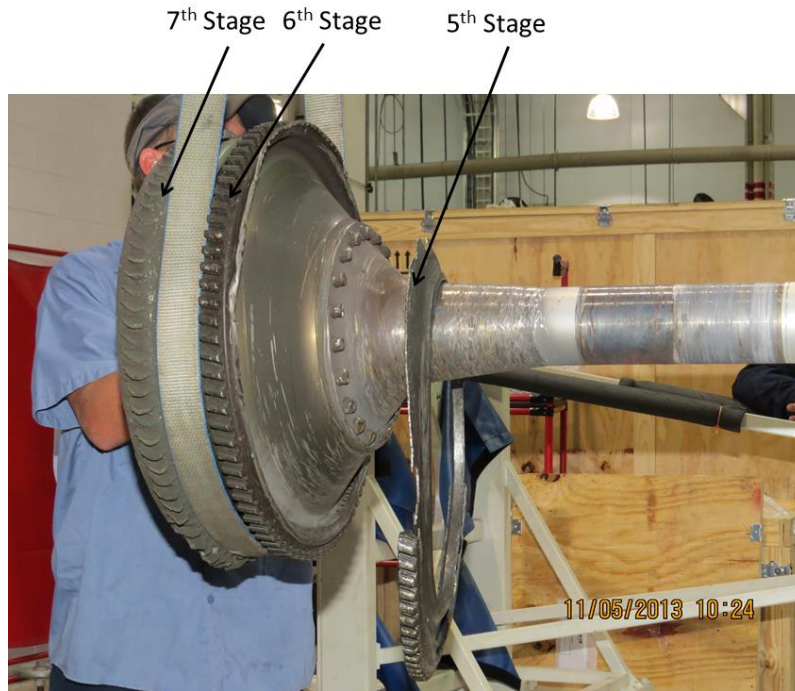
**Photo 21- Removal of the LPT Shaft From the Engine**

The LPT shaft and attached 6<sup>th</sup> and 7<sup>th</sup> stage disks were removed from the engine. The LPT 5<sup>th</sup> stage disk was detached from the LPT 6<sup>th</sup> stage disk and hanging freely from the LPT shaft (**Photo 21**). The LPT shaft exhibited circumferential rubs at multiple points along its length. Measurements were taken of each rub location and compared against engine drawings to determine which internal surfaces had contacted the shaft at each location. A series of four rubs on the forward half of the shaft aligned with the HPC 4<sup>th</sup> through 7<sup>th</sup> stage disk bores. The rub aligning with the HPC 4<sup>th</sup> stage bore was a light single point rub with no material loss. The rub aligning with the HPC 5<sup>th</sup> stage bore was approximately 180 degrees around with light material loss that could be felt. The rubs aligning with the HPC 6<sup>th</sup> and 7<sup>th</sup> stage disk bores were both 360 degrees around and depth increased with each stage (**Photo 22**). The circumferential rub aligning with the HPC 7<sup>th</sup> stage disk bore also exhibited material bluing around the circumference. The HPT shaft was borescoped and matching rubs were confirmed on the HPC disk bores (**Photo 23**). Rub/scoring was also present in positions that aligned with the high pressure shaft rear heat shield and HPT shaft below the 1<sup>st</sup> and 2<sup>nd</sup> stage disks (**Photo 24**). The points where the HPT shaft contacted the LPT shaft exhibited material transfer. The aft end of the

LPT shaft where the LPT disks are normally positioned exhibited heavy gouging and scoring 360 degrees around with material damage most concentrated over a 180 degree area. A ruler was placed on each side of the shaft and a gap comparison check confirmed that the shaft was bent (**Photo 25**).

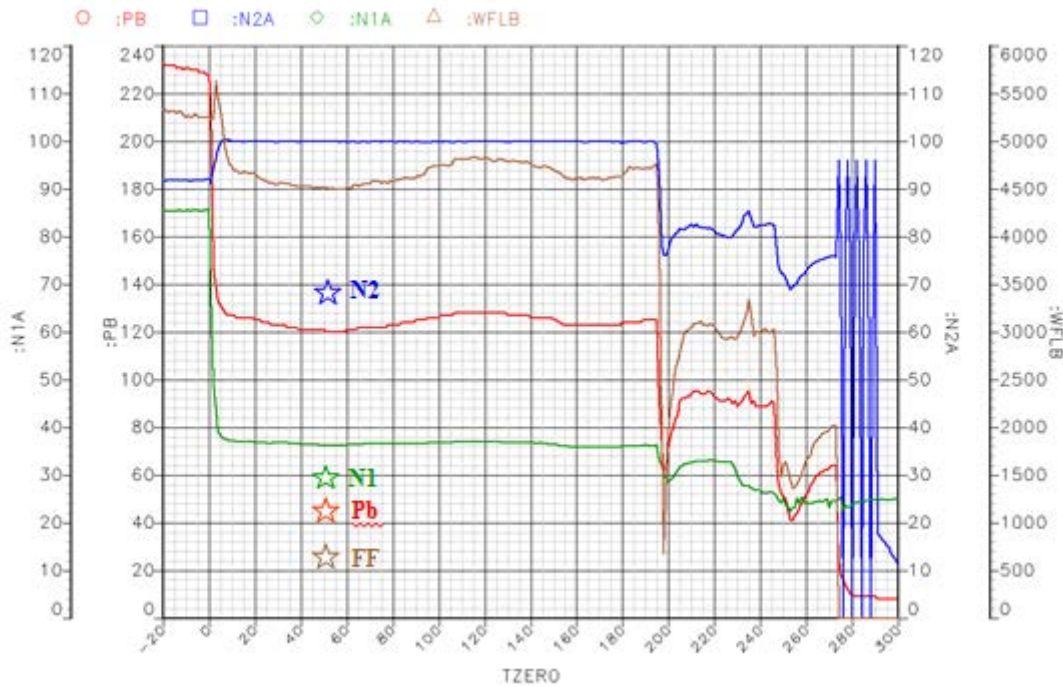
**Figure 3- Performance Plots, Stars Indicate Engine Parameter Levels if Throttle was Retarded to Idle**

IAE performance engineers conducted an analysis to determine how the engine would have responded if TLA had been reduced to idle position at the onset of vibration and warning indications. The analysis was performed with the assumptions that moving the TLA to the idle position would reduce fuel flow to minimum levels and damaged LPT efficiency calculations were based on N1 speed compared to a normal engine as recorded by the FDR during the event. The predicted minimum idle values for N1 speed, N2 speed, burner pressure, and fuel flow are shown in (**Figure 3**). The analysis

concluded that the  $T_{45}$ <sup>9</sup> (HPT discharge temperature) levels would decrease to approximately 710°F (377°C) shortly after TLA was decreased to idle.
