NATIONAL TRANSPORTATION SAFETY BOARD
Office of Aviation Safety
Washington, D.C. 20594

POWERPLANT GROUP CHAIRMAN'S FACTUAL REPORT

NTSB No: ENG14IA005

Location: St. Louis, Missouri
Date: December 23, 2013
Time: Approximately 1605 local time
Aircraft: Southwest Boeing 737-3H4, Registration Number N360SW

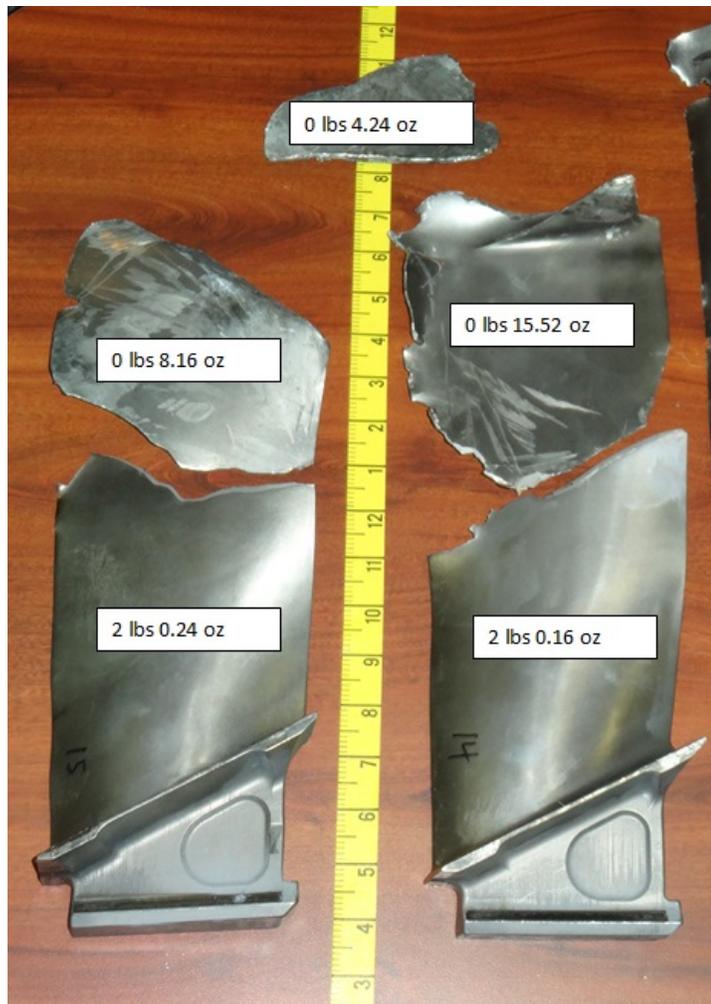
Figure 1 – Weights of Recovered Fan Fragments

The five recovered significant fan fragments were weighed, and the results are summarized on (Figure 1) below.

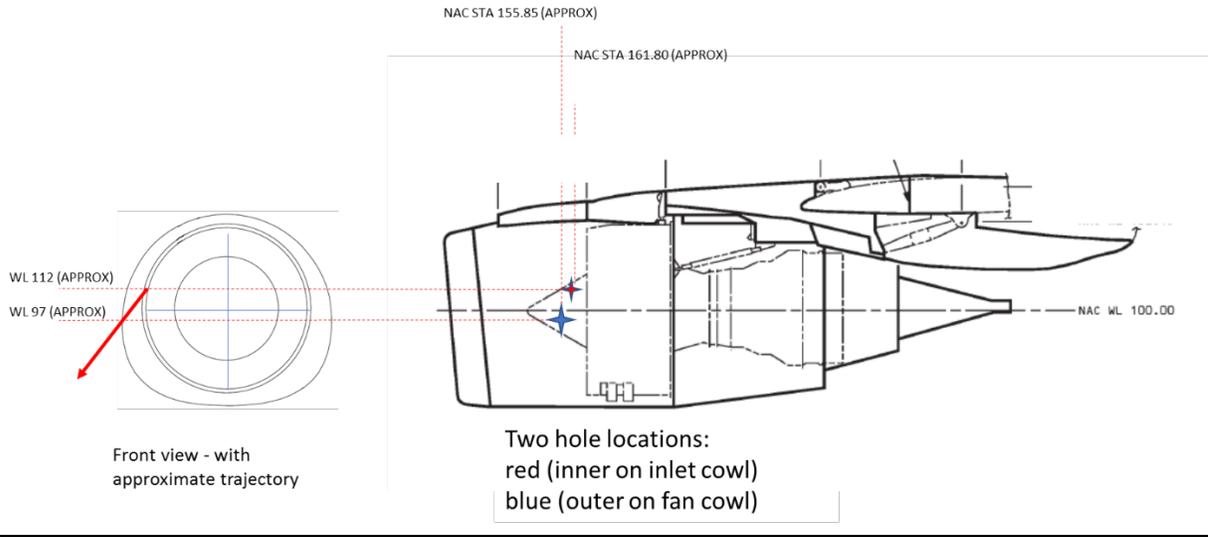
Figure 4 – Front and Side View of Uncontained Fan Blade Particle Trajectory

Locations of the penetration holes on the inlet cowl were measured and recorded on [Figure 2](#), [Figure 3](#), and [Figure 4](#). Boeing engineering used these measurements to estimate the external trajectory of the uncontained fan blade.

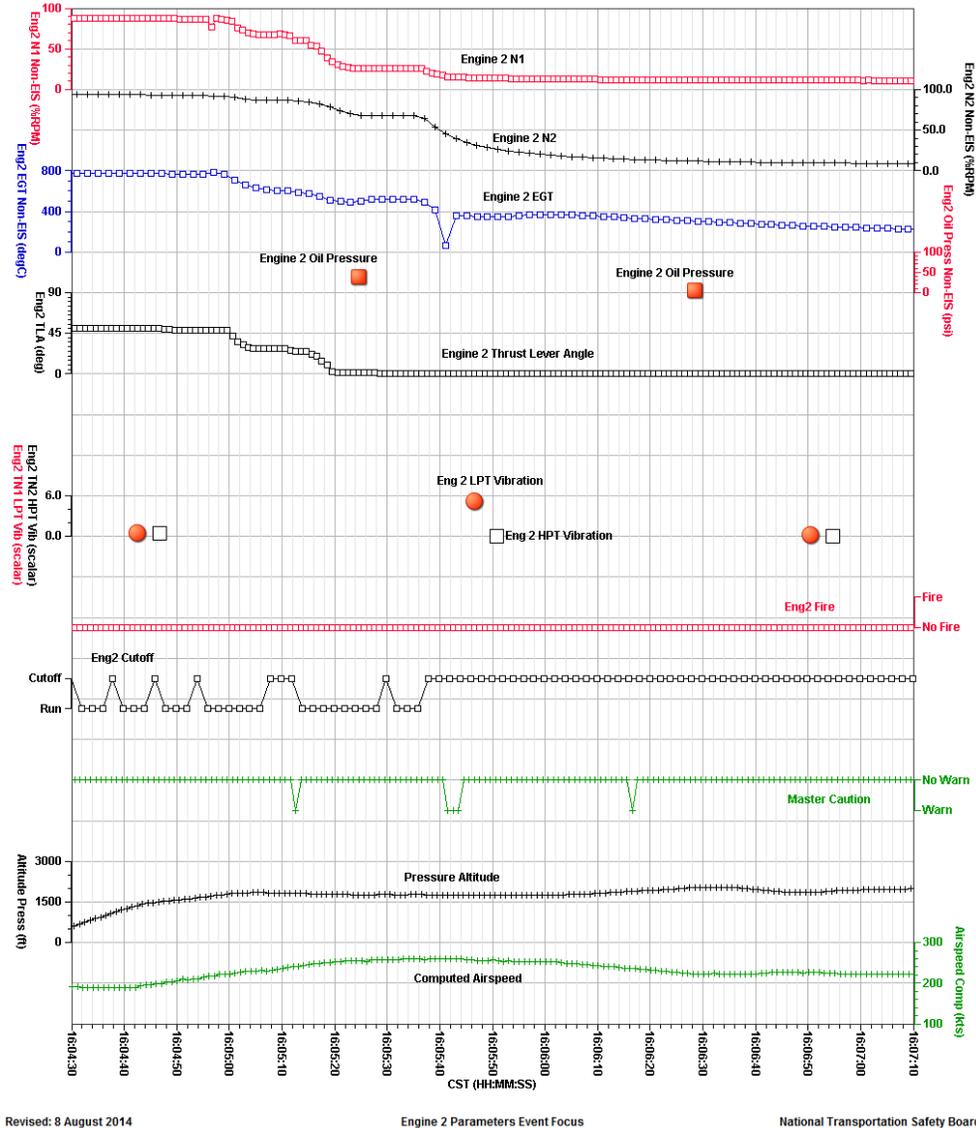
Table 1 – Plot of Engine No. 2 Parameters During the Engine Event

The digital flight data recorder (DFDR) was sent to the NTSB Headquarters in Washington, D.C. and was readout by the Vehicle Recorder Group. A sequence of events timeline was created based on data from the DFDR for the incident flight. See [Table 1](#) for the plot of the No. 2 engine parameters during the event. Refer to the DFDR Group Chairman’s Report ([Appendix I](#)) for additional data.

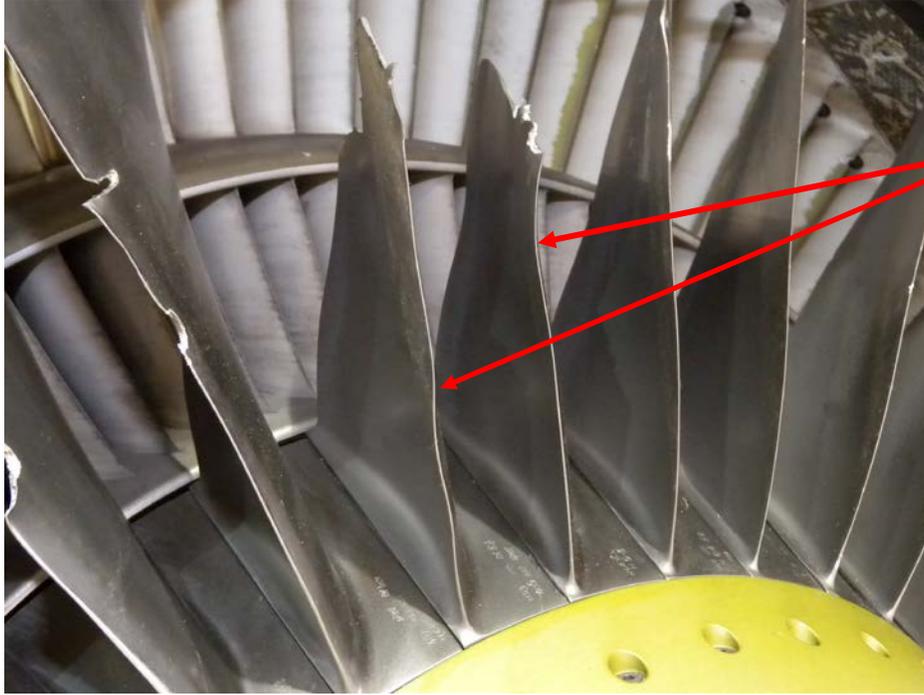
Photo 10 – Fan Blades - Details

Large-radius
Deformation

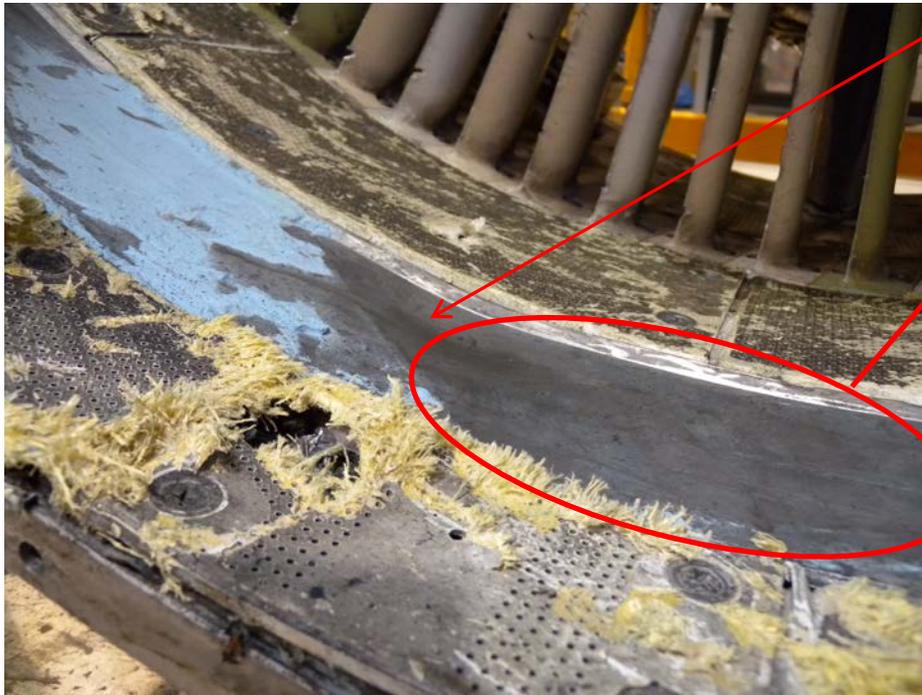
Approximately 75 percent of the fan abradable shroud material was missing (Photo 20), while the remaining abradable material was battered. The abradable material was completely missing at the 4 to 6:30 o'clock and 7 to 7:30 o'clock locations, exposing the steel containment ring material of the fan case. There was a dent in the plane of rotation of the fan rotor in the containment ring at the 5:30 o'clock location, the leading edge of which resembled a blade tip chord impact (Photo 21) and measuring approximately 6 inches circumferentially x 3 inches axially and 0.25 inches radially. There was also an impact mark in the shape of the fan blade chord through the abradable material at the 7:30 o'clock location (Photo 22).

Note Dent

Missing Fan
Abradable
Shroud
Material

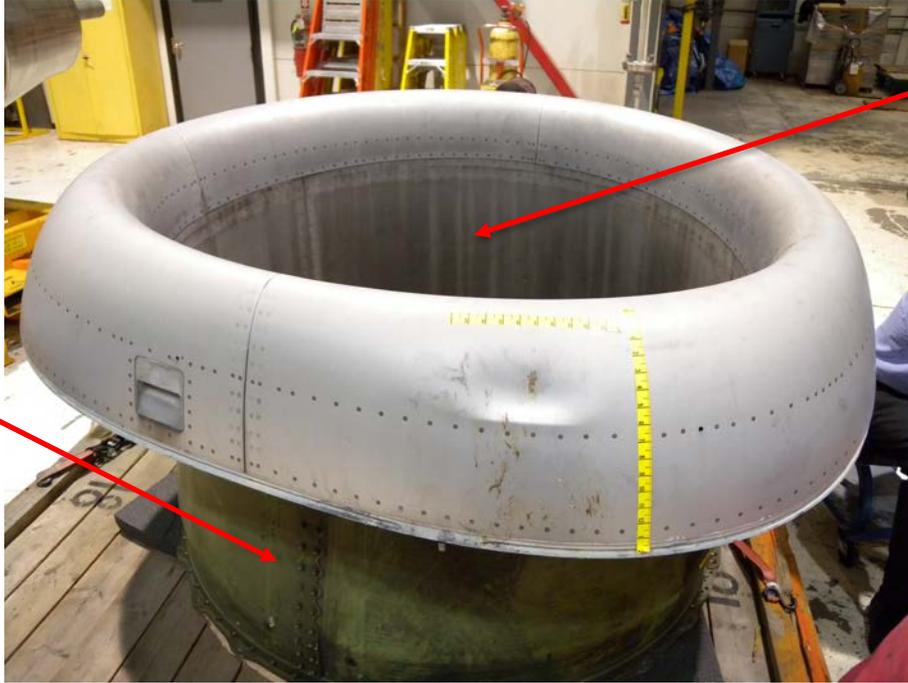
Photo 28 – Inlet Inner Barrel – Back Sheet - Left Side

According to the Boeing Structural Repair Manual, the inlet inner barrel is constructed from a perforated aluminum sheet, aluminum honeycomb, and prepreg fiberglass fabric. The inlet inner barrel ([Photo 28](#) & [Photo 29](#)) had multiple small punctures on the inner skin (airflow) side and two large thru-holes; the one at 2:30 o'clock location was approximately 3 inches axially x 2 inches circumferentially in size and the other at 3:00 o'clock was approximately 5 inches axially x 4 inches circumferentially ([Photo 30](#)) in size. The T12 sensor cable is fastened to the nacelle at this latter location and was severed. Several scrape marks, in a spiral pattern were observed on the inner skin and the forward acoustic panels ([Photo 31](#)).

Inlet Inner Barrel – Back Sheet

Inlet Inner Barrel – Face Sheet

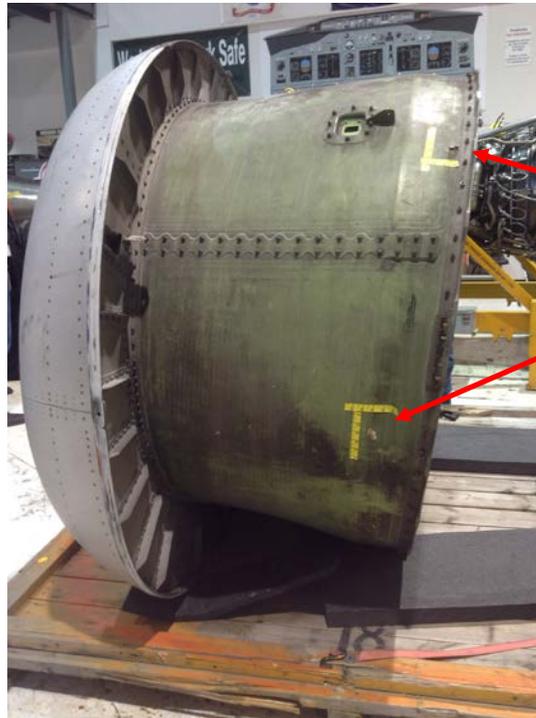
Photo 29 - Inlet Inner Barrel - Back Sheet – Right Side

Fractured Fiberglass on Back Sheet - Not Penetrated.

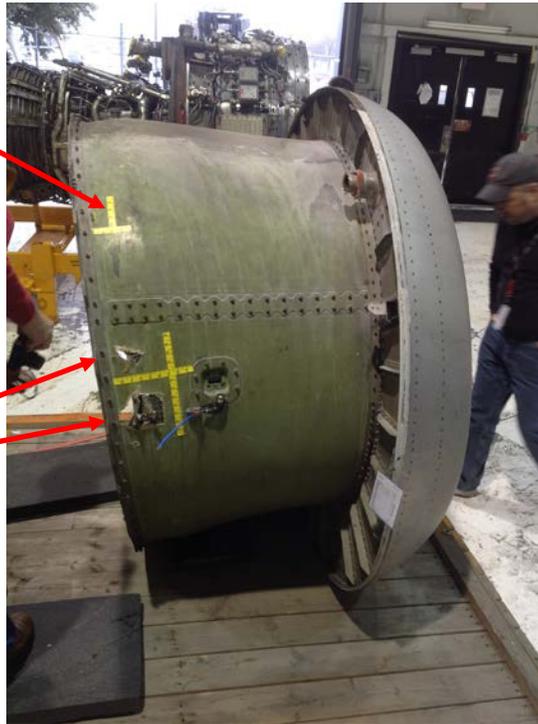
Photo 30 – Inlet Inner Barrel Back Sheet - Two Through Holes - Detail

Fractured
Fiberglass on
Back Sheet -
Not Penetrated.

Penetrated
Holes on
Back Sheet at
2:30 and 3:00
o'clock

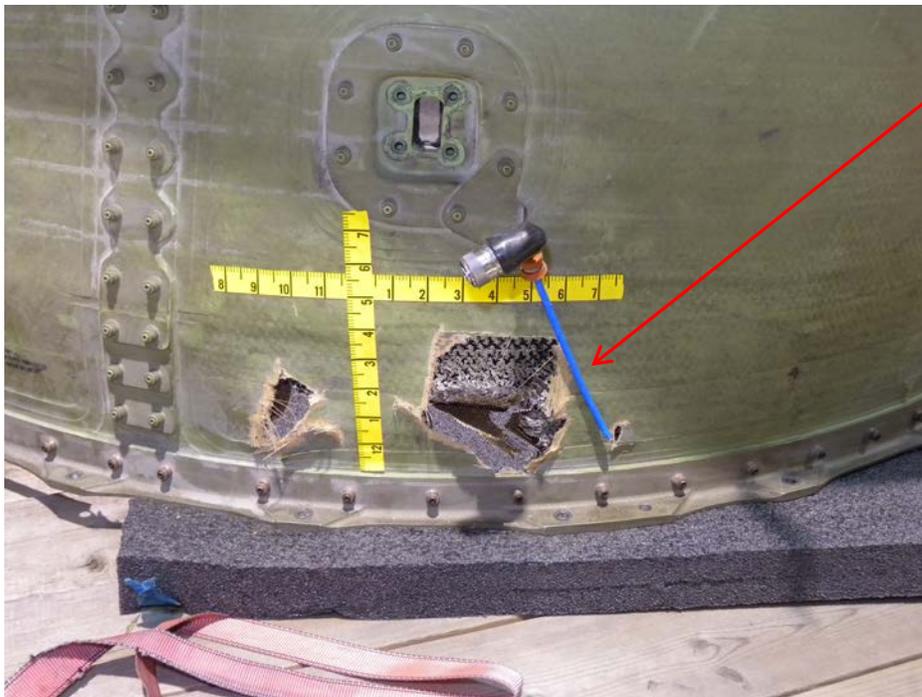
Photo 31 – Inlet Inner Barrel Face Sheet - Forward of A-Flange

Severed
T12 Cable
