NATIONAL TRANSPORTATION SAFETY BOARD
OFFICE OF AVIATION SAFETY
WASHINGTON, D.C. 20594

POWERPLANTS GROUP CHAIRMAN'S FACTUAL REPORT

NTSB ID No.: DCA18IA092

Location: Honolulu, Hawaii
Date: February 13, 2018
Time: 1200 Hawaiian standard time
Aircraft: Boeing 777-222, N773UA, United Airlines flight 1175

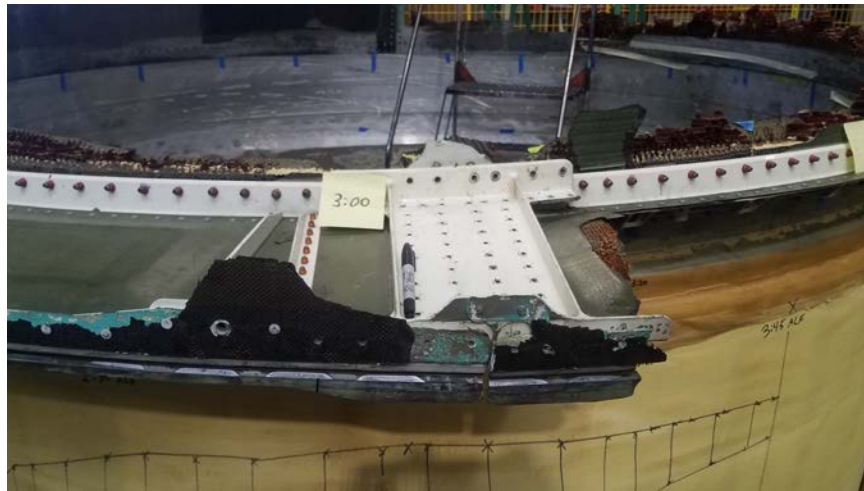
Photo No. 17: View of the aft bulkhead splice fitting showing no apparent damage. (Boeing)

The only portion of the upper outer barrel that remained was about a 1-inch piece of the edge band under the remaining fasteners of the upper outer stiffener between about 9 and 10 and 12 and 3 o'clock. (Refer to Photo No. 17) These remaining pieces were delaminated.

The inner barrel splice fittings at 9 o'clock had no apparent damage. (Refer to Photo No. 18) The fasteners were intact and tight except where they were removed at HNL. There were about 3-inches of the inner barrel splice fitting at 3 o'clock that remained attached to the remaining pieces of the inner barrels and aft bulkhead inner stiffeners. (Refer to Photo No. 17)

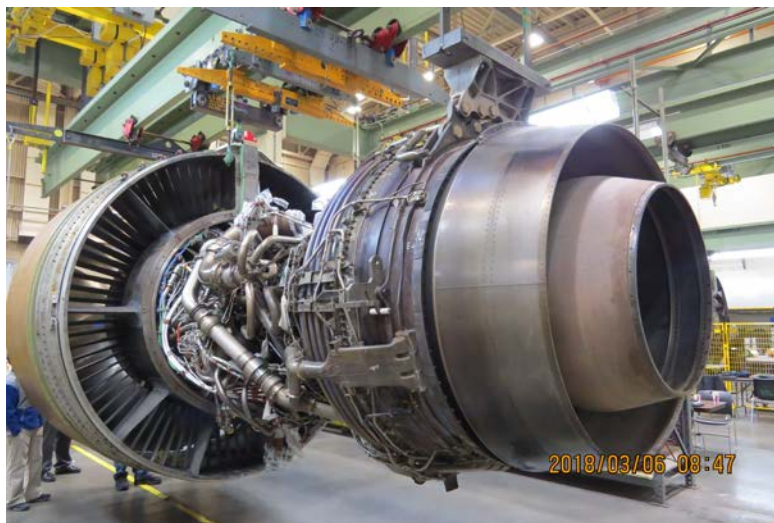
The engine was complete from the fan case front flange to the turbine exhaust case rear flange. The exterior of the engine did not have any indications of an uncontainment, case rupture, or a fire. (Photos Nos. 21 and 22)

Photo No. 21: View of left side of engine showing no indications of an uncontainment, case rupture, or fire. (P&W)

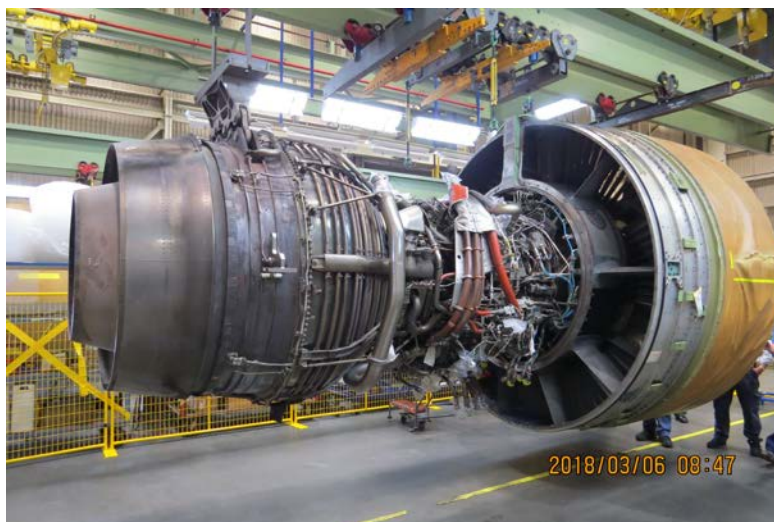
Photo No. 22: View of right side of engine showing no indications of an uncontainment, case rupture, or fire. (P&W)

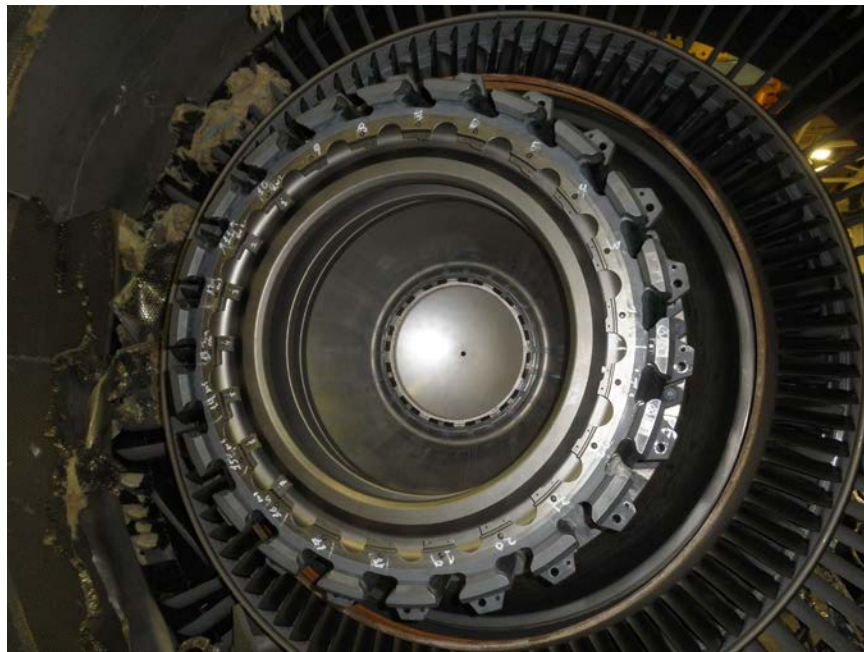
The fan hub was intact. The fan blade retaining ring was in place. There were seven 10-ounce-inch clip-on counterweights on the counterweight flange under blade slots Nos. 10, 11, 12, 13, 14, 15 and 16. There was also a small counterweight riveted to the counterweight flange under blade slot No. 1. (Photo No. 35)

Photo No. 35: View of fan disk showing that it was intact.

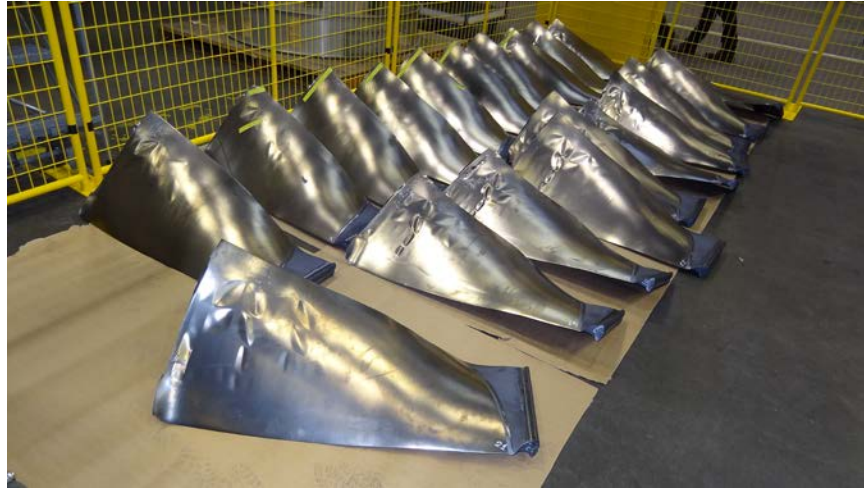
At the start of the engine examination at SFO, all of the fan blades were in place in the fan disk with the exception of fan blade Nos. 10 and 11 that had been removed from the engine at Honolulu and shipped to P&W, East Hartford, Connecticut for the metallurgical examination.³⁷ All of the remaining fan blades were full length. (Photo No. 36)

Photo No. 36: View of other fan blades after that had been removed from the engine. (Boeing)

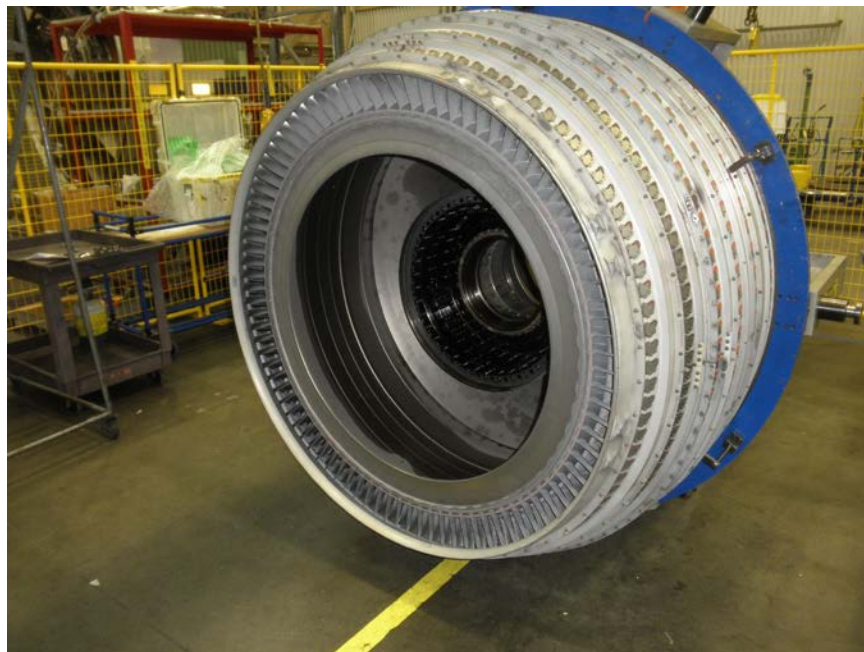
The LPC drum was intact. (Photo No. 39)

Photo No. 39: View of LPC drum showing that it is intact.

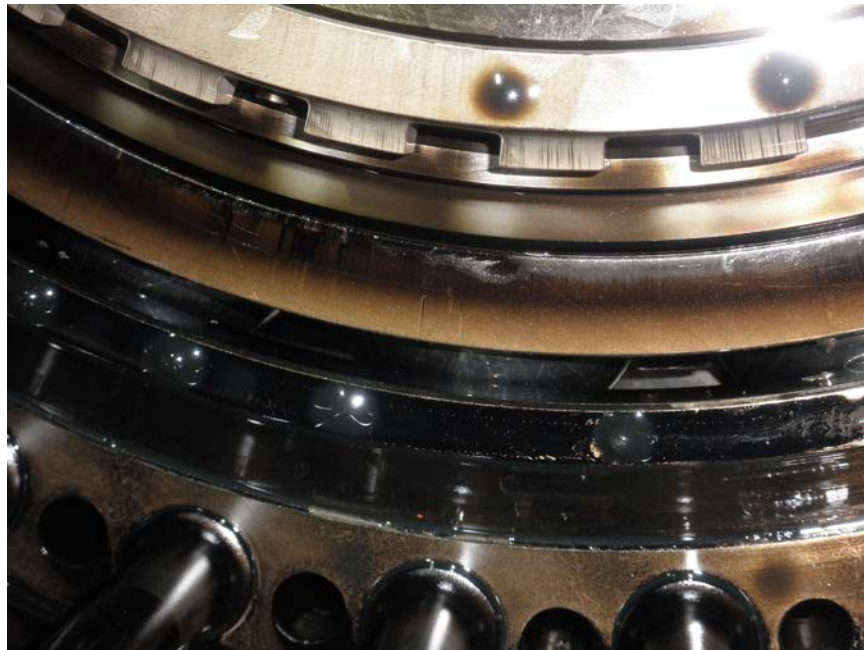
The Nos. 1 and 1 1/2 bearings were intact, wet with oil, and did not have any apparent rotational damage on the rolling elements. (Photos Nos. 49 and 50) The respective bearing supports did not have any apparent damage.

Photo No. 49: Close up of No. 1 bearing balls showing they are wet with oil and have no visible rotational distress.

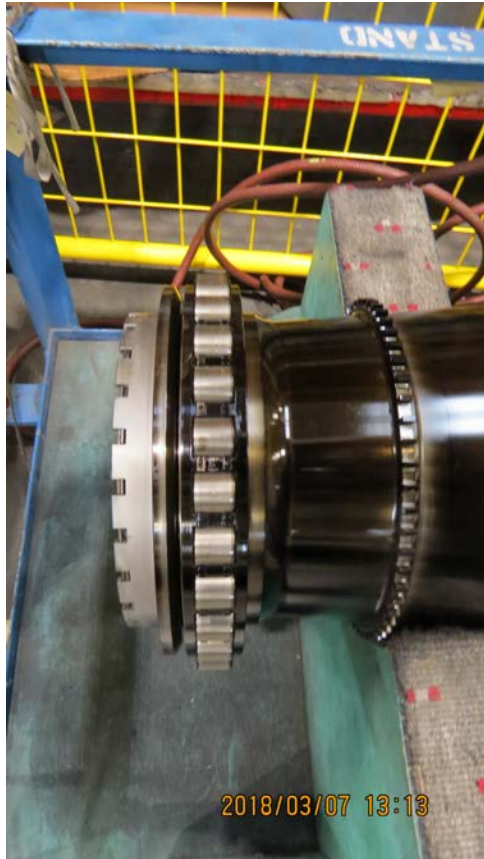
Photo No. 50: View of No. 1 1/2 bearing showing that it is wet with oil and did not have any rotational distress. (P&W)

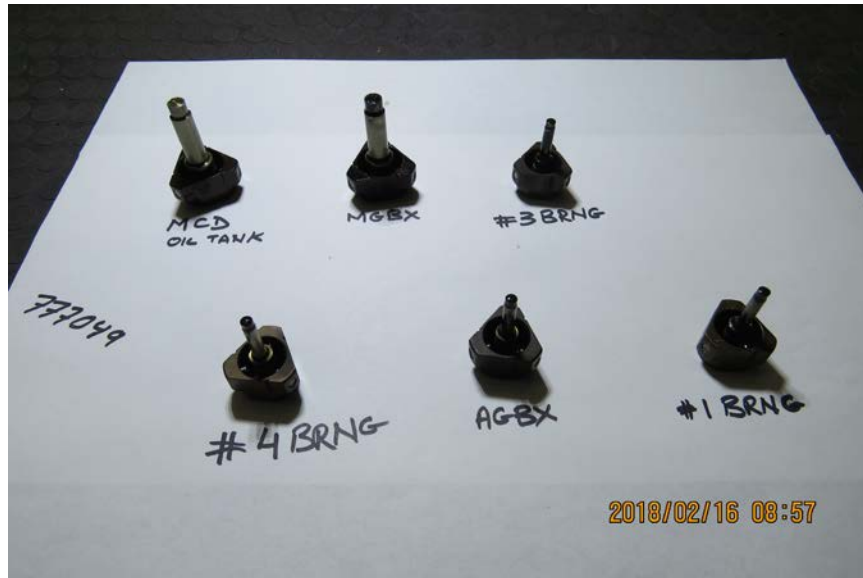
The magnetic chip detectors in the oil tank, the main and accessory gearboxes, and the lube and scavenge pump were removed for inspection. (Photo No. 51)

Main oil tank	A few small metal chips
Main gearbox	A few small metal chips
No. 3 bearing	Very fine metal chips
No. 4 bearing	Clean
Accessory gearbox	Clean
No. 1 bearing	1 metal sliver and a few small metal chips

Photo No. 51: View of magnetic chip detectors. (P&W)

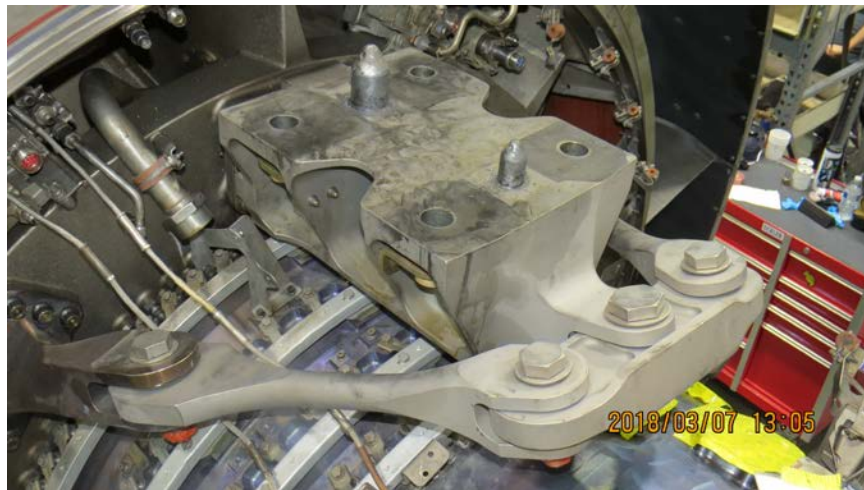
The engine mounts and mount bolts did not have any apparent damage. (Photos Nos. 52, 53, and 54) The engine mounts and mount bolts were removed from the airplane and engine and underwent an FPI. It was reported that there were no cracks or defects noted during the inspection.

Photo No. 52: View of forward engine mount. (P&W)

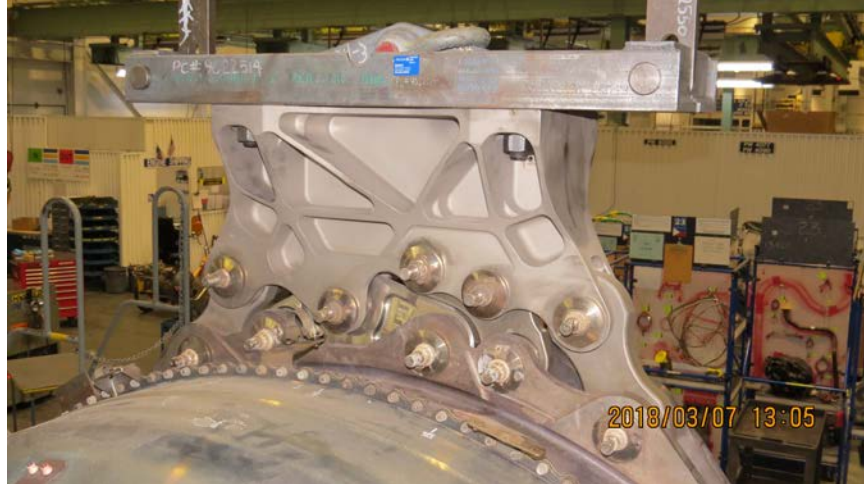
Photo No. 53: View of aft engine mount. (P&W)

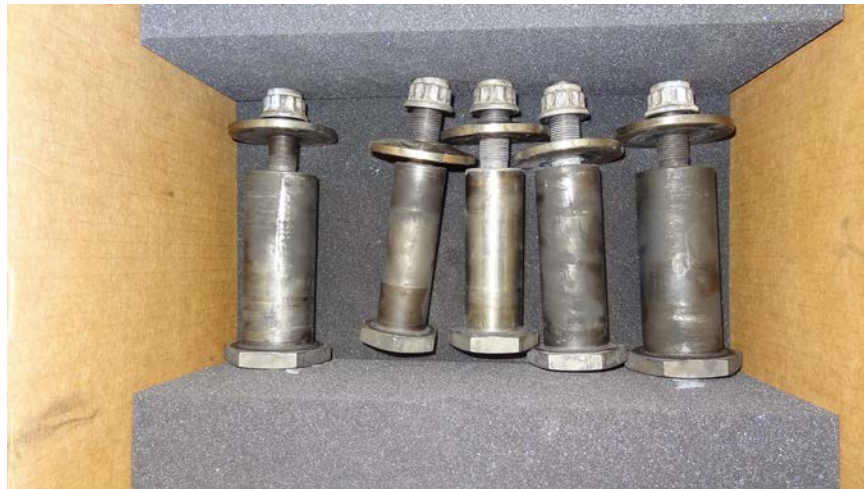
Photo No. 54: View of aft engine mount bolts. (Boeing)

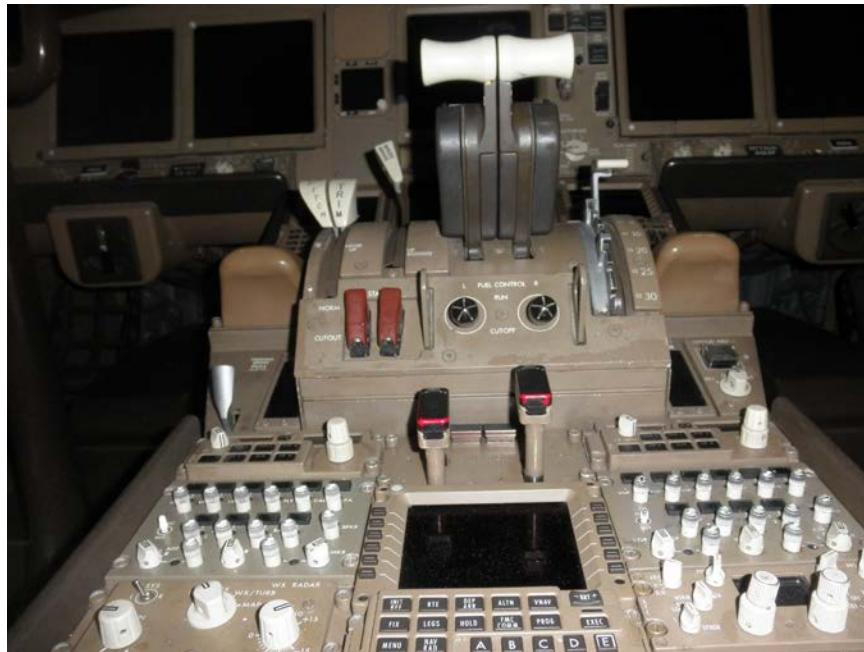
The examination of the cockpit revealed the No. 2 engine's fire handle was pulled. (Photo No. 55)

Photo No. 55: View of center console showing right engine's fire handle pulled up.
