Service Investigation
Accident / Incident Report

Report No.:16-157

**Aero Smart Solutions Inc.
Lancair Evolution & Registration No. N38DM
Allen County, Kansas
October 1st 2016
PT6A-42
S/N 93158**

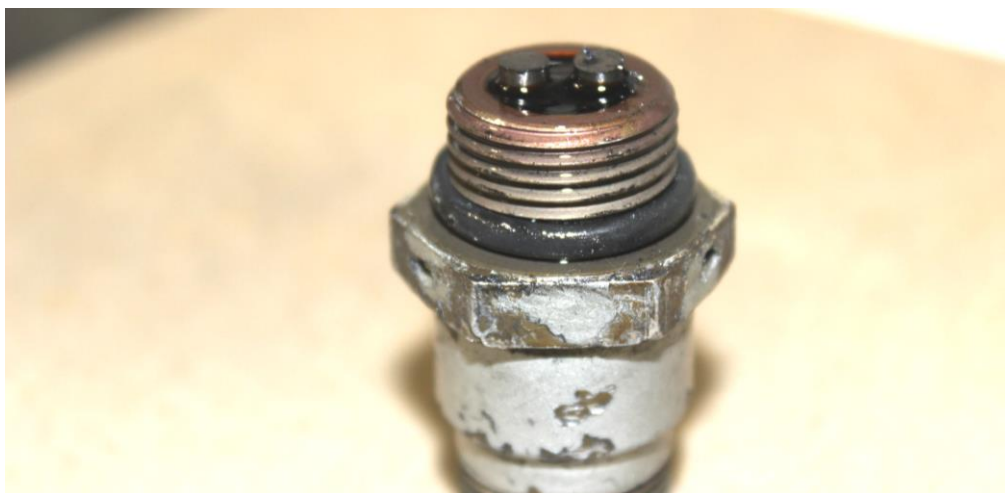
Photo No. 22

Reduction Gearbox Chip Detector: Some minor metal flakes and particulate were adhered to the magnetic poles (Ref. Photo No. 22).

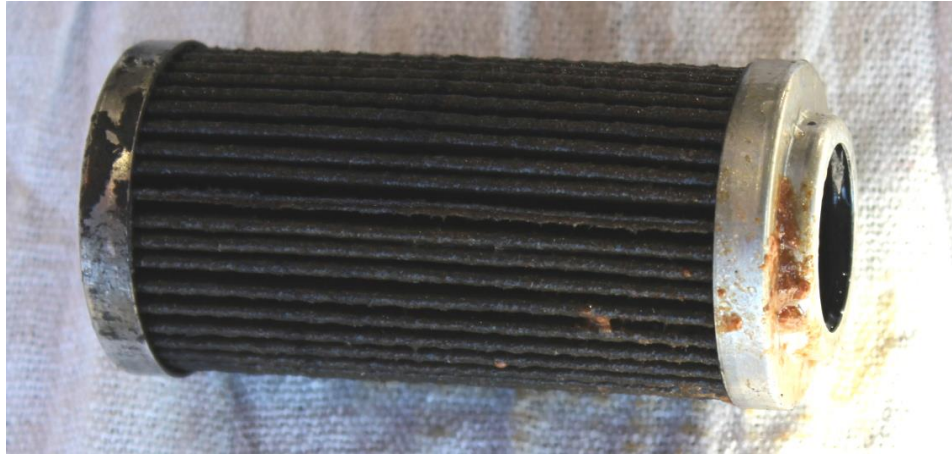
Photo No. 24

Fuel Filter: Outlet filter was discoloured and sediment was evident on the surface of the filter (Ref. Photo No. 24). The residual liquid in the outlet filter cover bowl was contaminated with sediment and there was a visible separation of the liquids, indicating it was most likely contaminated with water (Ref. Photo No. 25). The liquid was retained by the NTSB for analysis. The inlet filter exhibited a sediment build up on the surface (Ref. Photo No. 26). The residual liquid in the inlet filter cavity of the pump was contaminated with sediment and there was a visible separation of the liquids, indicating it was most likely contaminated with water (Ref. Photo No. 27). The liquid and filter were retained by the NTSB for analysis.

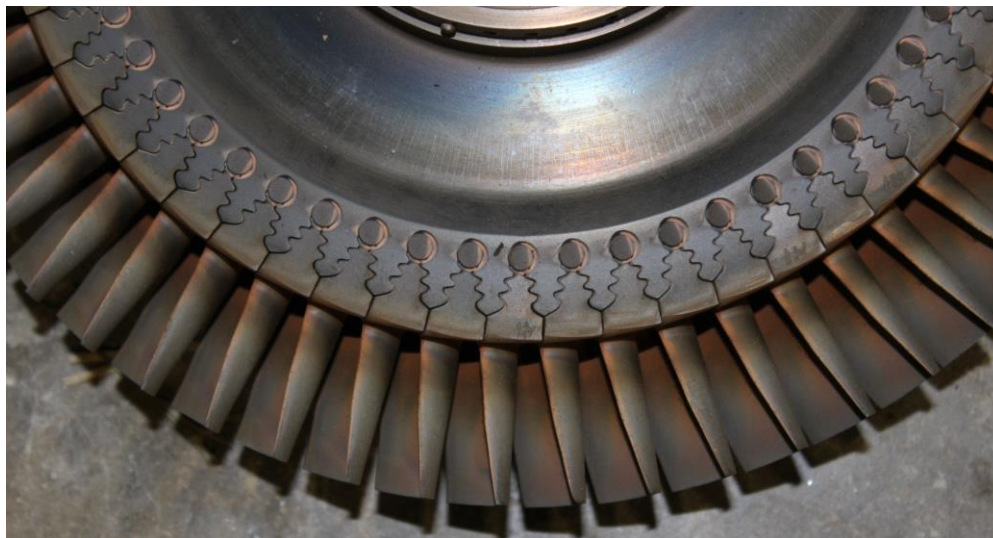
Photo No. 38, view of the upstream side

Compressor Turbine: The upstream side of the turbine and blades exhibited operational stains (Ref. Photos No. 37 & 38). The area adjacent to the retention bolt bore on the downstream side was polished from contact with the 1st stage power turbine baffle (Ref. Photos No. 39 & 40, red arrow). One of the tooling lugs was polished and several blade platforms exhibit mechanical damage (Ref. Photos No. 40, blue arrow & No. 41, blue arrow). The polished lip, polished lug and the blade platform damage were most likely from the compression of the gas generator case and rotor displacement from the loss of inlet case/No. 1 bearing support.

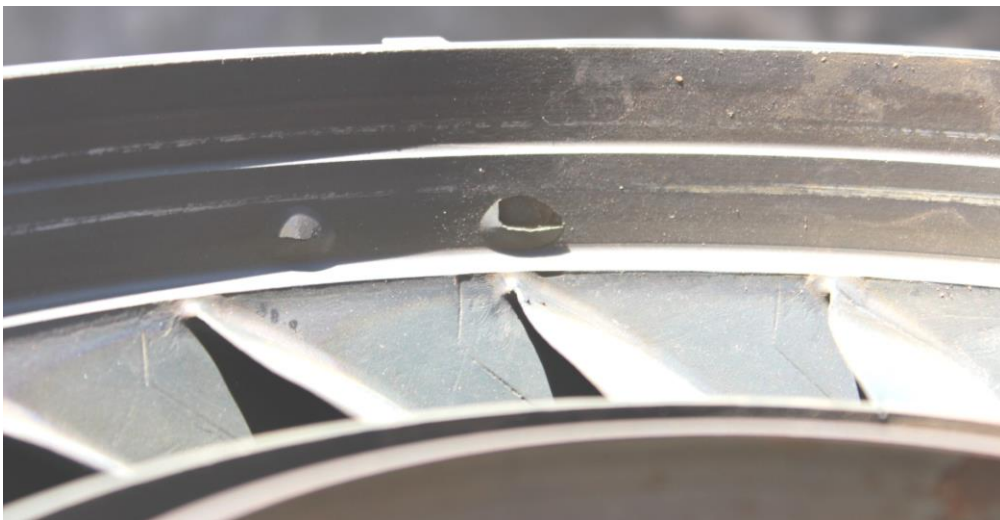
Photo No. 49

1st Stage Power Turbine Shroud: The shroud exhibited a rub from both knife edges of the 1st stage power turbine blade tips (Ref. Photo No. 48, red arrows). The surface of the shroud also exhibited some blisters and missing material on the shroud restoration coating that was applied during a previous shop visit (Ref. Photo No. 49).

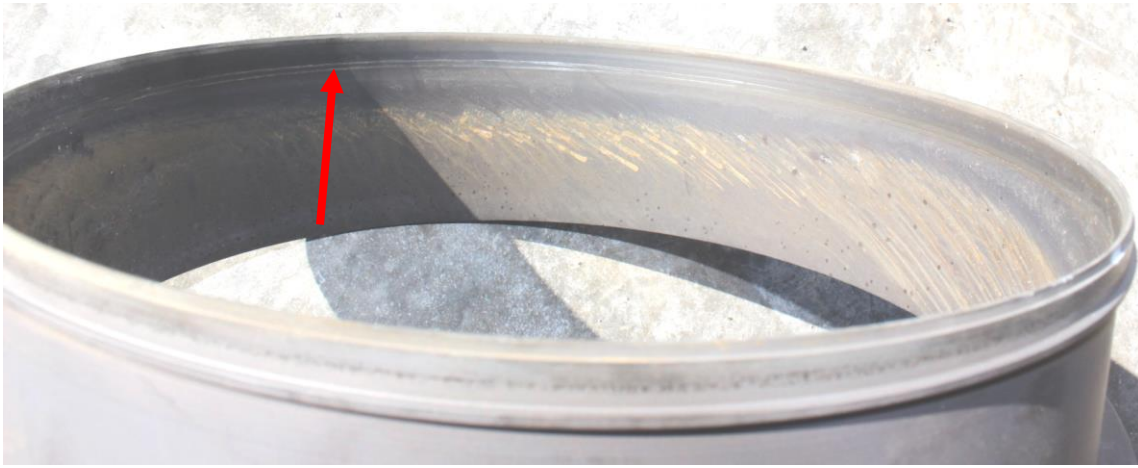
Photo No. 54

2nd Stage Power Turbine Shroud: The shroud exhibited localized rubs from contact with the 2nd stage power turbine blade tips (Ref. Photo No. 54, red arrow).

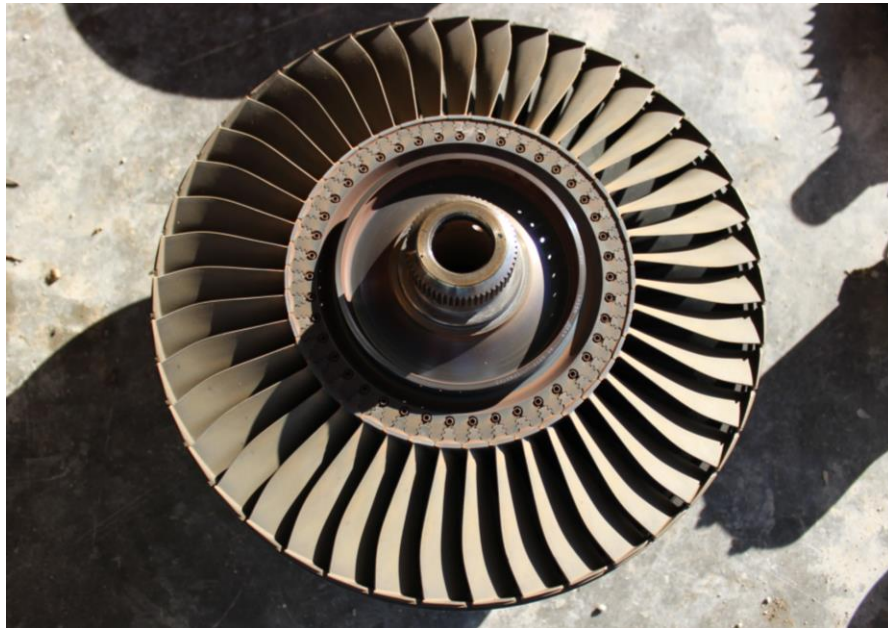
Photo No. 55, view of the downstream side

2nd Stage Power Turbine: The downstream side of the disc was unremarkable (Ref. Photo No. 55). The blade tips had rubbed with their respective shroud (Ref. Photo 56, red arrow).

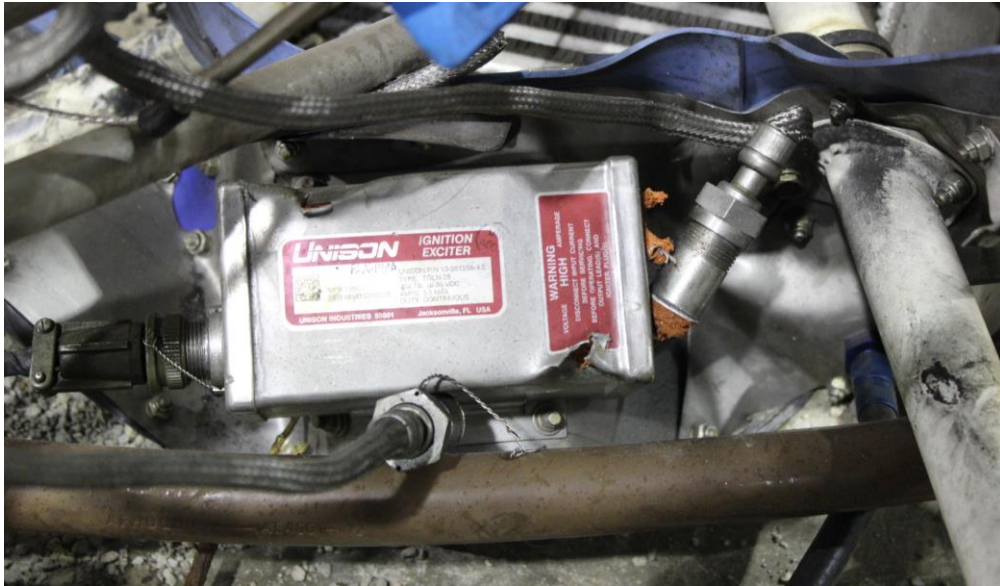
Photo No. 60

Exciter Box: The housing was breached at two locations and both ignition lead connectors were pulled from the box (Ref. Photo No. 60).

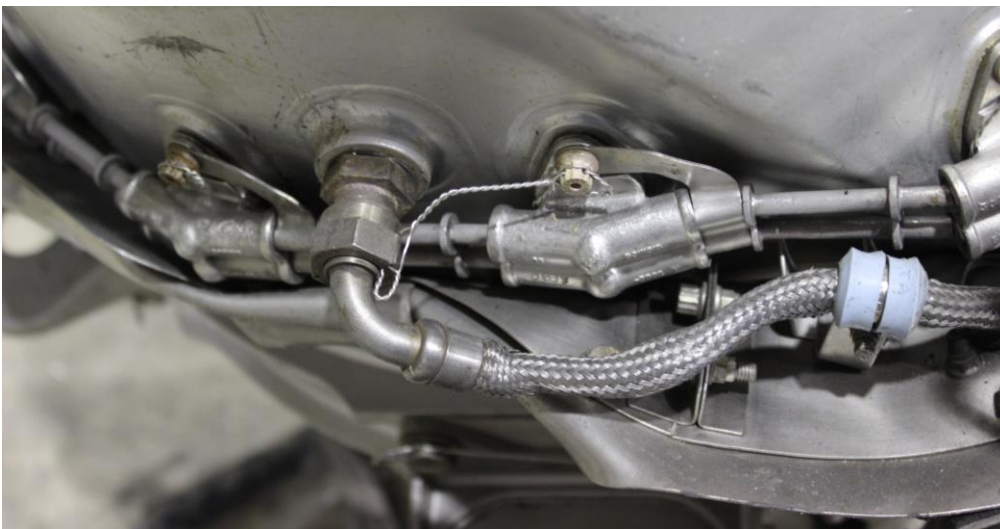
Photo No. 61

Ignition Leads: The leads were in place and secure (Ref. Photo No. 61).

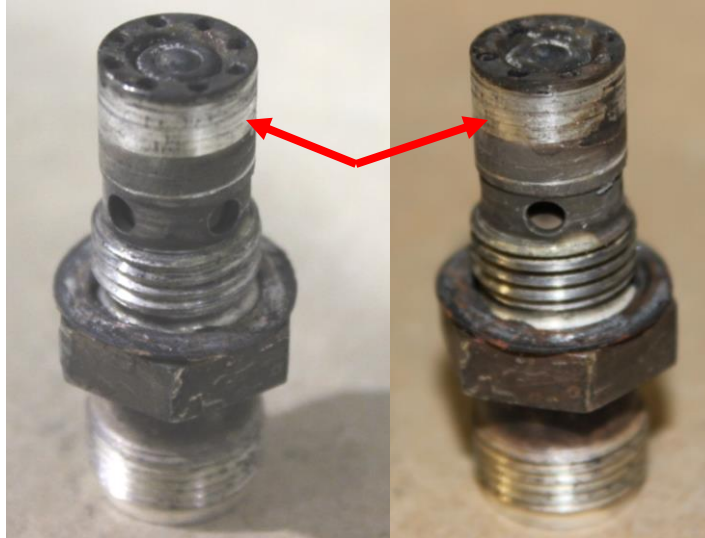
Photo No. 62

Ignition Plugs: Erosion was evident to the tips of both plugs (Ref. Photo No. 62). The ends were scored during the removal process from contact with the liner (Ref. Photo No. 62, red arrows).

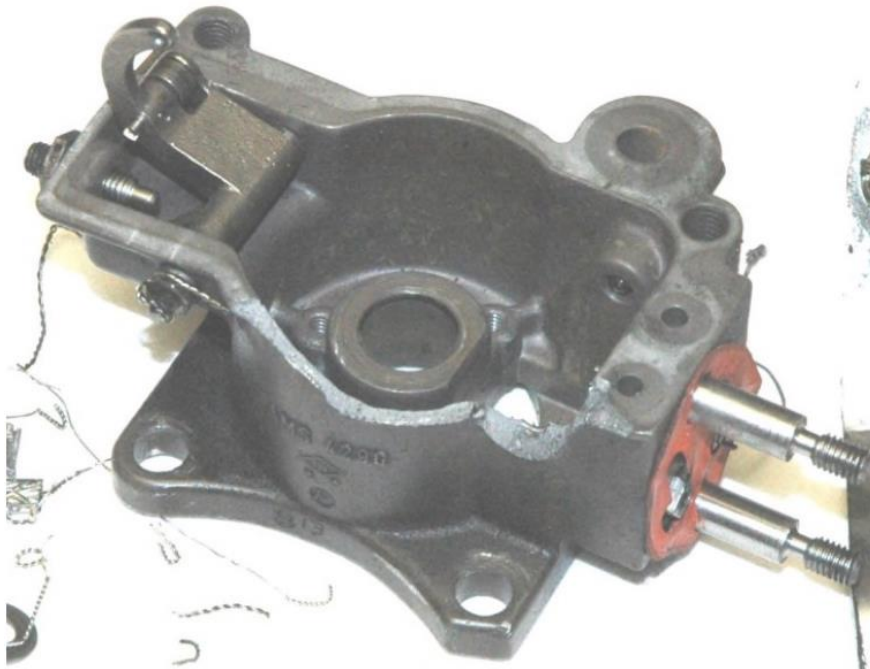
Photo No. 73

The FCU driveshaft rotation was restricted and the drive-housing was damaged. The drive-body was removed and another drive-body was installed for testing purposes (Ref. Photo No. 73). The FCU was tested per the manufactures overhaul manual. The results were consistent with field adjustments and impact damage, this would not have impeded the function of the control.

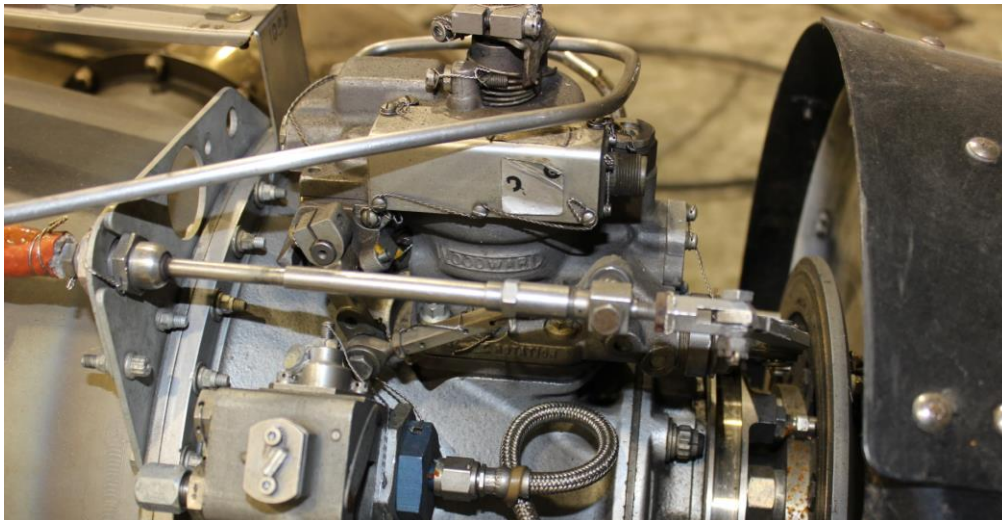
Photo No. 80

Propeller Governor: The governor was in place and secure (Ref. Photo No. 80).
