SECTION A - EVALUATION OF THE EXISTING GOVERNOR USING THE TEST BENCH

SECTION B - DISASSEMBLY OF THE EXISTING GOVERNOR

TABLE A – NTSB Case Number CEN16LA043

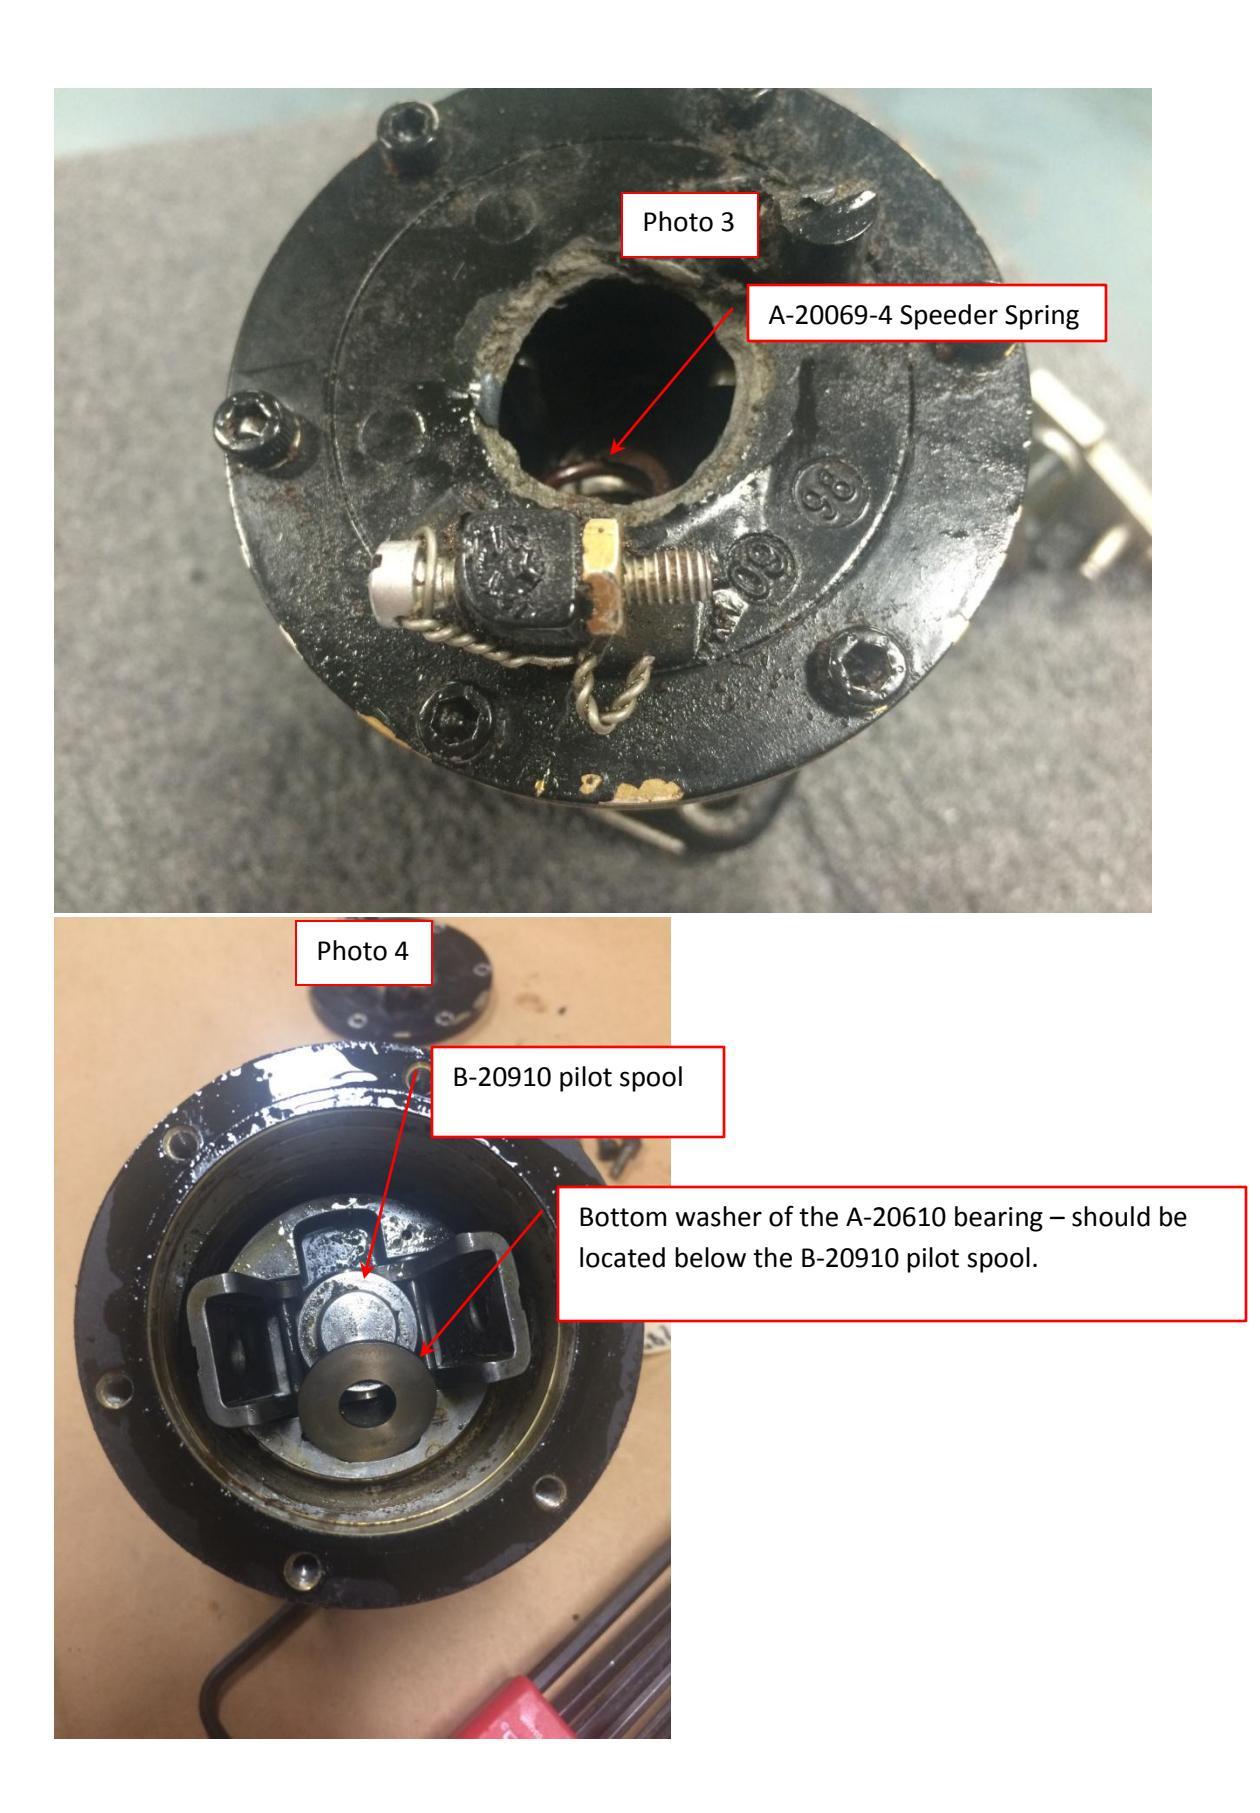
PART NUMBER	PART NAME	OBSERVED CONDITION
A-20264	DRIVE	No abnormalities were observed
A-20284	SPRING-PRESS	No abnormalities were observed
A-20572	STOP-PISTON	No abnormalities were observed
A-20609	CONTROL LEVER	C-20606 was bent. Control shaft and control lever rotated freely inside the severed top cover shaft. See photos 5 and 6
A-20610	BEARING-THRUST	After removal of the top cover, the bottom half of the A-20610 bearing was found loose inside of the body. It is believed that because of the severed top cover, the B-20910 pilot spool, A-20610 bearing and the A-20069-4 spring became dislodged. The parts were then placed inside of the governor body after the accident. See photos 3 and 4.
B-20024	GASKET	N/A
B-20040B	SPRING-TORSION	Missing
B-20160	CAP-LOCKING	No abnormalities were observed
B-20251A	CYLINDER-PRV	Normal wear observed. No abnormalities.
B-20255	PLUG-RELIEF	No abnormalities were observed

A-20609 Control Lever – Angular fracture
