**NATIONAL TRANSPORTATION SAFETY BOARD**  
**Office of Aviation Safety**  
**Washington, D.C. 20594**

**PROPULSION GROUP CHAIRMAN'S FACTUAL REPORT**

**NTSB No: DCA15MA019**

Vehicle: Scaled Composites, LLC Model 339 SpaceShipTwo

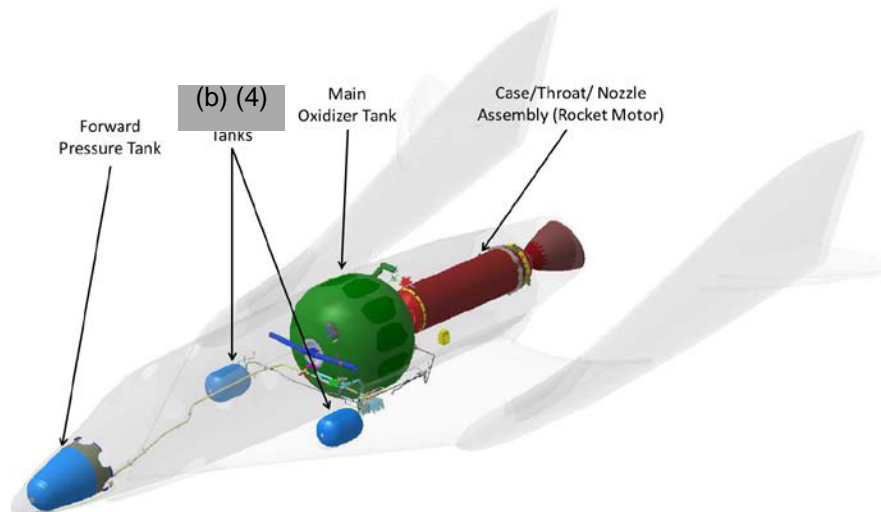
**Figure 1- SS2 Propulsion System**

SS2 featured a hybrid rocket motor which utilized nylon fuel grain and nitrous oxide (N<sub>2</sub>O) to generate thrust. The main components of the propulsion system were the forward pressure tank (FPT), main oxidizer tank (MOT), CTN, and two (b) (4) bottles (**Figure 1**).

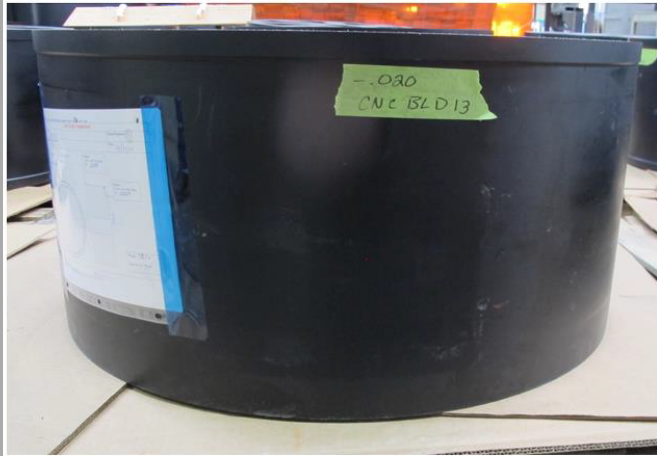
**Photo 1- Representative Nylon Fuel Grain Puck, (L) Overhead View (R) Side View**

The CTN consisted of a (b) (4) COPV fuel cartridge integrated with a nozzle throat and nozzle expansion bell. The accident fuel cartridge held (b) (4) (Photo 1). The case and the forward and aft domes were lined with ethylene propylene diene monomer (EPDM) rubber. The forward dome mating flange included ports for instrumentation, (b) (4), and gaseous nitrogen (GN<sub>2</sub>) purge<sup>2</sup>.

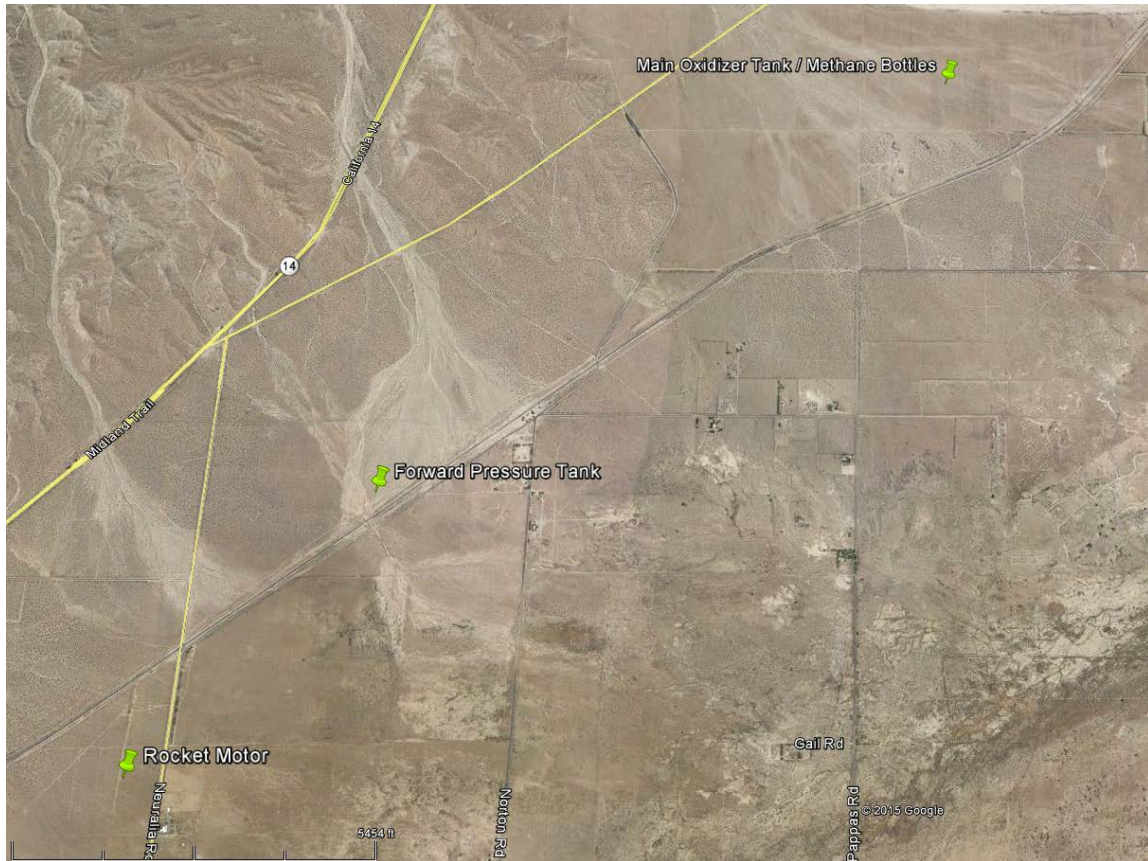
**Figure 2- Map of Propulsion Wreckage Sites**

The wreckage field was spread over about five miles with components concentrated at seven sites<sup>5</sup>. The location of the major propulsion components are shown in the image below and are labeled according to survey points gathered by the Federal Bureau of Investigation (**Figure 2 and Table 1**). A detailed description of all wreckage is available in the vehicle recovery factual report.
