**National Transportation Safety Board**  
Office of Research and Engineering  
Washington, D.C. 20594

**Radar Performance Study**

**Location:** Charleston, West Virginia  
**Date:** May 5, 2017  
**Time:** 1051 GMT (6:51 am EDT)  
**Airplane:** Shorts SD3-30, N334AC  
**NTSB Number:** DCA17FA109

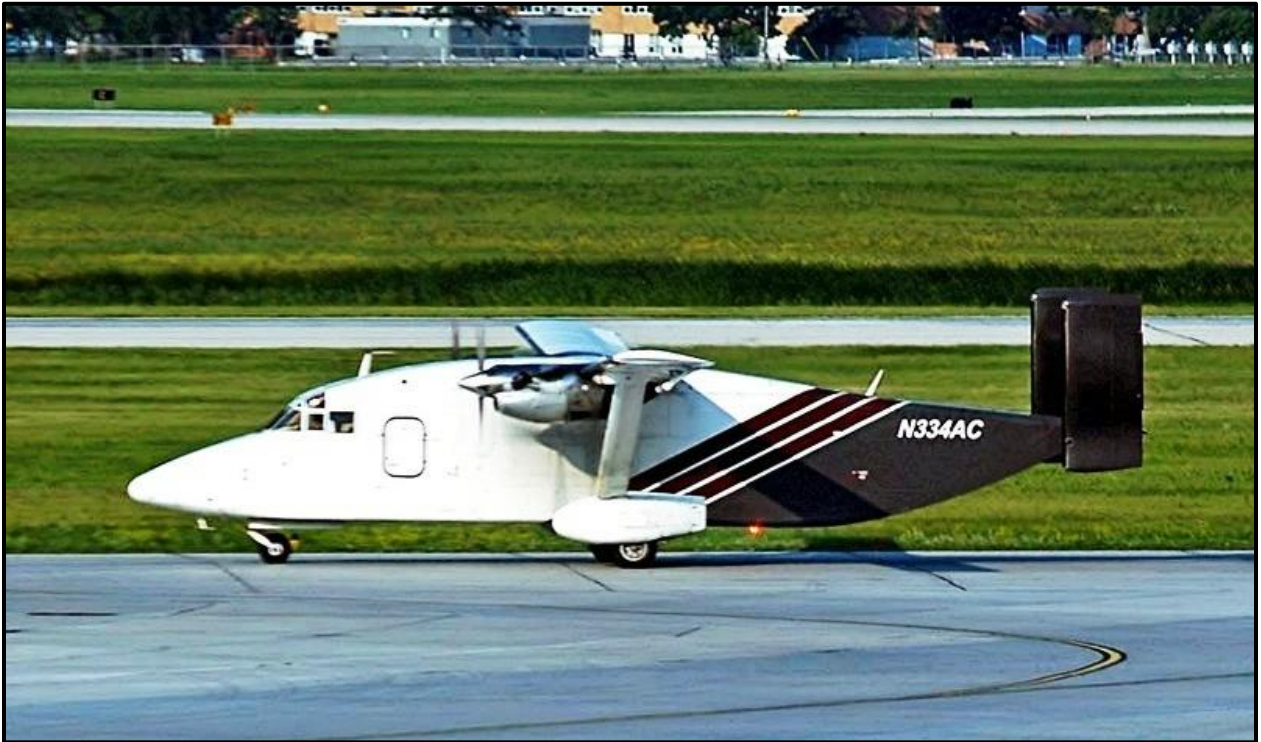
**Figure 1: Accident Airplane, N334AC, a Shorts SD3-30**

A picture of the accident airplane, a Shorts SD3-30, is shown in Figure 1. The airplane registration is held by ACC Integrated Services, Inc, of Milwaukee, Wisconsin.

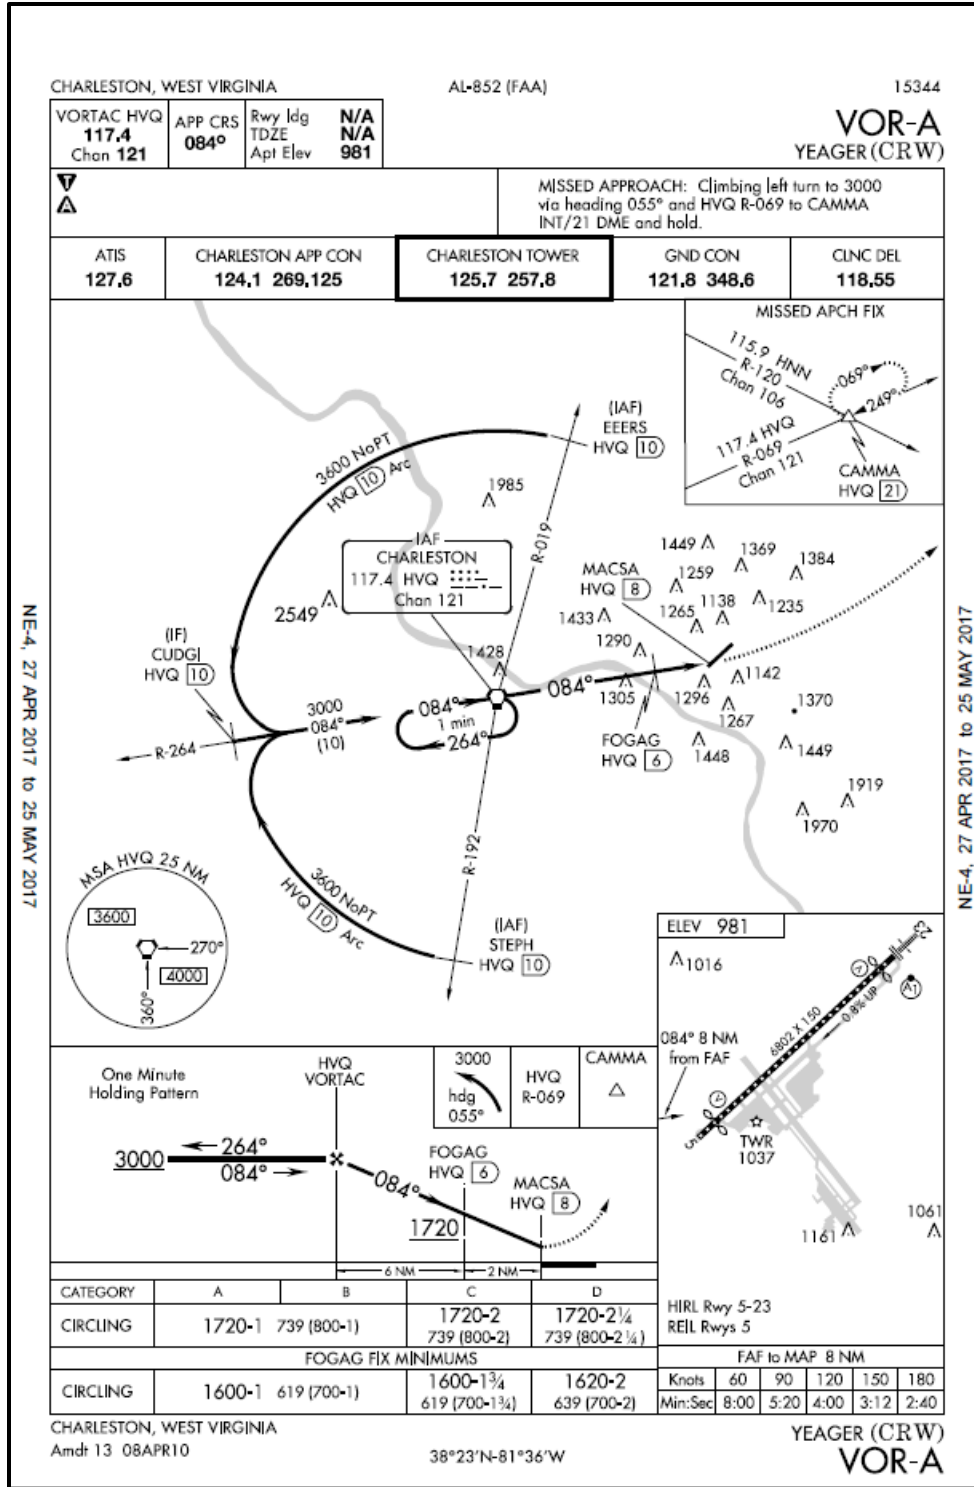
**Figure 4: Published Approach for which N334AC had been Cleared**

N334AC started its descent from a cruising altitude of 9,000 ft just before 6:38 am. The crew requested and was cleared for the VOR-A circling instrument approach<sup>1</sup> to runway 5 at CRW. Figure 4 shows the approach plate for Charleston's VOR-A approach.
