SITE (ID); Jennings/Kreilow, LA-5136

TOWER TYPE / HT: Guyed Tower / ~480 ft.

Jennings/Kreilow LA-5136

Guyed Tower Inspection Report

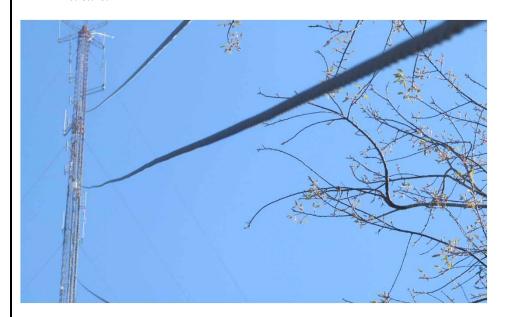
-Replace all guy wires at the 7th and 8th level. The two on side A show visible damage and side C shows some possible stretching or kinking.

Guy wires on C side appear to be kinked and stretched
