**National Transportation Safety Board**  
Office of Railroad, Pipeline and Hazardous Materials Investigations  
Human Performance and Survival Factors Division  
Washington, D.C. 20594

**Railcar Crashworthiness Group Chairman's Factual Report**  
**August 19, 2015**

Railroad: Metro-North Railroad  
Train: Passenger Train 659  
Location: Valhalla, New York  
Date: February 3, 2015  
Time: 6:26 pm EST<sup>1</sup>  
Number: DCA15MR006

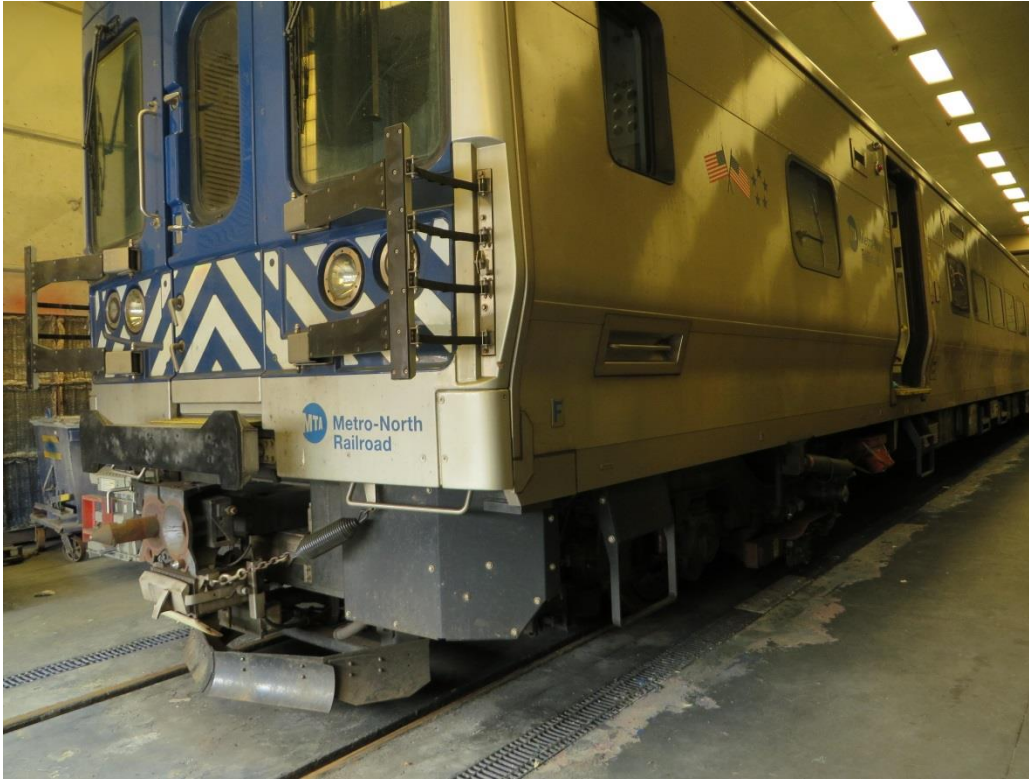
The cab end of the car is sheathed under a fiberglass end cap with stainless steel of strength equivalent to 2-inch thick steel with a yield strength of 26,000 psi. The mechanical coupler is a Wabco N-6-A coupler. (See figure 11.) The diameter of the pin is about 3 inches. The coupler height is about 34 inches above top of rail to the centerline of the coupler. Buffer face plates are held against the face plate of a coupled car by a side stem and compression spring. There is a snowplow and pilot assembly at the cab end of the car. The snowplow is "V" shaped to direct snow over the third rail. According to the specification, the pilot should protect all of the equipment at the end of the cars to the extent possible. The maximum width of the assembly is about 59 inches.

Figure 11- A side view of the cab end of car 4332.

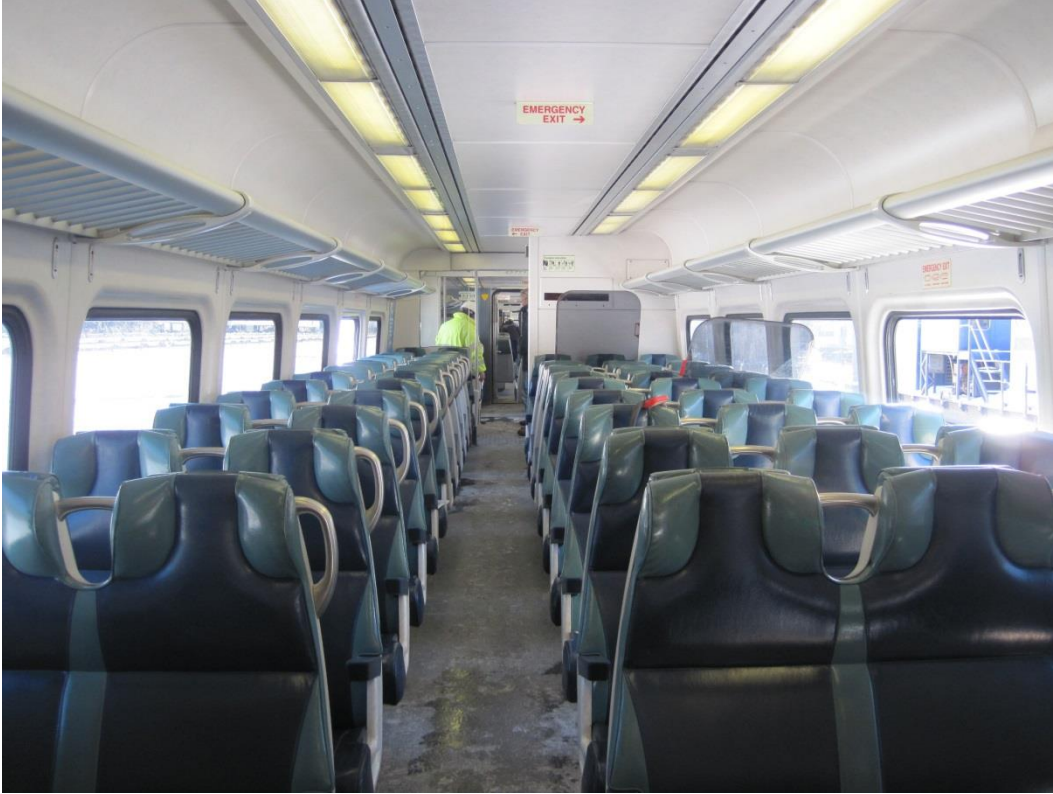
Each side of the car has a two or three person seat. (See figure 12.) The distance between the front of a backrest cushion and the back of the next seat back is about 30 inches. The distance between the backrest cushions of facing seats is about 48 inches. The seat frame backrest is about 17 degrees angle. The right side seats have grab handles on the aisle side of the seat pair. The handles are a stainless steel casting with a nickel-plated satin finish. The handle and its attachment are specified to withstand a 500-pound longitudinal force without permanent deformation or separation. Headrest handles are made from nickel-plated aluminum with the same strength requirements for the aisle grab handles.

Figure 12- A view of the interior of car 4197 looking toward the rear of the car

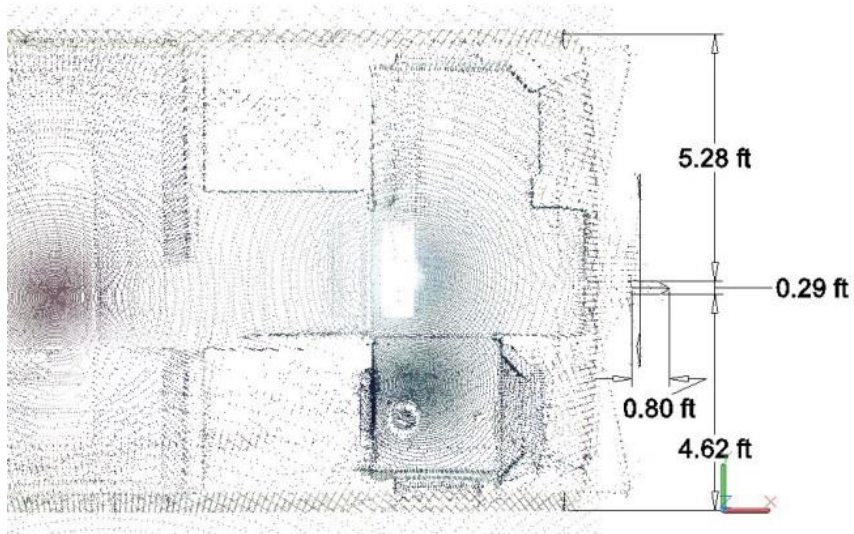
Figure 14- An overhead view showing the position, length, and diameter of the coupler alignment pin based on the 3D laser scan of an exemplar railcar 4021

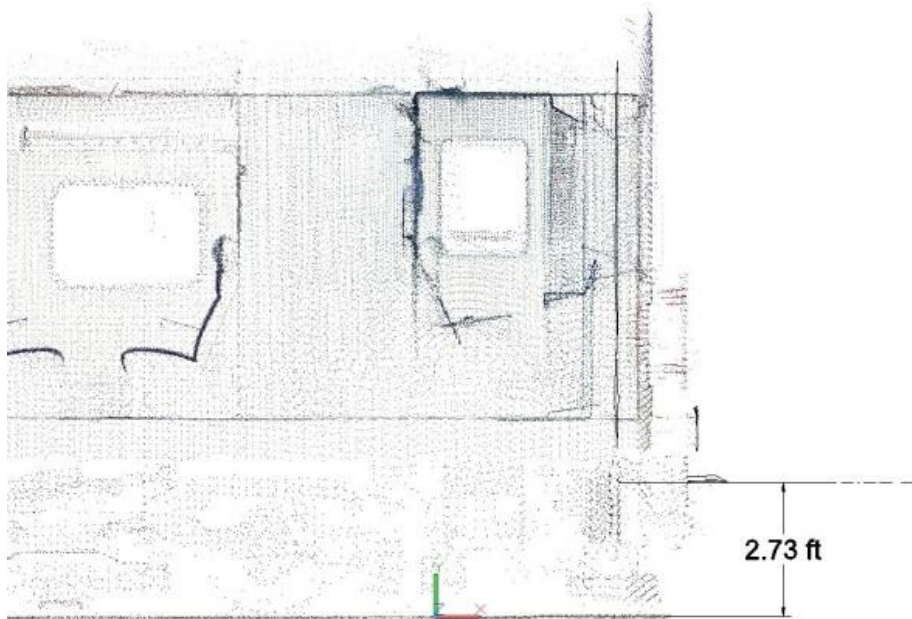
Figure 15- A side view showing the height of the coupler above the ground taken from the 3D laser scan of an exemplar car 4021
