**RECONSTRUCTION GROUP CHAIRMAN'S FACTUAL
REPORT OF INVESTIGATION**

A. ACCIDENT: DCA-96-MA-070

Location: East Moriches, New York
Date: July 17, 1996
Time: 2031 Eastern Daylight Time
Airplane: Boeing 747-131, N93119

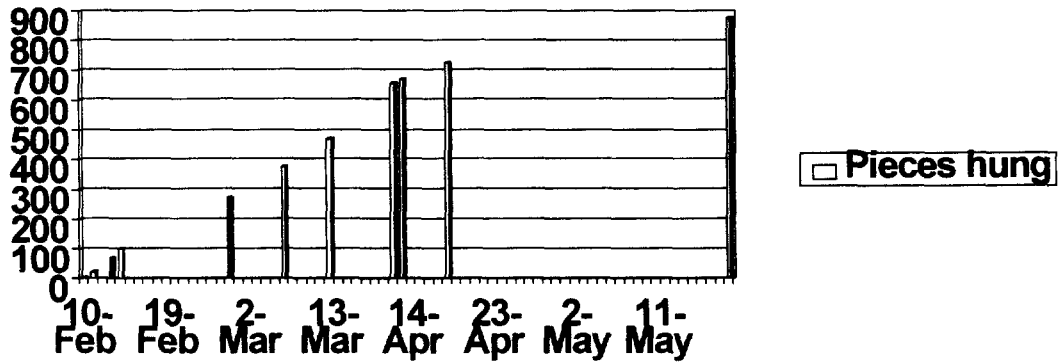
Figure 1 -

A database was developed to keep track of the pieces fastened to the reconstruction. The database provided information on the pieces in the reconstruction and included information on what pieces were hung, by whom, and dated. In the comments section, the number of holes drilled for attachment and special features were indicated. The database also served as a quality control on tagging of pieces, and documentation on the piece. See figure 1, which displays the cumulative number of pieces hung on the reconstruction.

Cumulative Pieces Hung on the Reconstruction vs. Time
