Continental Motors

ENGINE FIELD INSPECTION REPORT

ENGINE MODEL	IO-520-L46B
ENGINE SERIAL	1000795
AIRCRAFT MAKE & MODEL	Cessna 210L
AIRCRAFT SERIAL NUMBER	21061454
AIRCRAFT REGISTRATION	N732EJ
FILE NUMBER	13-386

The engine sustained impact-related damage that fractured the crankshaft aft of the propeller flange and deformed the crankcase, cylinders, and oil sump, all of which precluded crankshaft rotation. However, examination of identified components did not reveal any pre-existing anomalies that would have prevented normal engine operation and production of rated power.

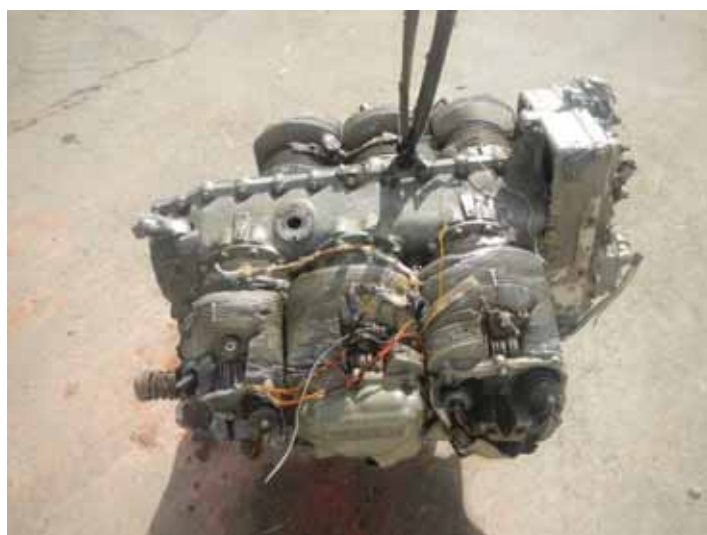
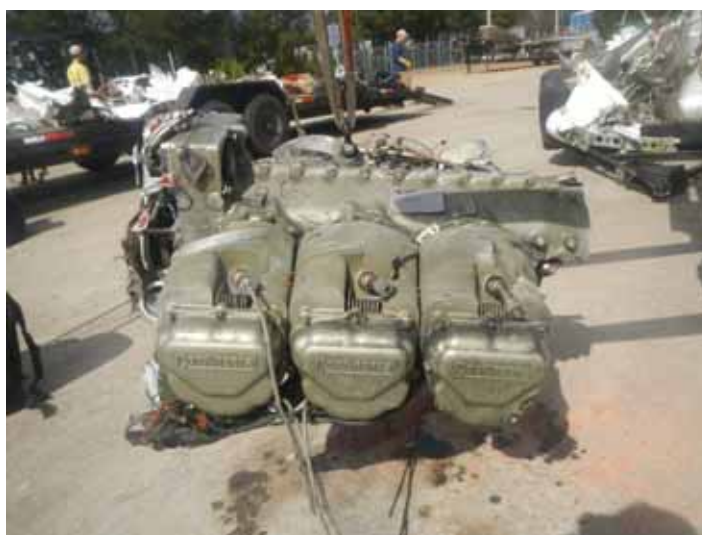
The engine came to rest in a deep impact crater in an upright position with its left side low. The propeller was separated from the crankshaft aft of the propeller flange. The separation featured rough, angular shear lips. The propeller came to rest approximately 6 feet from the engine at the leading edge of the impact crater. All of the engine's exterior components were separated from the engine with the exception of the oil pump housing, the starter adapter housing, portions of the left and right exhaust risers, and one fuel injector line. Portions of all but the #2, #4, #5, and #6 bottom sparkplugs remained attached to their cylinders. The #2 and #6 rocker covers were destroyed and the #4 rocker cover was fractured. The #6 cylinder head was fractured, the barrel was dented, and the rocker arms and pushrods were missing.

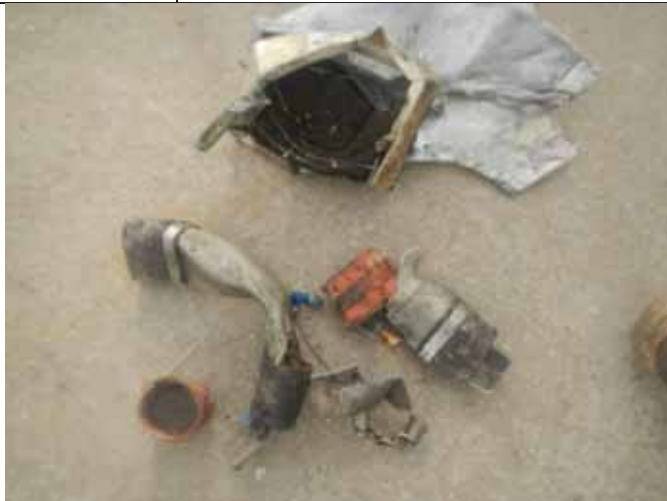
The induction system was destroyed. Portions of intake manifolds were identified at the accident site. The intake filter sustained deformation damage, but its foam filter remained in place. The throttle body was fractured and the throttle lever remained attached to the shaft of the throttle valve.

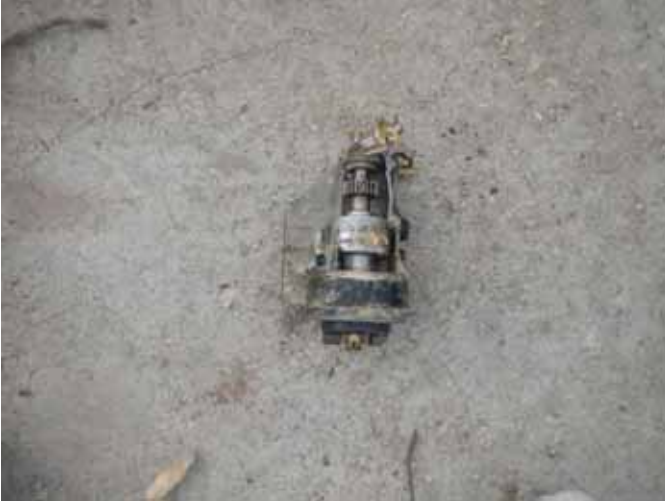
Both magnetos were separated from the engine and all ignition leads were separated from the magnetos. The magneto housings were fractured, the distributor caps were separated, and some of the internal components were missing. Functional testing was not possible.

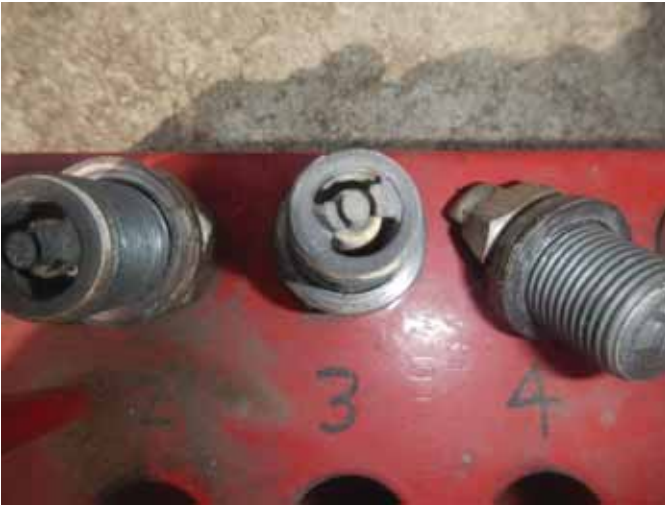
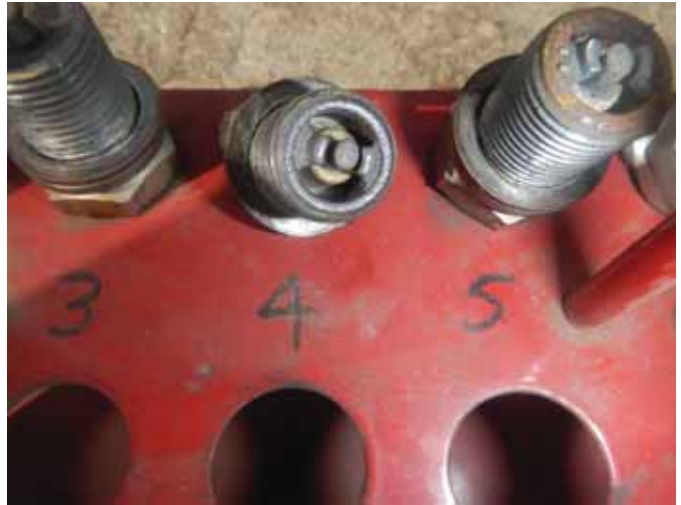
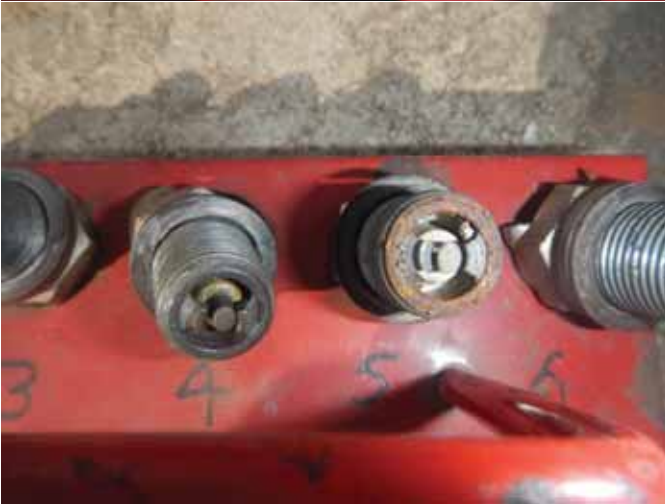
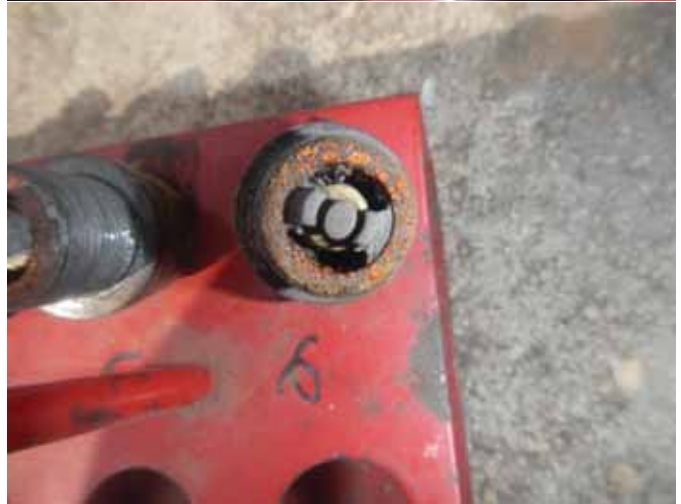
The #2, #4, #5, and #6 bottom sparkplugs were separated from their respective cylinders. Some of the sparkplugs that remained attached to the engine sustained deformation damage or were fractured. The top sparkplugs were removed and examined. The sparkplugs displayed a normal worn condition and no signs of lead or carbon fouling. The #2 and #5 top sparkplugs contained some organic debris on the electrodes and the #6 top sparkplug was rusted.

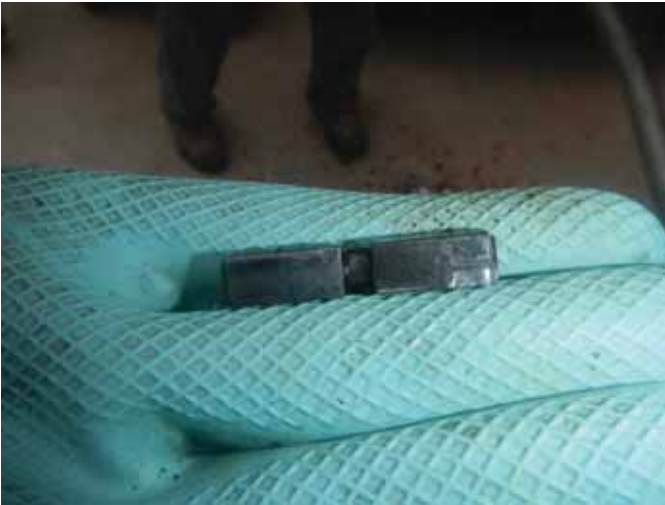
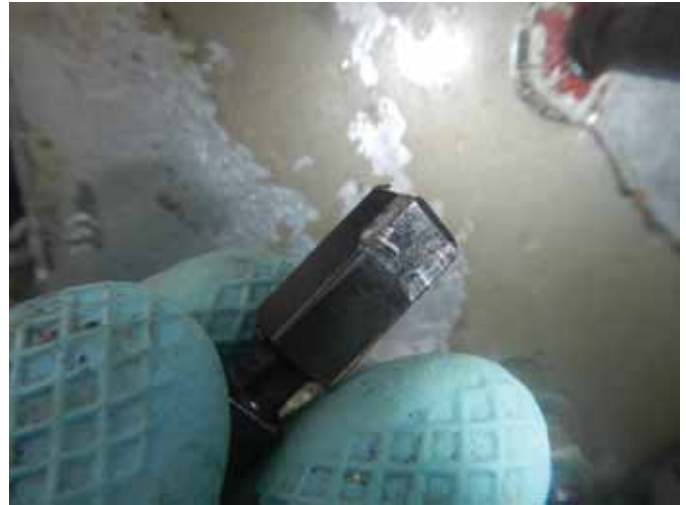
The fuel pump was fractured with only the fuel pump adapter remaining attached to the engine. The adapter was fractured and the sheered remains of the fuel pump assembly bolts remained with the adapter. The fuel pump drive coupling remained inserted in the drive gear. Removal of the drive coupling from the adapter revealed that it was intact but bent, with fresh scrape marks visible on one end of the drive. The remaining fuel pump components were not observed at the accident site and were not located within the retrieved components at the salvage facility.

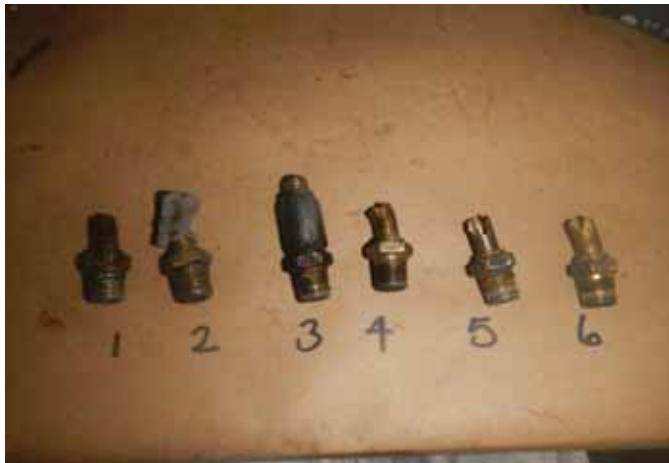
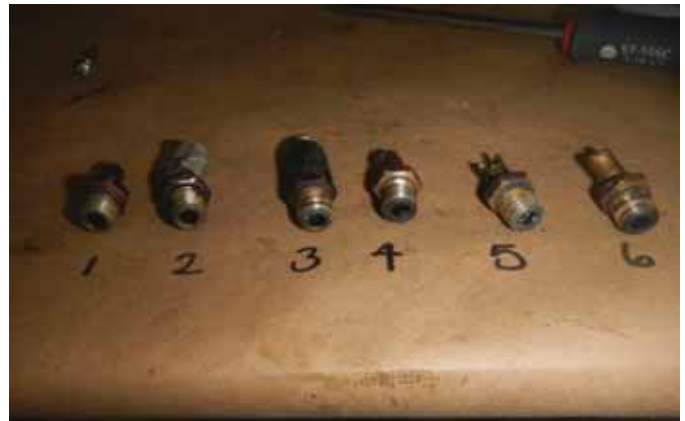
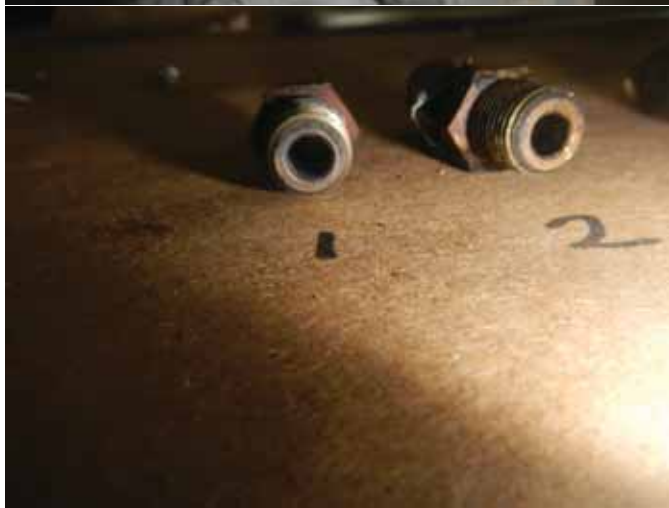
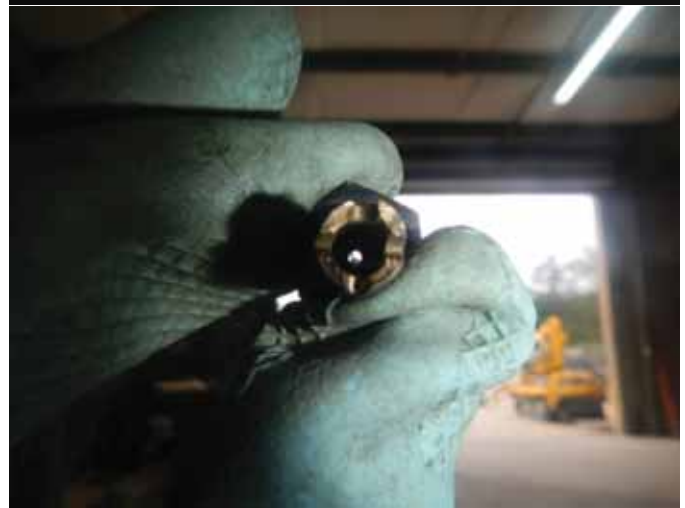
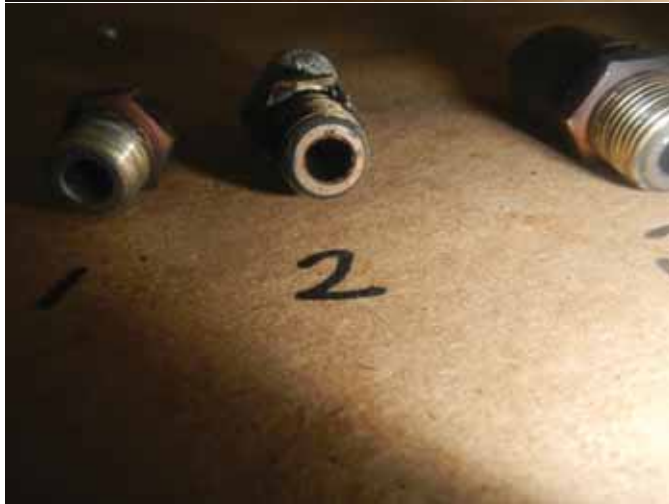
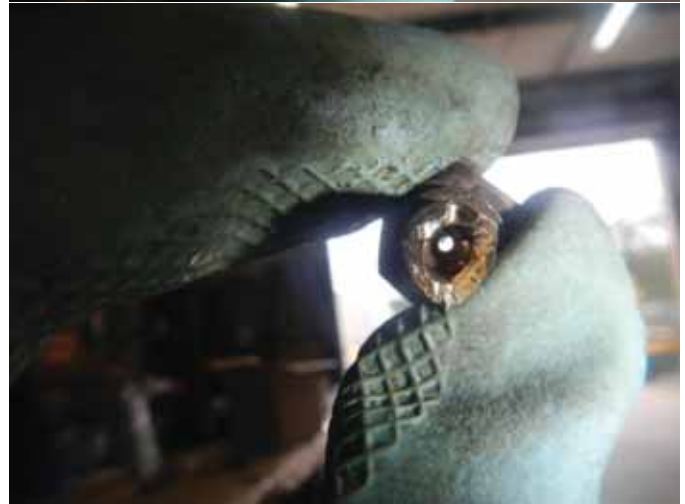
Position	#1	#3	#5	#2	#4	#6
Size (S/N)	047 (6250)	047 (1250)	047 (4250)	047 (2250)	047 (5250)	047 (3250)
Condition:	All of the fuel injector nozzles were fractured, except the #3, and all sustained bending deformation. Light was observed through all of the nozzles with the exception of the #3 and #6, which were bent to a greater degree. No pre-existing anomalies were noted with the remains of the nozzles.

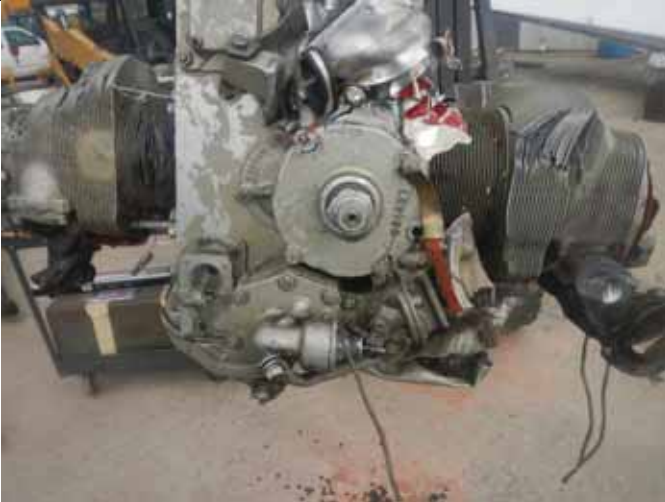
The oil pump housing remained intact and attached to the backside of the engine. The pump was removed and the gears were intact and the oil pump walls were free from contaminants. There was light scoring on the oil pump walls. A ½-inch arch of material was shaved from the housing wall in an area adjacent to the drive gear. Residual oil was found in the oil pump housing.

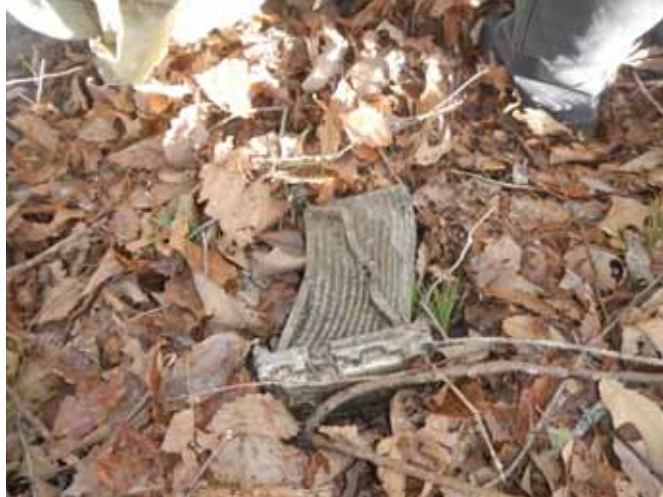
The oil cooler and oil cooler adapter were separated from the engine. The oil cooler was deformed.

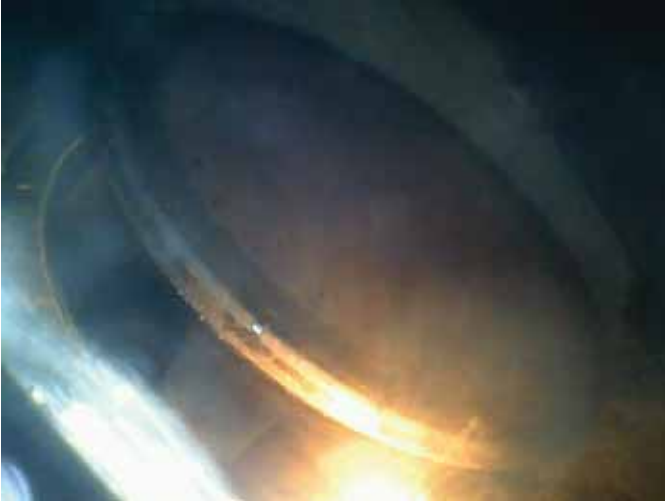
CYLINDER #1	P/N: Unknown	S/N: Unknown	Head Date: Unknown
Work Orders:	Unknown		
Condition:	Cylinder #1 remained attached to the engine and the rocker cover was in place. Numerous cooling fins were cracked and deformed. Removal of the rocker cover revealed that the head was cracked through the pushrod entry holes. The crack was irregular in shape and jagged. The cylinder was borescoped and no anomalies were noted with the piston, barrel, or valves.

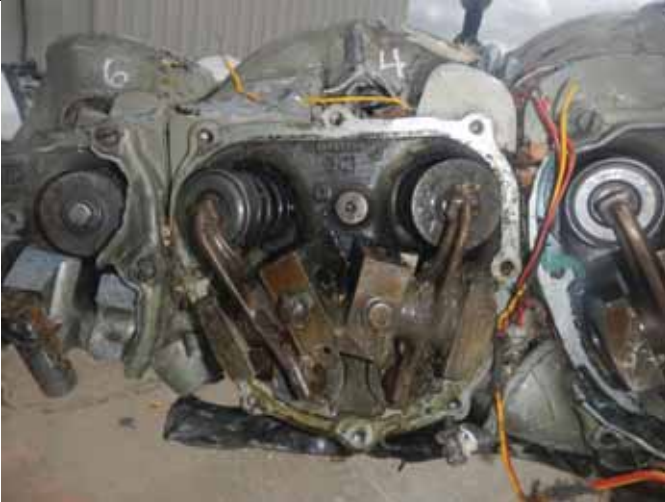
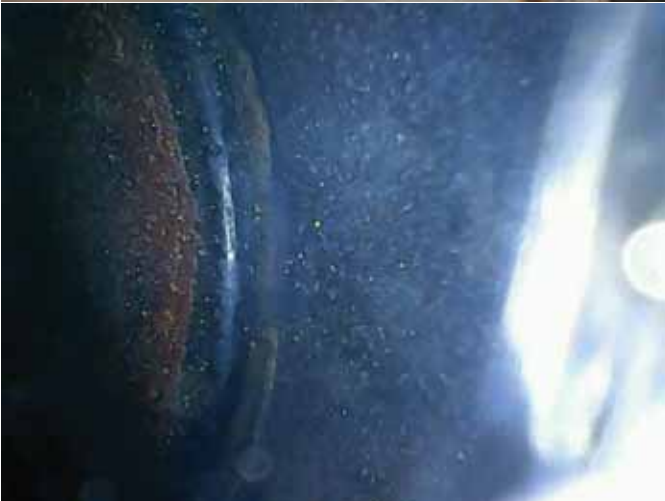
The #4 cylinder remained attached to the crankcase. Numerous cooling fins were cracked and deformed. The rocker cover was fractured and dirt was located in the rocker area. No pre-accident external or internal anomalies were noted with the cylinder, barrel, piston or valves.

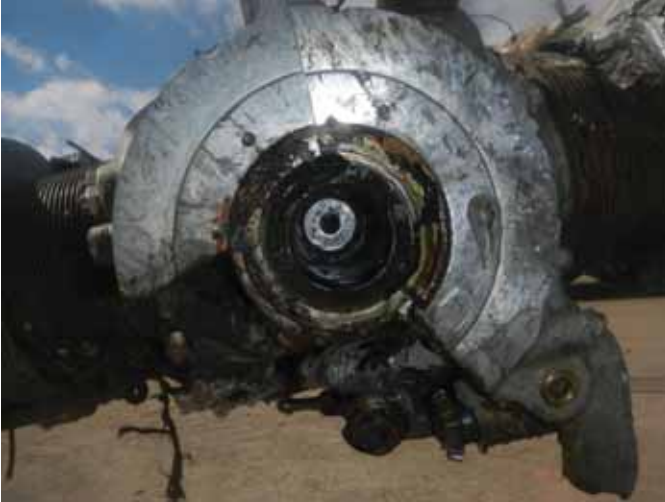
The crankshaft was fractured aft of the propeller mounting flange in the area where the crankshaft enters the crankcase. The fracture surfaces were irregular in shape and displayed 45° shear lips. Examination of the crankshaft through the bottom of the engine did not reveal any pre-accident anomalies with the crankshaft. The crankshaft gear remained attached and secured to the crankshaft.

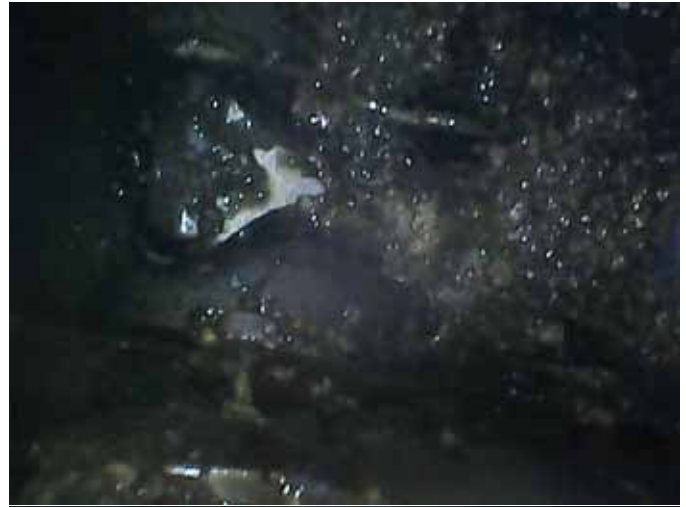
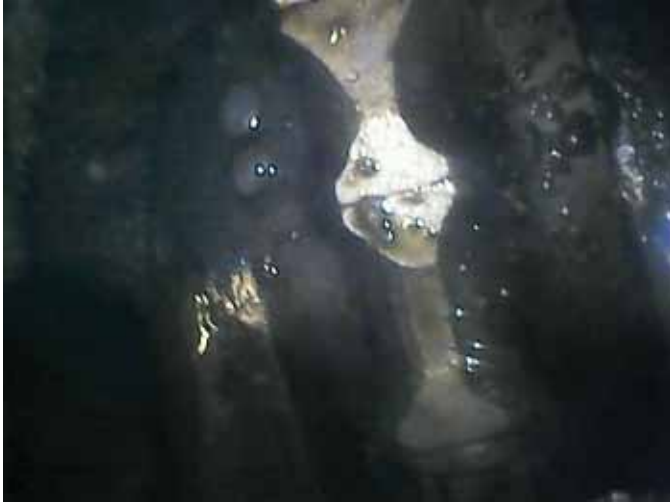
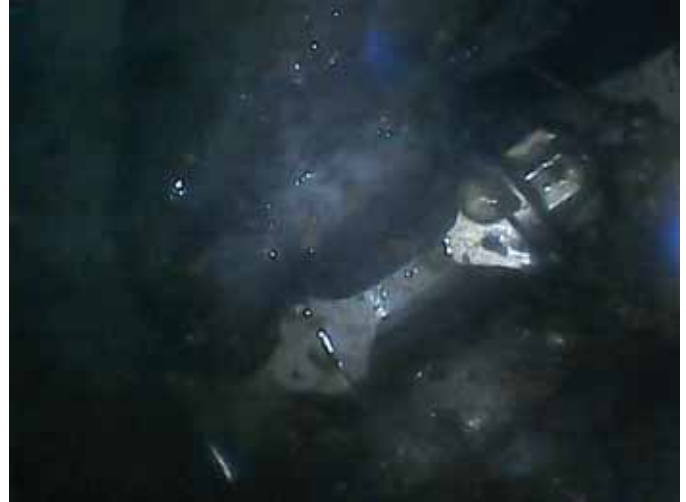
Condition: The connecting rods were examined through the bottom of the engine. Using a lighted borescope it appeared that all six connecting rods remained attached to their respective connecting rod journal and piston pins. There was no sign of operational or heat distress on any of the connecting rods (the photos below are of the connecting rods #1 through #6, in that order).

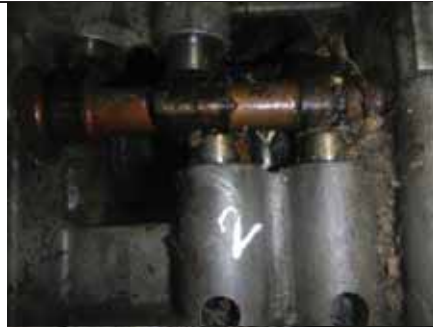
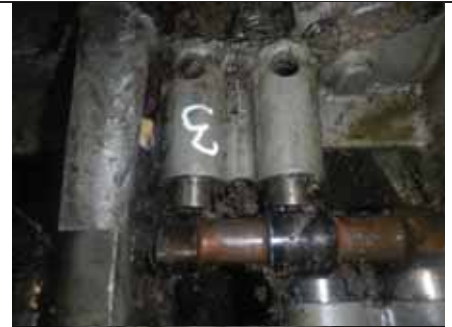
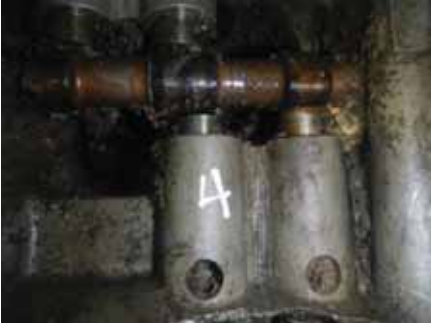
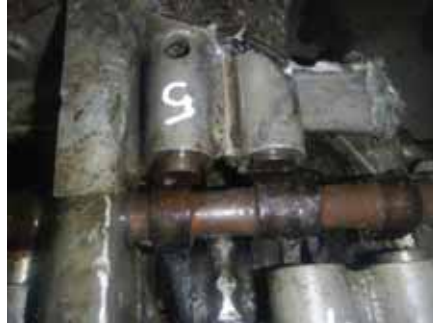
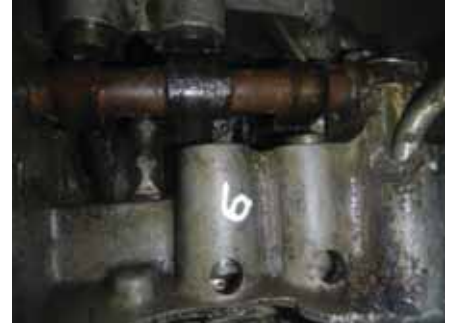
The lifters remained in place adjacent to their respective lobes. No pre-accident anomalies were noted with the lifters.

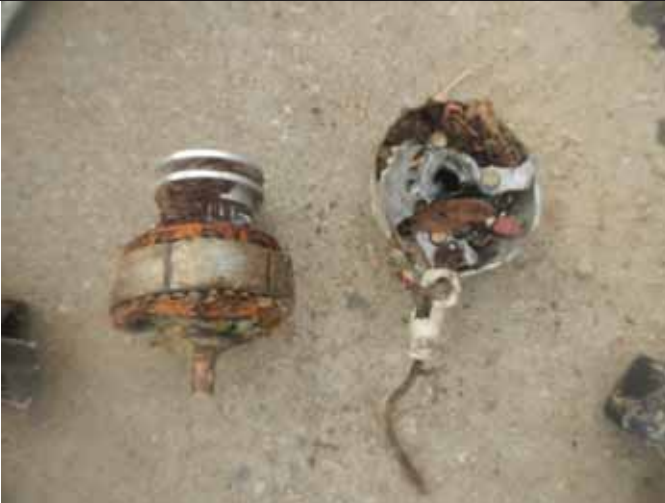
The alternator was separated from the engine and fractured.

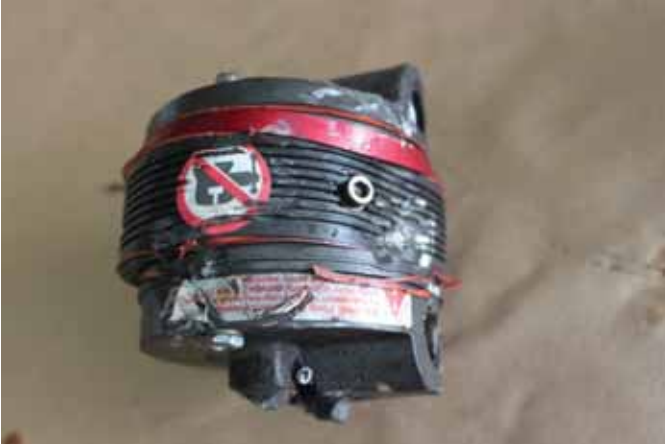
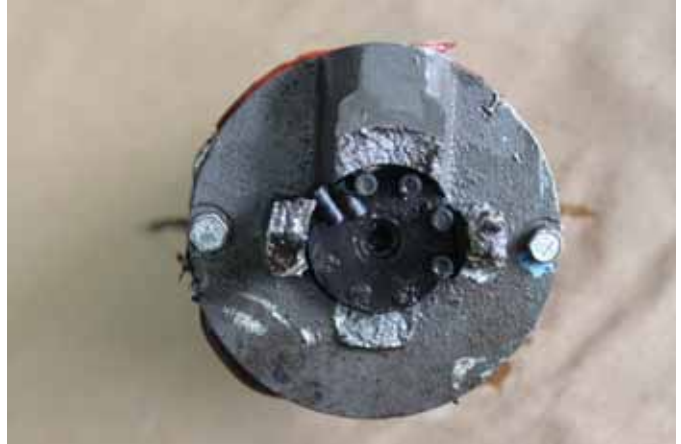
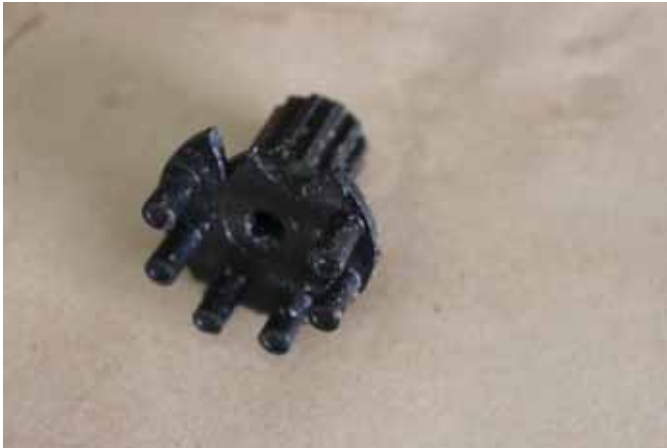
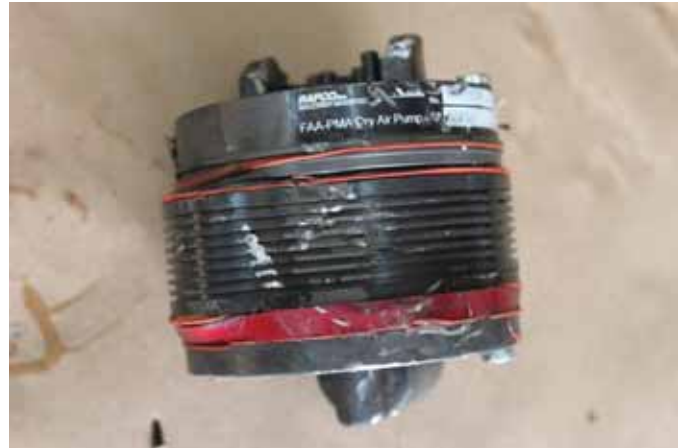
VACUUM PUMP

The vacuum pump was separated from the engine and the coupling was not observed. The vacuum pump was photographed and shipped to the manufacturer's facility for further examination under federal supervision.

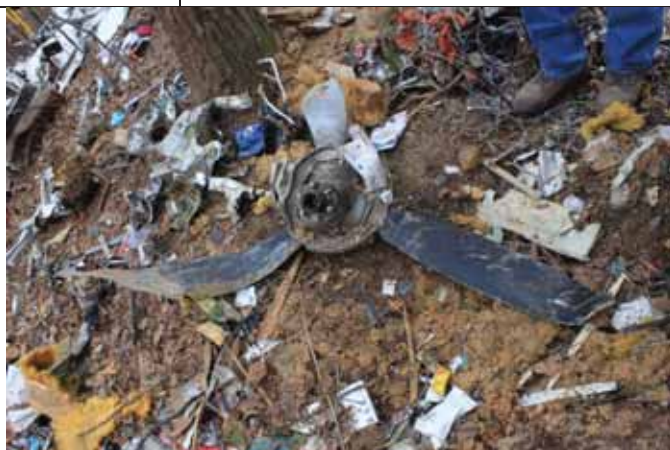
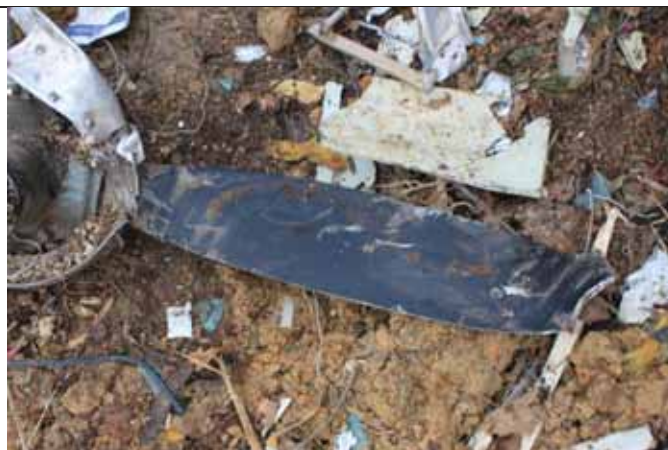
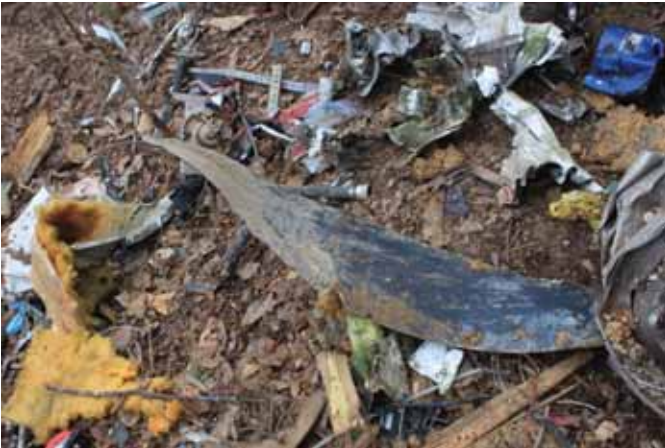
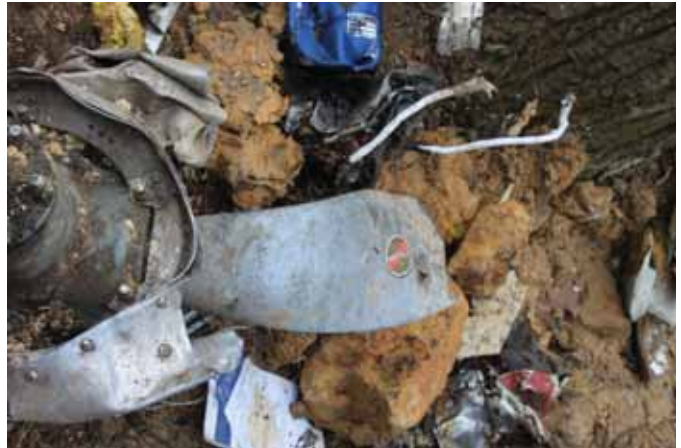
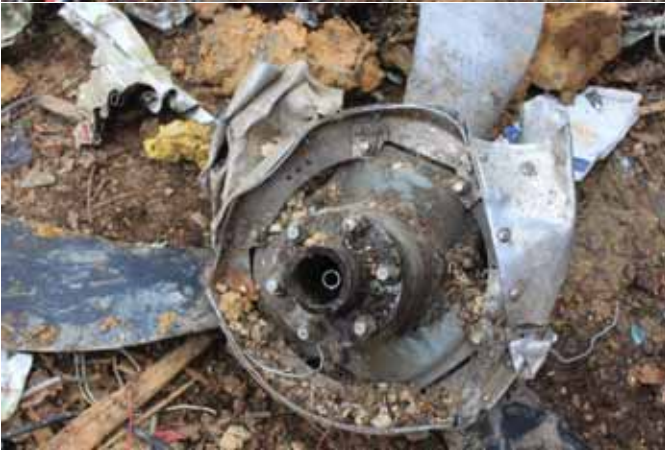
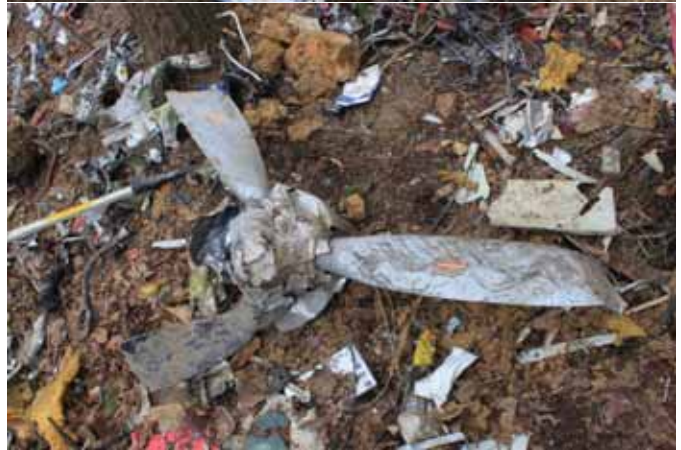
The propeller remained bolted to the propeller flange, but the crankshaft was fractured aft of the propeller flange. The propeller came to rest at the leading edge of the impact crater with the propeller spinner displaced aft around the propeller hub. The propeller blades remained attached to the hub with one blade rotated 180 degrees from its normal position. The outboard half of the rotated blade was separated into two pieces, which were located at the accident site. Assembling the separated pieces revealed that the rotated blade sustained heavy s-bending and leading edge gouging. Another blade was missing its tip, which was later located within the impact crater. All blades displayed heavy gouging on the camber side and tip curling. In addition, numerous large pieces of wood were located at the accident site that displayed a fresh angular cut. Some of the cut surfaces contained a gray paint transfer that was similar in color to the gray paint on the camber side of the blade.
