**Air Tractor, Inc.**  
Accident Investigation

**AILERON DEFLECTION ANALYSIS**

**ERA18FA088**

**2/26/18**  
**Greenwood, MS**

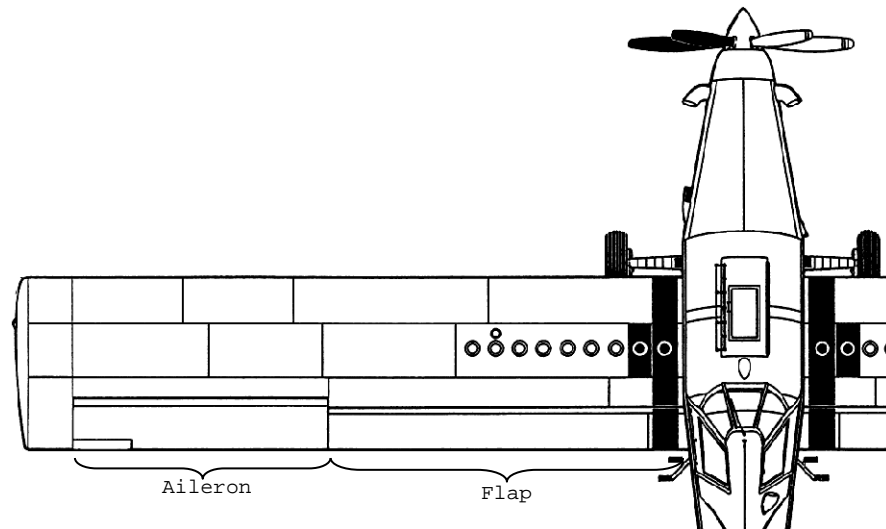
**Location of AT-802A Aileron (Lefthand Shown)**

The AT-802A aileron system is a mechanically controlled control system that uses pushrods, bellcranks, and idlers to transmit side-to-side motion of the cockpit control stick to movement of the ailerons. The ailerons are attached to the outboard portion of the wings and are bordered on the outboard end by the wing trailing edge and on the inboard end by the flap. The total design travel for each aileron is 17° up to 13° down.
