EGYPTIAN CIVIL AVIATION AUTHORITY

REPORT OF INVESTIGATION OF ACCIDENT

EgyptAir Flight 990

Boeing 767-300ER SU-GAP

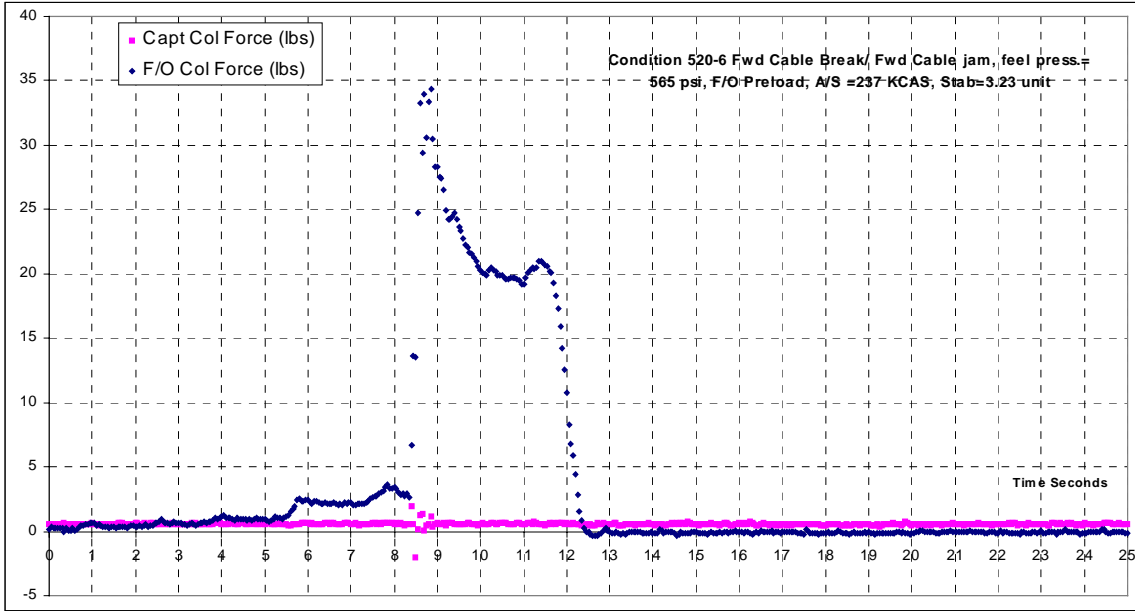
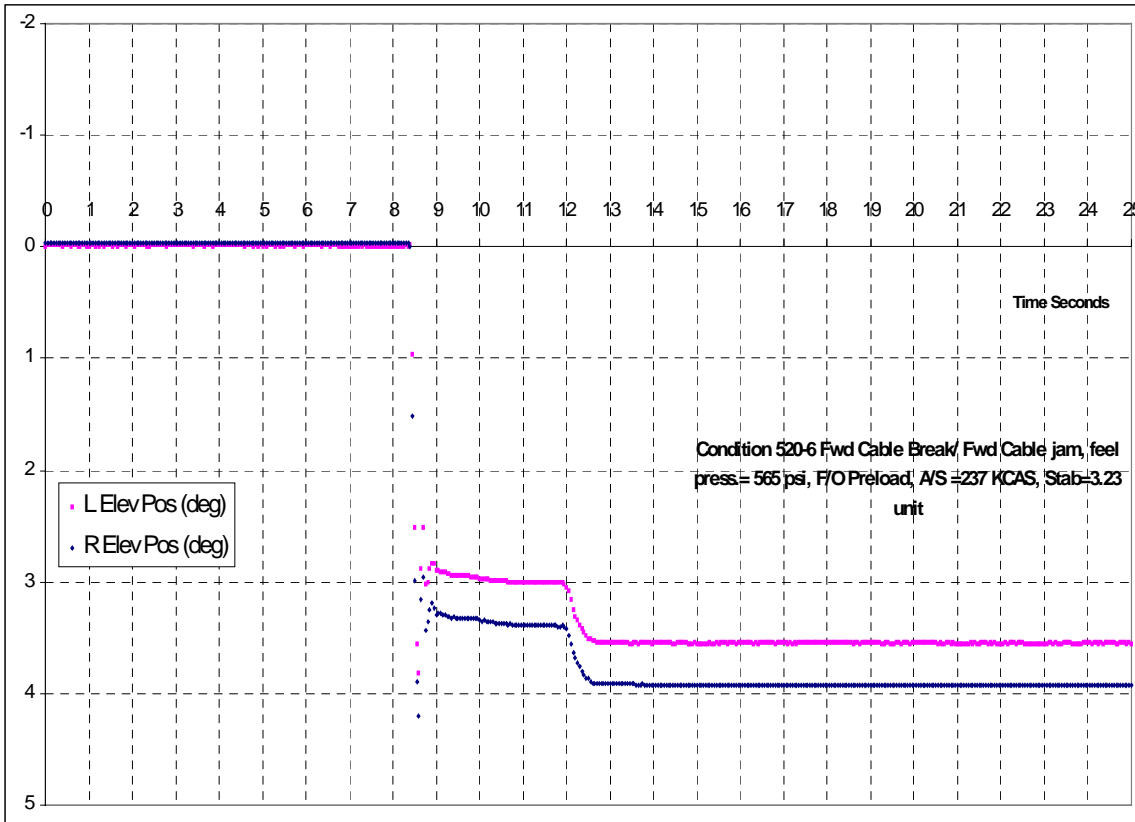
Figure 9, F/O pre load, condition 520.6

Figures 9,10,11,12,13 and 14 shows six conditions of F/O pre-load (conditions 520.6, 521, 521.1, 531, 531.1, 531.2).
