**FACTUAL OBSERVATIONS OF AIRCRAFT MISHAP
ROGERS HELICOPTERS 206L-1 S/N 45434 N10864
MONTELLO, NEVADA
3 AUGUST 2000**

FACTUAL OBSERVATIONS OF AIRCRAFT MISHAP ROGERS HELICOPTERS 206L-1 S/N 45434 N10864 MONTELLO, NEVADA 3 AUGUST 2000

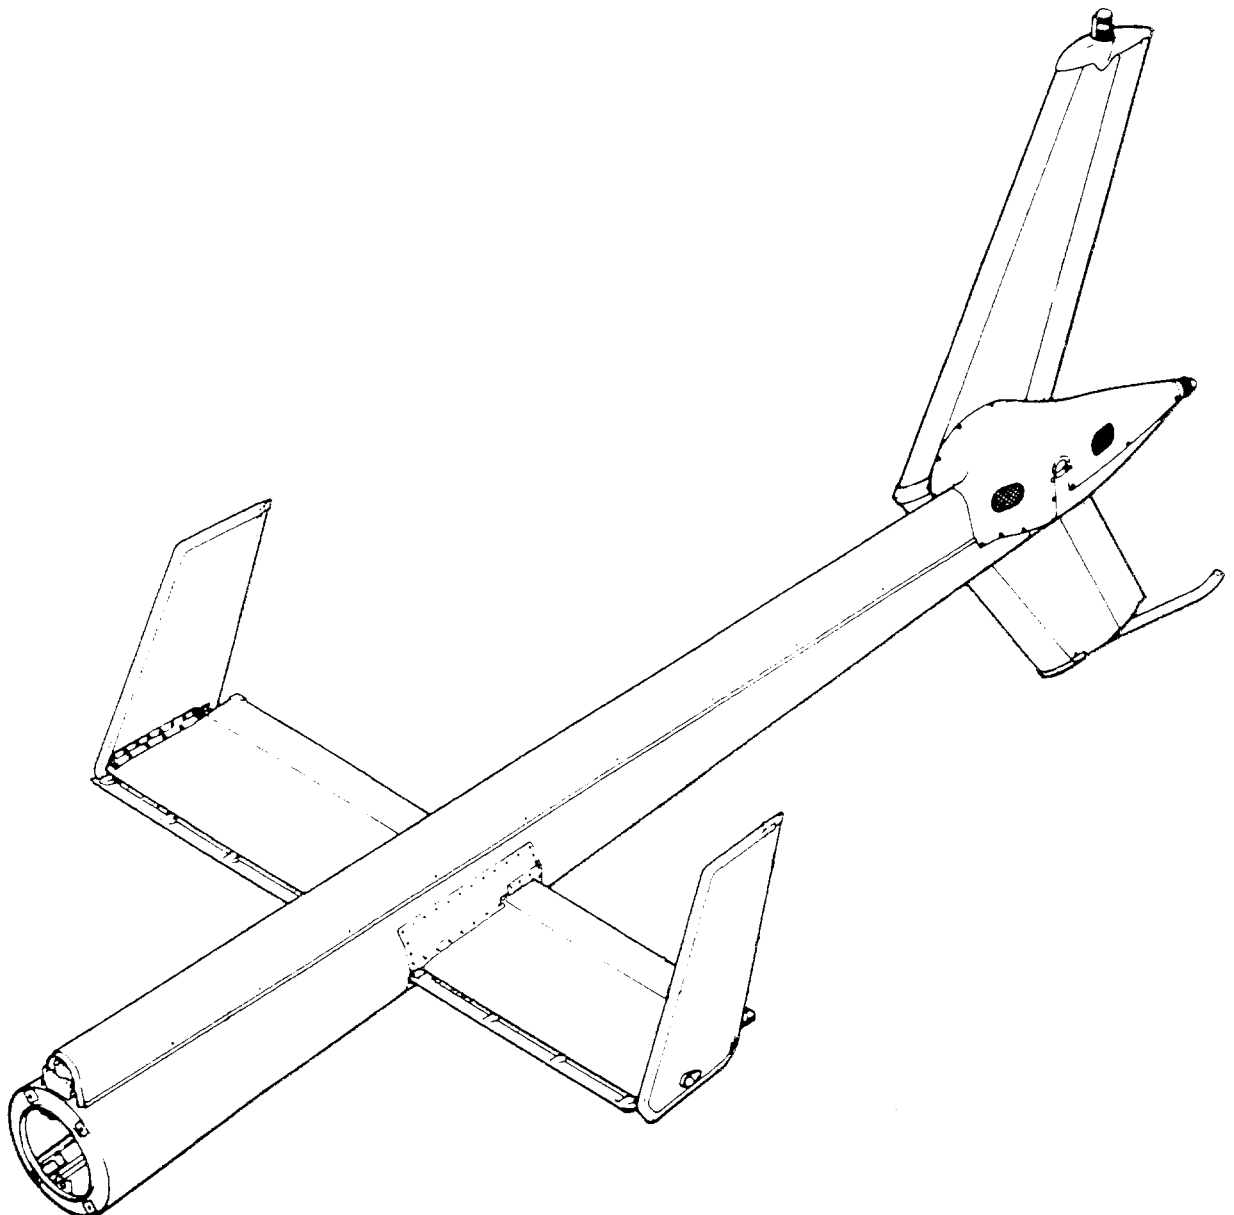
Tailboom

The tailboom includes a fixed horizontal stabilizer with fixed leading edge slats, a controllable elevator, and a swept-back vertical fin. The horizontal stabilizer is installed on the tailboom and the elevator is installed on the horizontal stabilizer by means of antifriction bearings and bolts. The vertical fin extends from aft end of the tailboom and is canted to relieve tail rotor thrust requirements in forward flight. Auxiliary fins are mounted on the outboard ends of the horizontal stabilizer and are canted to counteract yaw-roll. A tubular type tail skid is installed on the vertical fin to protect the tail rotor blades in the event of tail-low landings.
