**Continental Airlines, Inc.**  
**Submission**

**Aircraft Accident**  
**Boeing B-737-524, N18611**  
**Denver International Airport (DEN)**  
**Denver, Colorado**  
**December 20, 2008**

**NTSB ACCIDENT INVESTIGATION**  
**DCA09MA021**

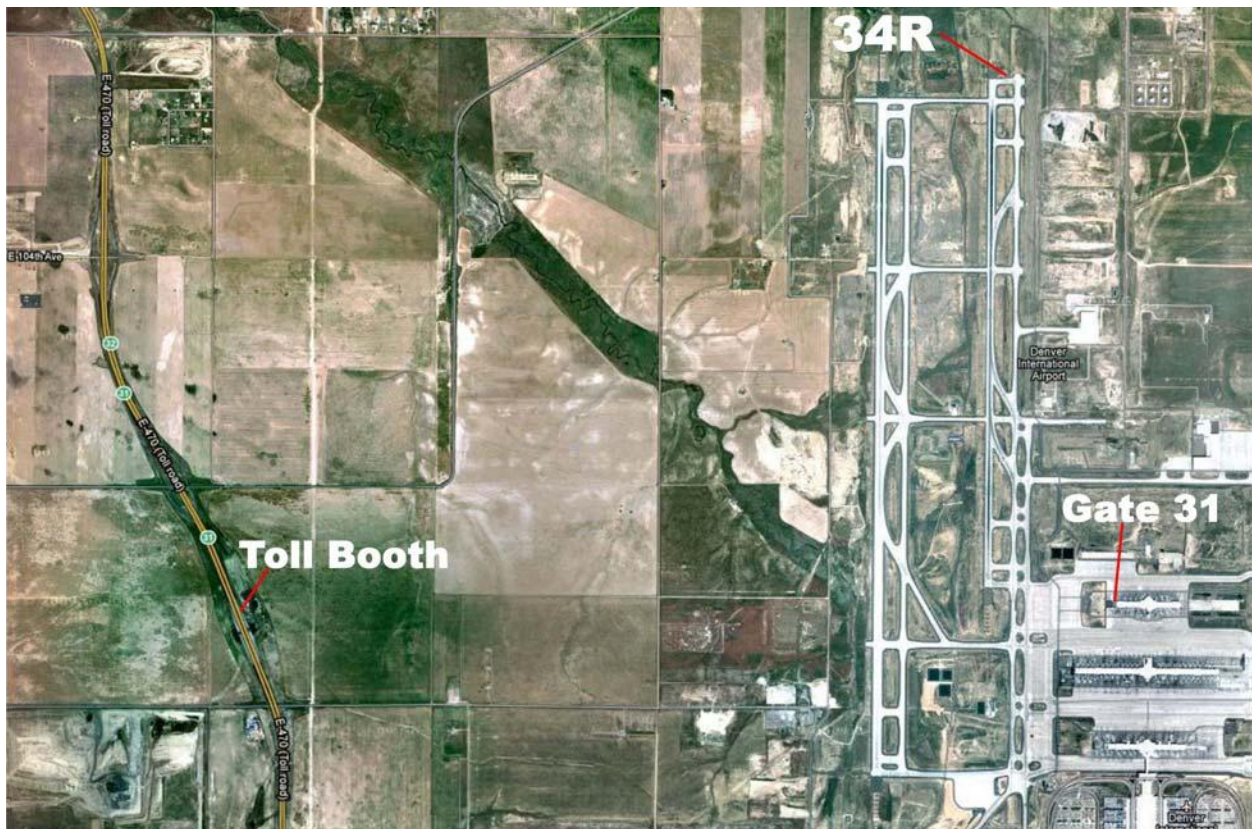
**Figure 4.**

An employee of DEN and his wife were traveling northbound on E-470 just north of Pena and arrived at the E-470 toll plaza at 1818. According to the witness, the toll plaza is located almost exactly due west of the threshold of Runway 34R. See [Figure 4](#). The witness has a very specific recollection of looking at the clock in his car. As he arrived at the toll plaza, he noticed the wind, because it was blowing Christmas decorations around, and he even commented to his wife about it. As he pulled out of the toll plaza and accelerated to highway speed, an extremely large gust of wind came out of the northeast. He was concerned that the gust was going to blow his F-250 4X4 crew cab pickup truck off the road, and had to steer his truck into the wind to counter the direction it was trying to push his vehicle. The side window deflectors on the windows were bending, and he had never seen that before. The wind gust lasted for 2-3 minutes and ended abruptly. He estimates the wind speed to be in excess of 50 miles per hour.<sup>34</sup>

The Captain of US Airways Flight 94, a Boeing 737-300, en route from DEN to PHX, was interviewed by phone on January 30, 2009. He stated that while at Gate C-31 about the time of the Flight 1404 accident, he experienced a rumbling or shaking of his airplane. See [Figure 4](#). He looked outside and saw material blowing on the ramp, and people on the ramp having “trouble standing.” He estimated the wind at 50+ miles per hour with gusts from the west that lasted

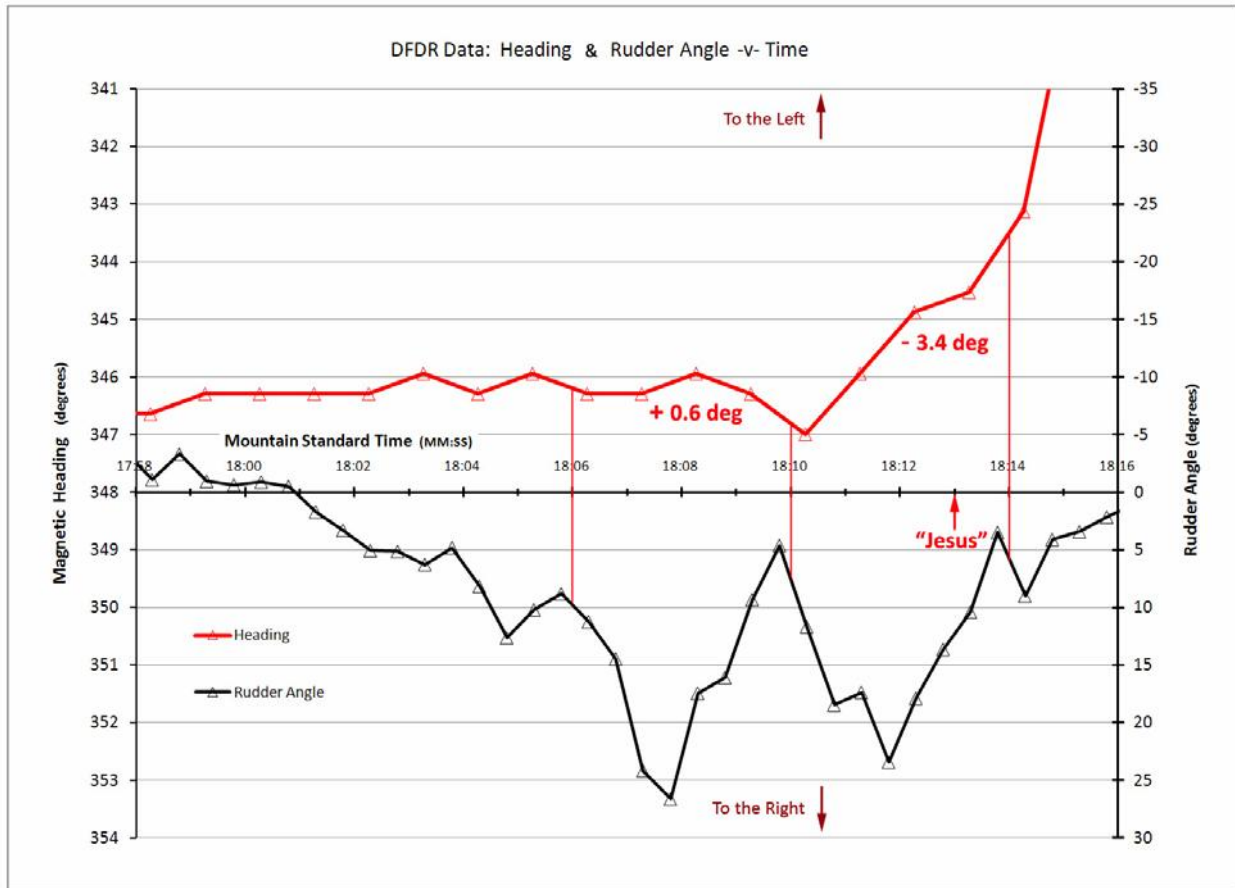
**Figure 5.**

During the initial part of the takeoff roll, the Captain used variable right rudder to keep the airplane aligned with the runway centerline. He recalled that it felt at first like a “normal crosswind takeoff.”<sup>36</sup> As the aircraft continued down the runway, the Captain made two applications of aggressive right rudder. Figure 5 demonstrates that the Captain’s first aggressive application of right rudder at 1818:08 resulted in a heading movement to the right of 0.6 degrees. However, the second rudder application failed to control the aircraft’s heading when it was struck by a strong, gusty, localized crosswind from the left. Figure 5 demonstrates that the aircraft weathervaned or yawed 3.4 degrees to the left despite the Captain’s proper use of right rudder.

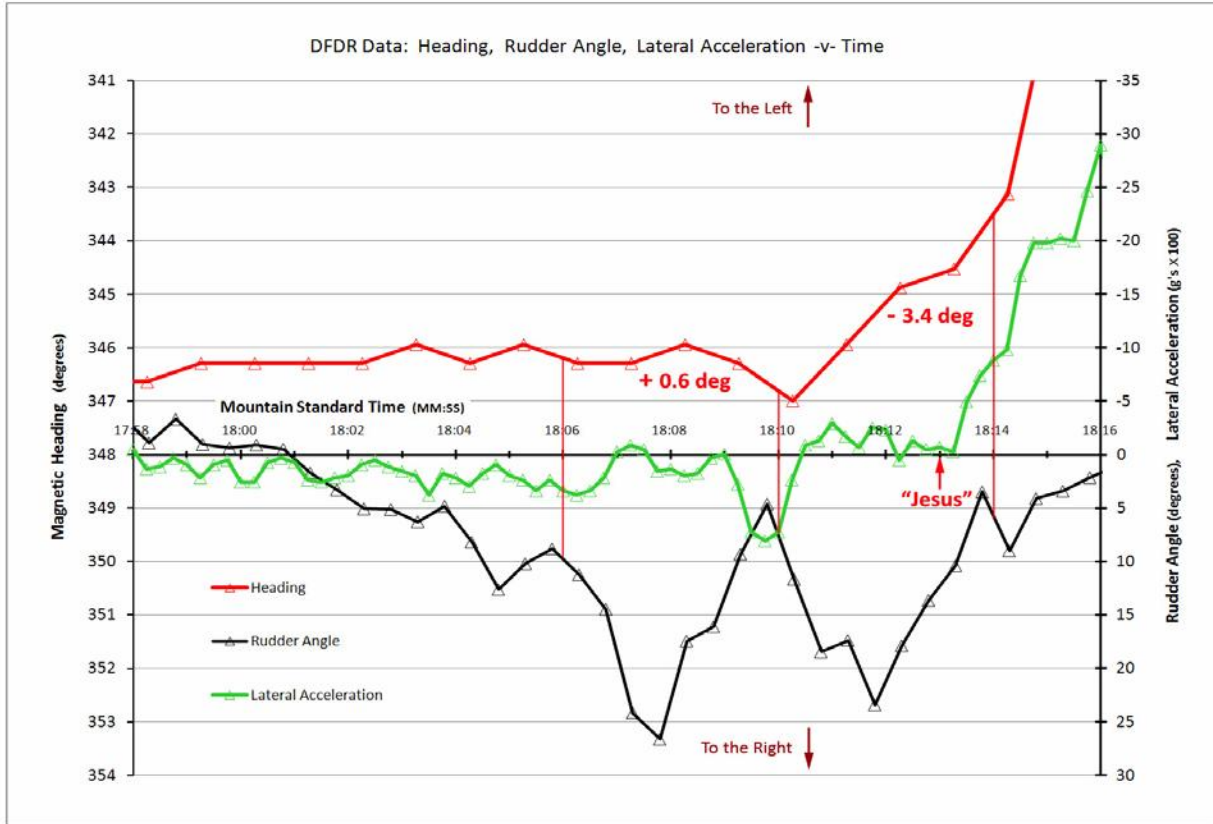
**Figure 6.**

The Captain of Flight 1404 cued off the lateral acceleration shift as feedback for his rudder inputs, and the lateral acceleration shifts preceded the aircraft heading reaction. Moreover, high crosswind takeoffs show an increasing magnitude of lateral acceleration shifts in response to rudder inputs at higher airspeeds, especially those exceeding 80 knots. Figure 6 demonstrates that right lateral acceleration feedback was present during the Captain’s first large rudder input, but the expected right lateral acceleration shift did not occur during the second large rudder input. The plane continued to yaw left despite significant right rudder input. The absence of the expected right lateral acceleration, followed by the continued movement of the nose to the left, clearly signified loss of rudder control to the Captain. This resulted in the Captain losing confidence in the plane’s rudder.

Figure 7 plots historical data from a typical high crosswind takeoff. The lateral acceleration experienced by Flight 1404, as depicted in Figure 6, differs dramatically from the normal lateral acceleration during other high crosswind takeoffs. Compare Figure 6 with Figure 7.

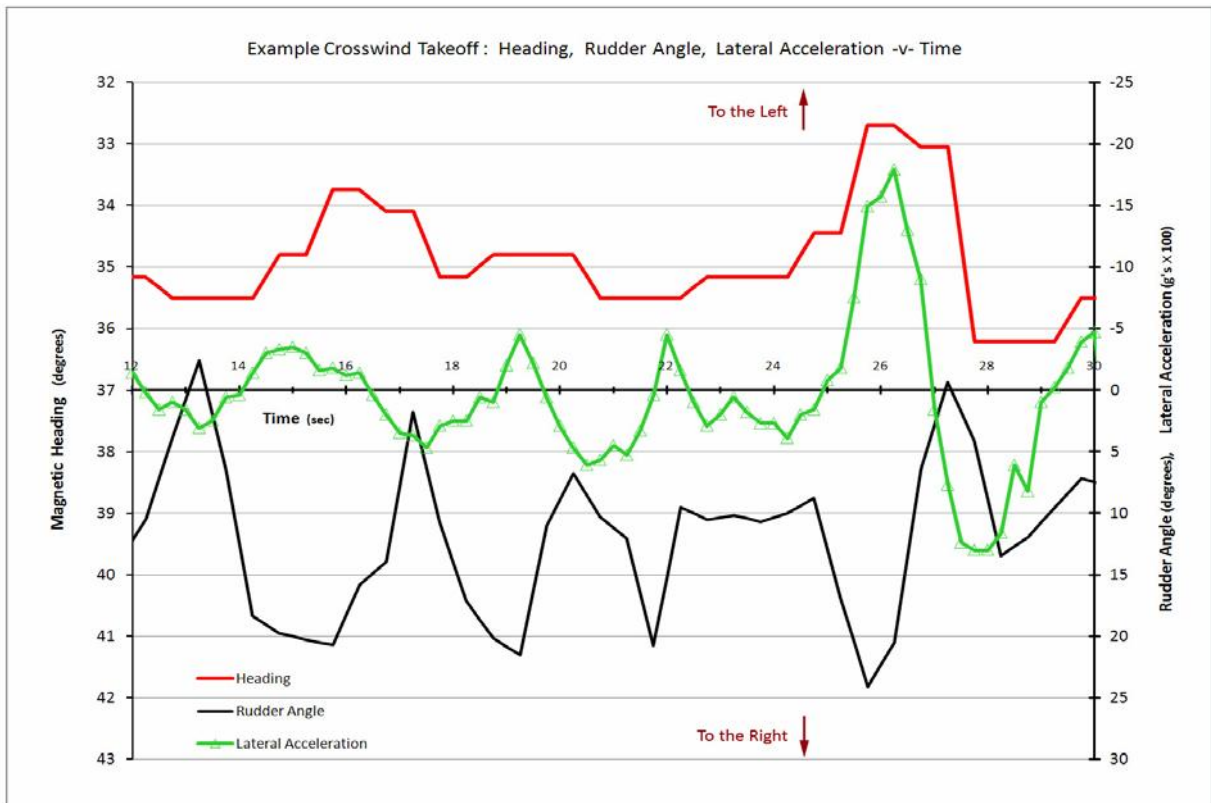
**Figure 7.**

<sup>37</sup> The data relied on to create Figure 7 demonstrates that lateral acceleration is the first cue to which a pilot responds for changing rudder inputs during a crosswind takeoff.

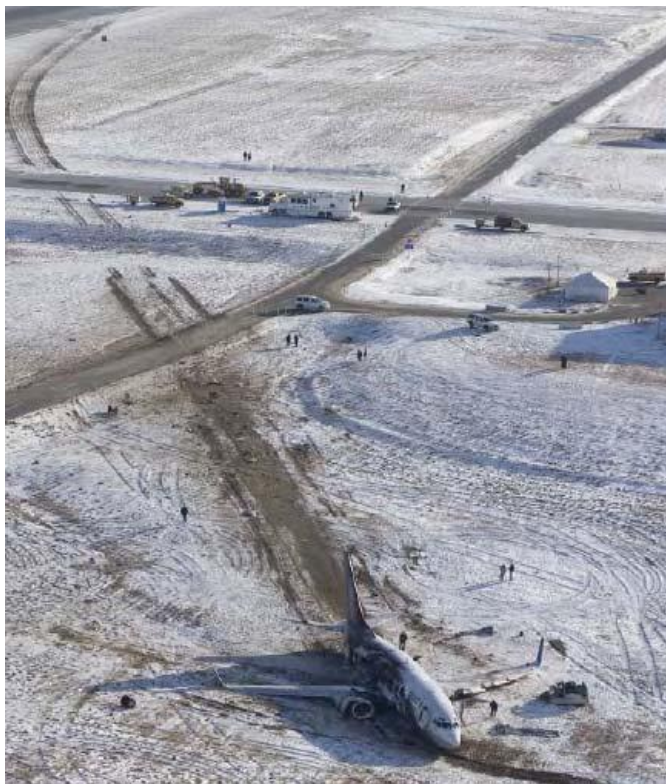
**Figure 11.**

Figure 11<sup>42</sup> shows the tracks of the aircraft main wheels were parallel and uniform in separation from the edge of the paved surface of runway 34R to the end of the ground run. The airplane rests in alignment with the ground scar witness marks.

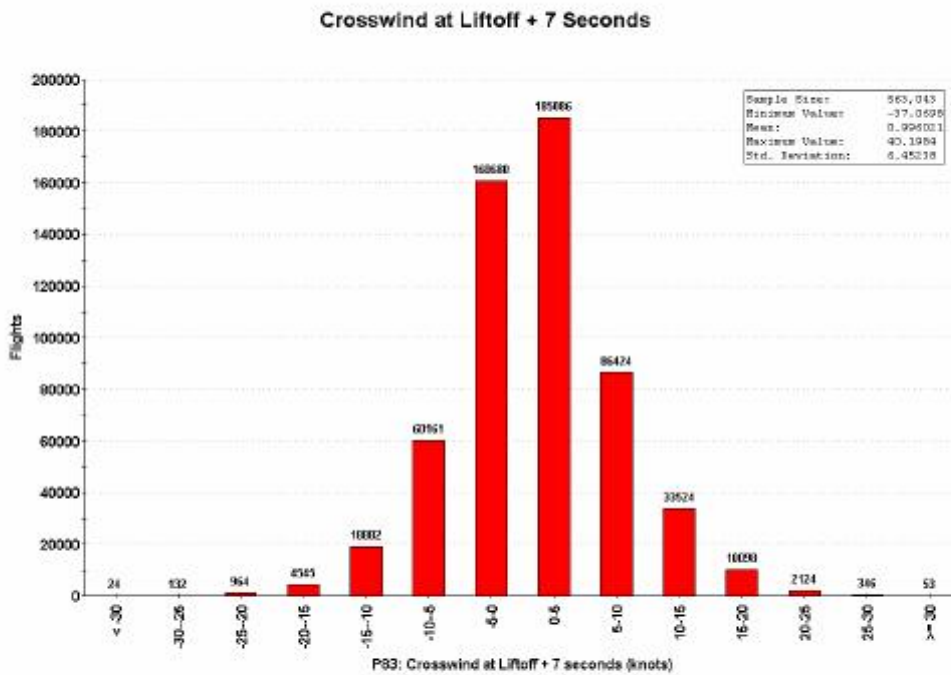
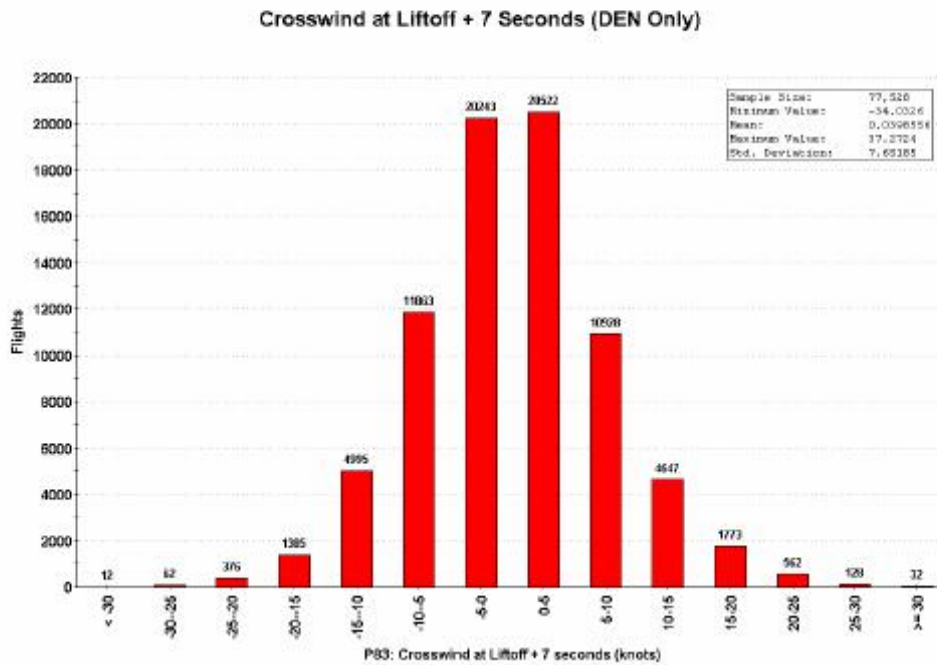
**Figure 12.**

Furthermore, 57% of their crosswind takeoffs in excess of 30 knots occurred at DEN. See Figure 12.<sup>45</sup>
