Continental Motors

ENGINE EXAMINATION REPORT

ENGINE MODEL	IO-550-N7B
ENGINE SERIAL NUMBER	685788
AIRCRAFT MAKE & MODEL	Cirrus SR22
AIRCRAFT SERIAL NUMBER	0064
AIRCRAFT REGISTRATION	N451TD
FILE NUMBER	17-508

FILE NUMBER:	17-508	ENGINE S/N:	685788	PAGE 2 of 24
---------------------	--------	--------------------	--------	---------------------

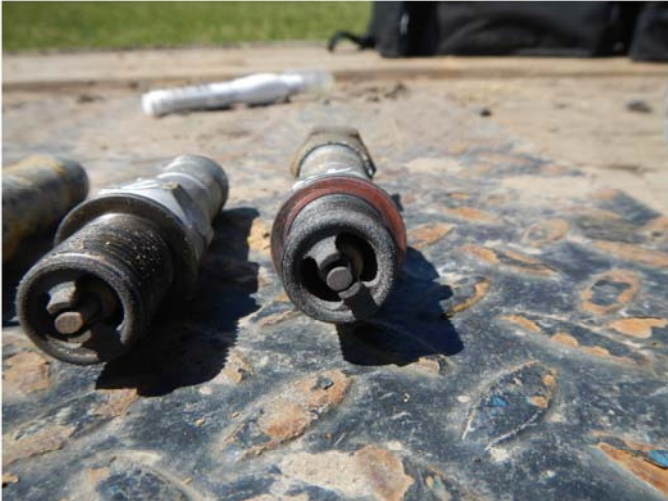
1T

Condition: The top sparkplugs were removed from their respective cylinders. All displayed a normal worn condition with no signs of lead or carbon fouling.
