Joint Submission to

**The National Transportation Safety Board**

Chalk's Ocean Airlines  
Miami, Florida  
December 19, 2005

NTSB No. : DCA06MA010

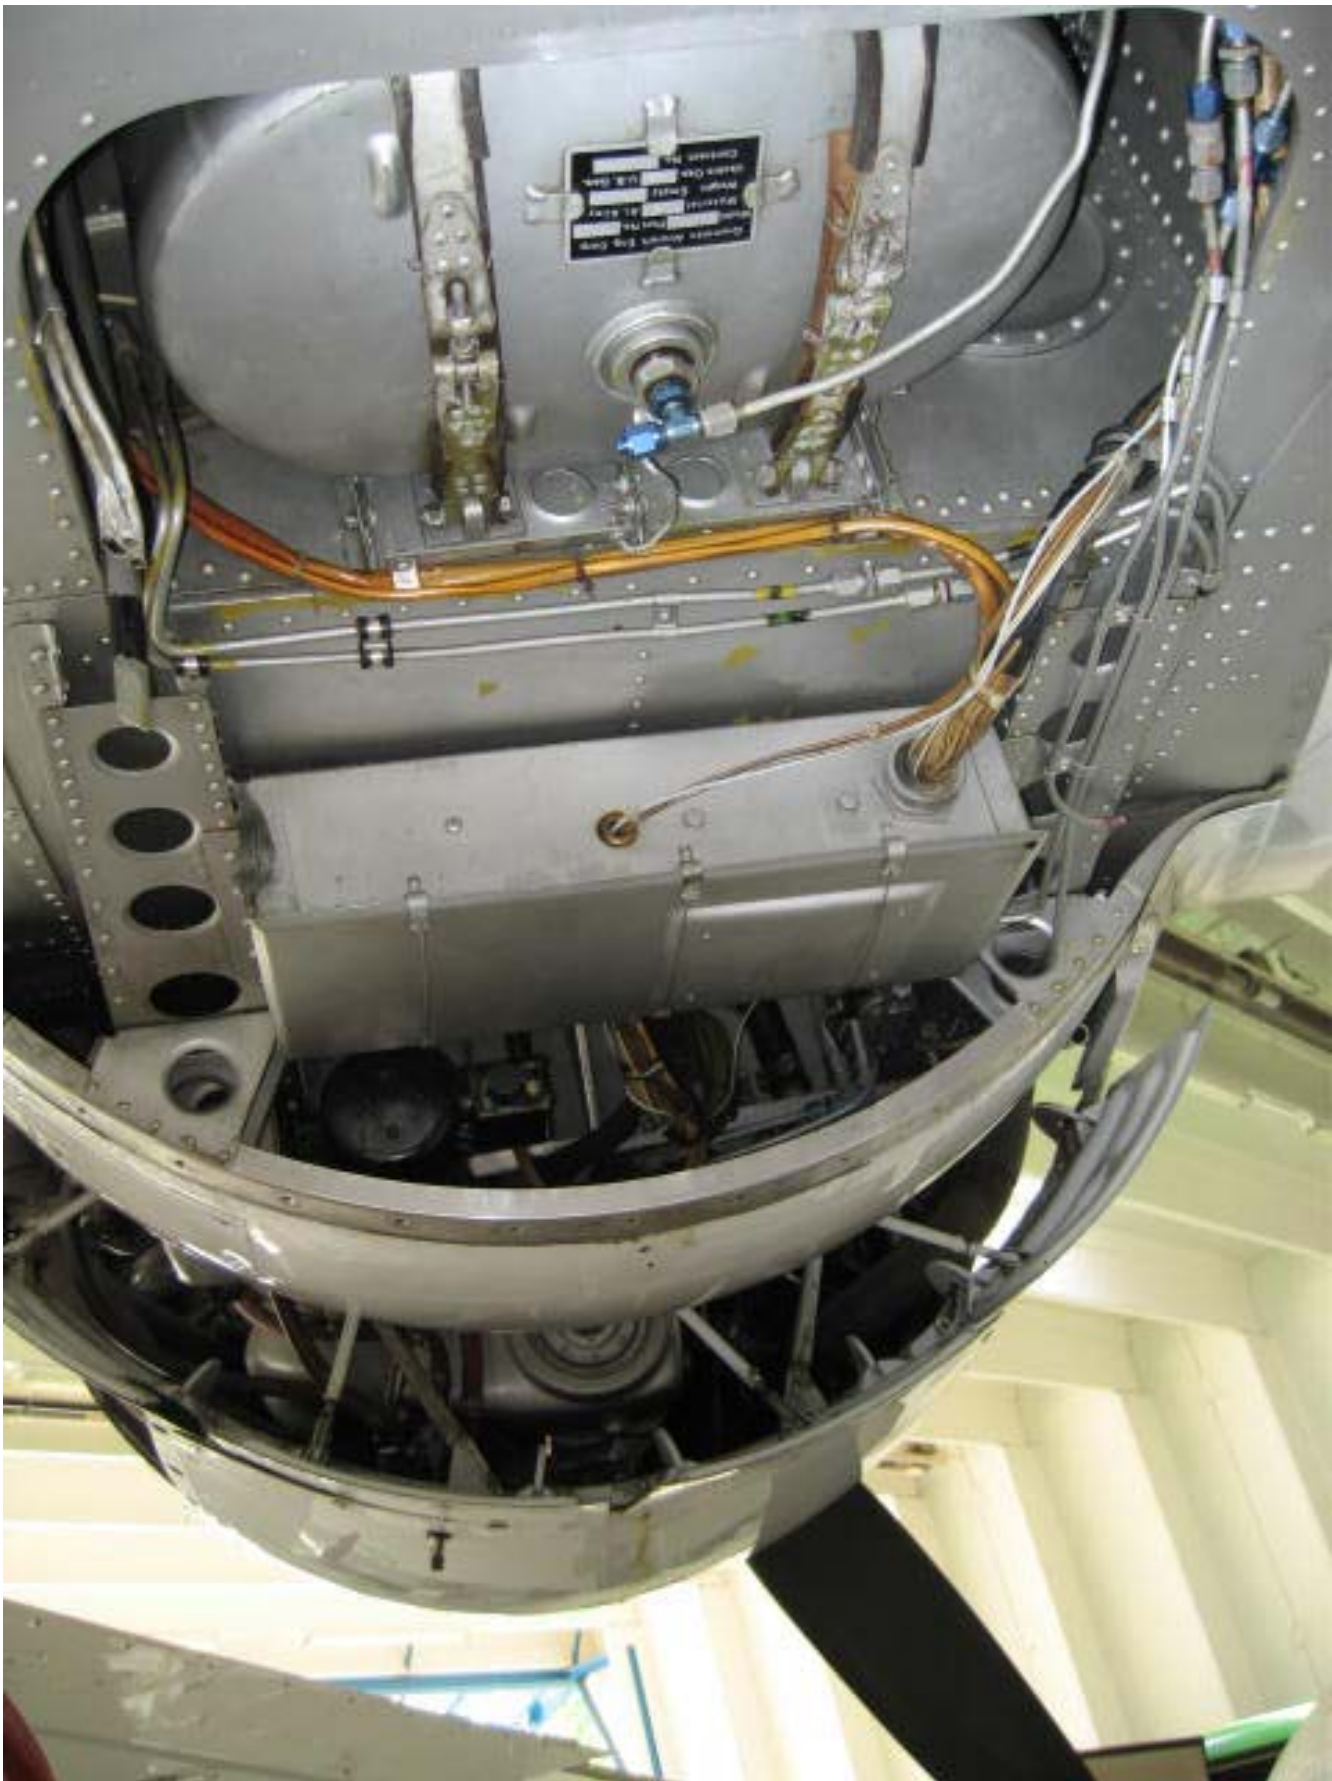
Zero corrosion or structural deterioration--.  
Typical of private/corporate Mallards operated  
within certified limits.
