PARTY SUBMISSION OF BOMBARDIER LEARJET

Global Exec Aviation's Learjet N999LJ

Columbia, South Carolina 19 September 2008

DCA-08-MA-098

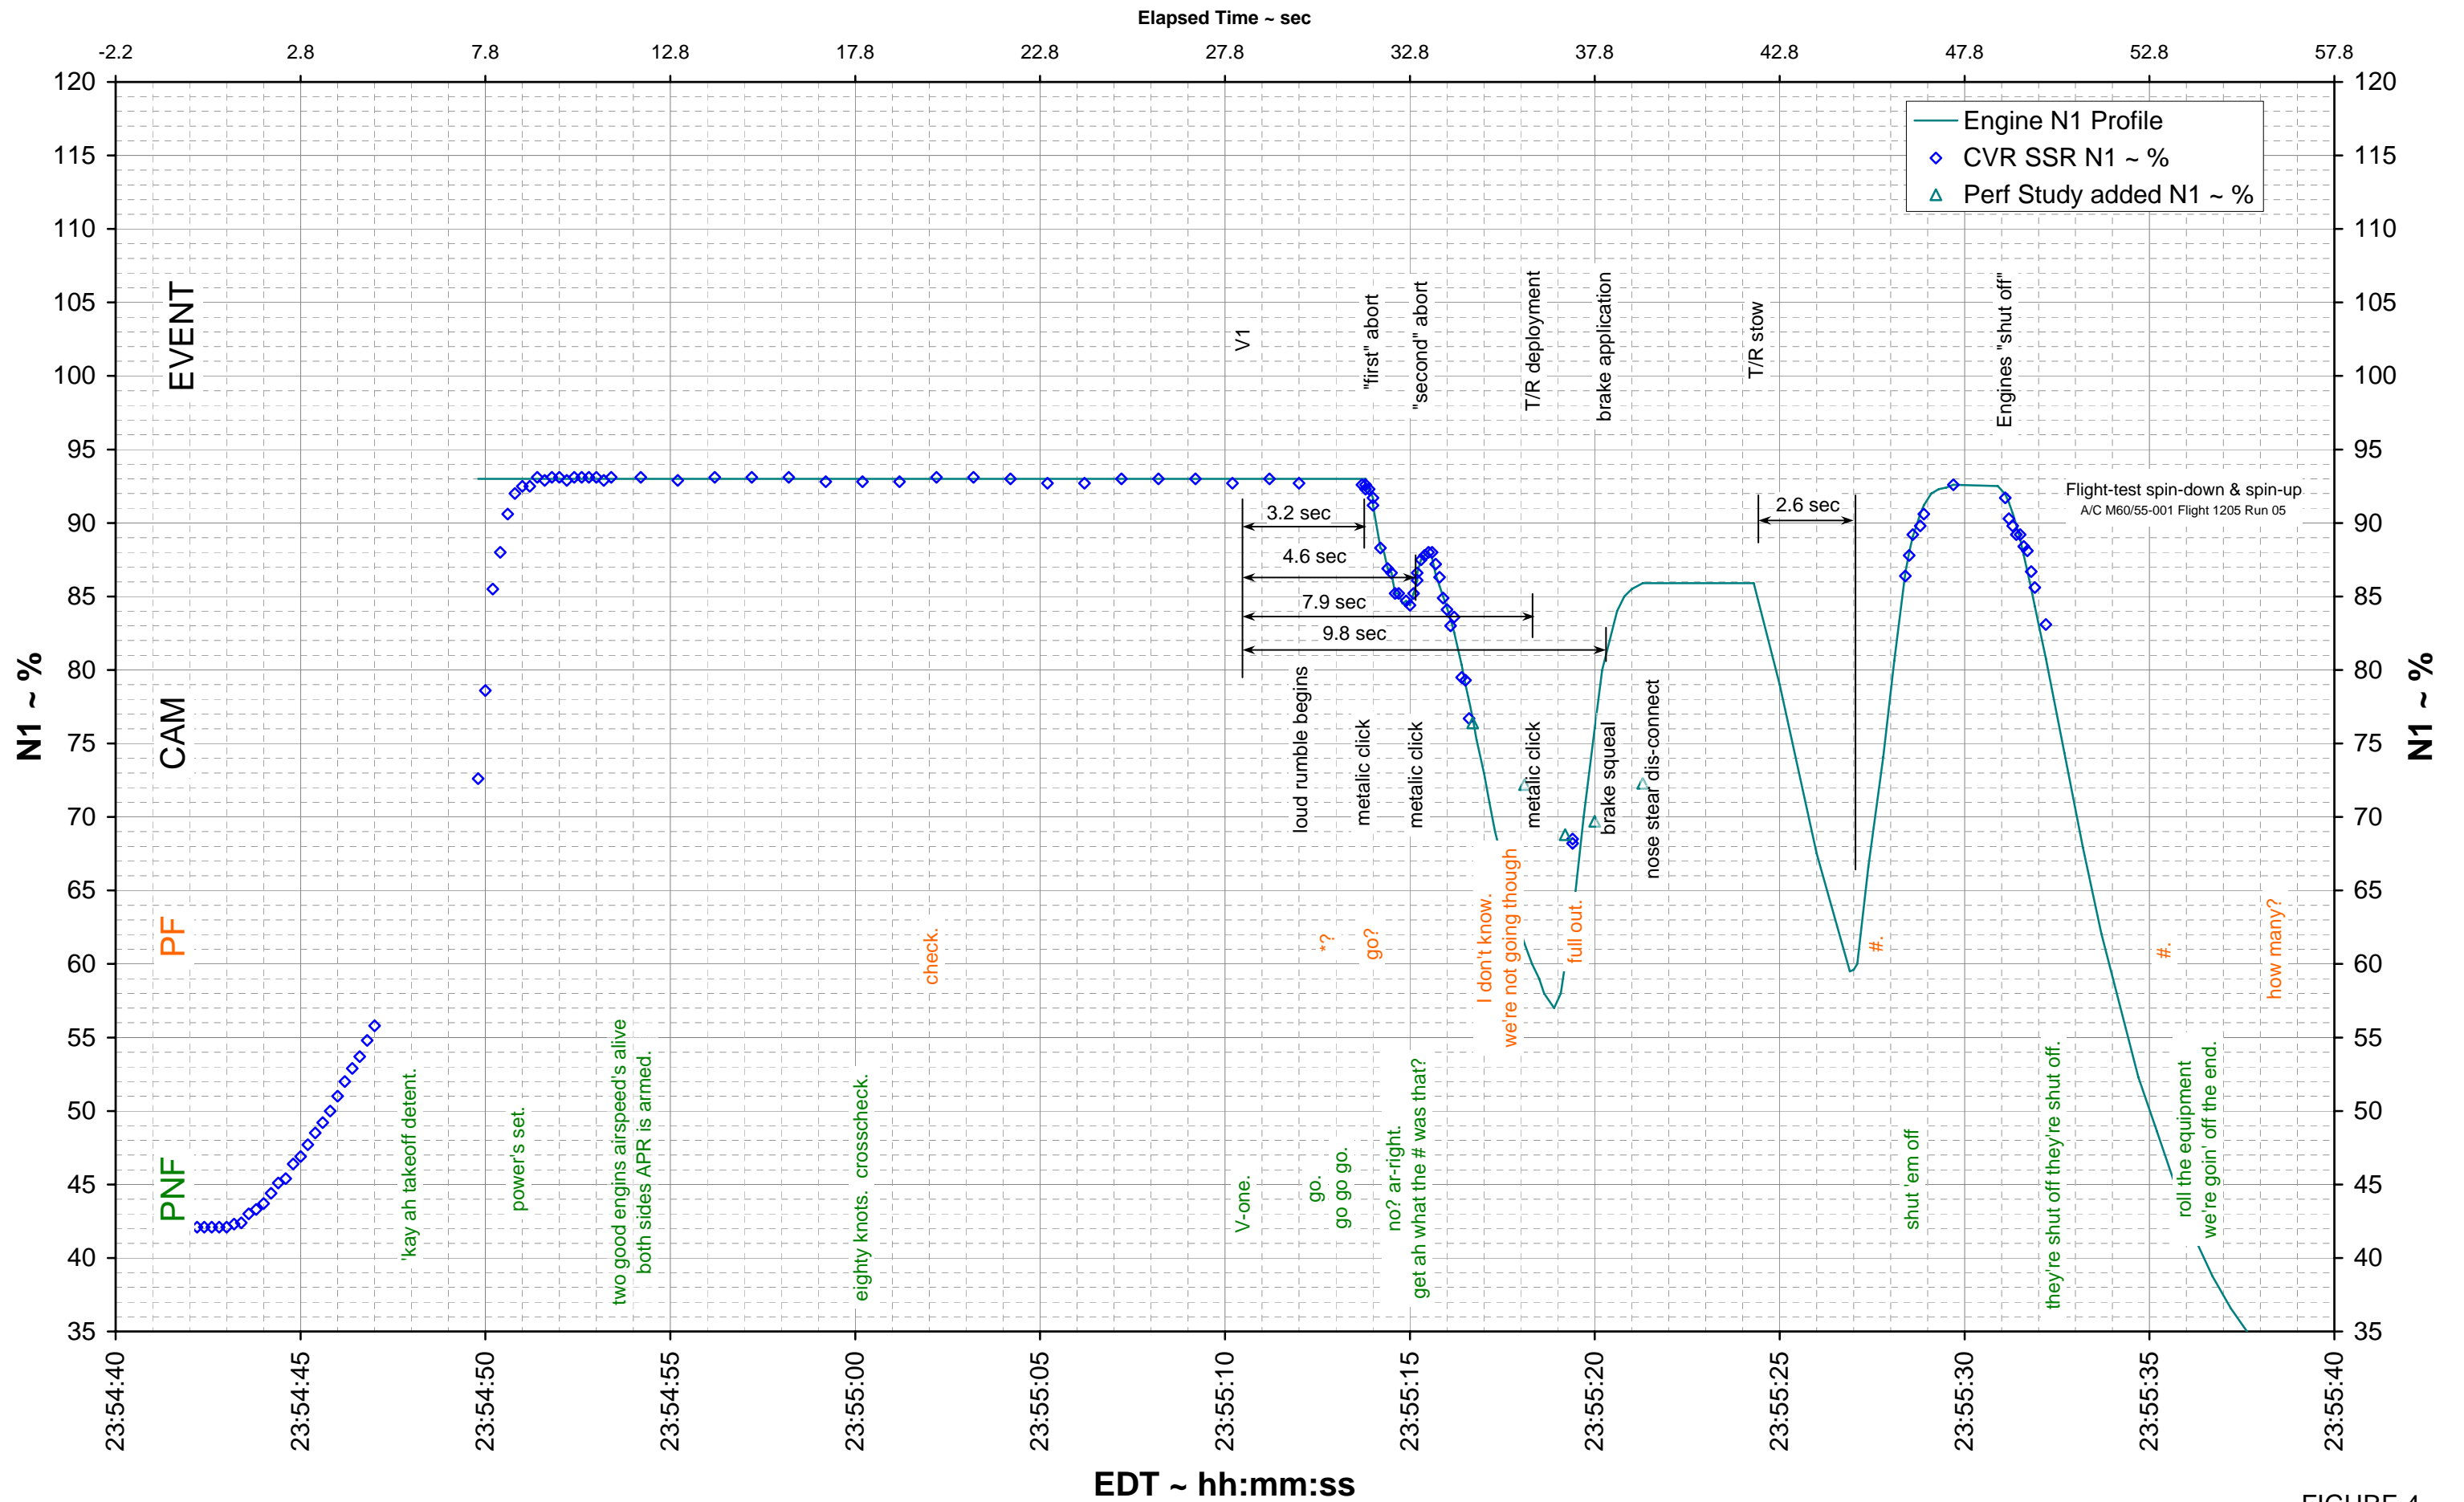
FIGURE 4

Figure 4, Section VIII of this Submission, presents a time history of the N1 profile described above, along with the event assignments stated herein and their respective time delays from V1. For reference, CVR audio elements are also shown.

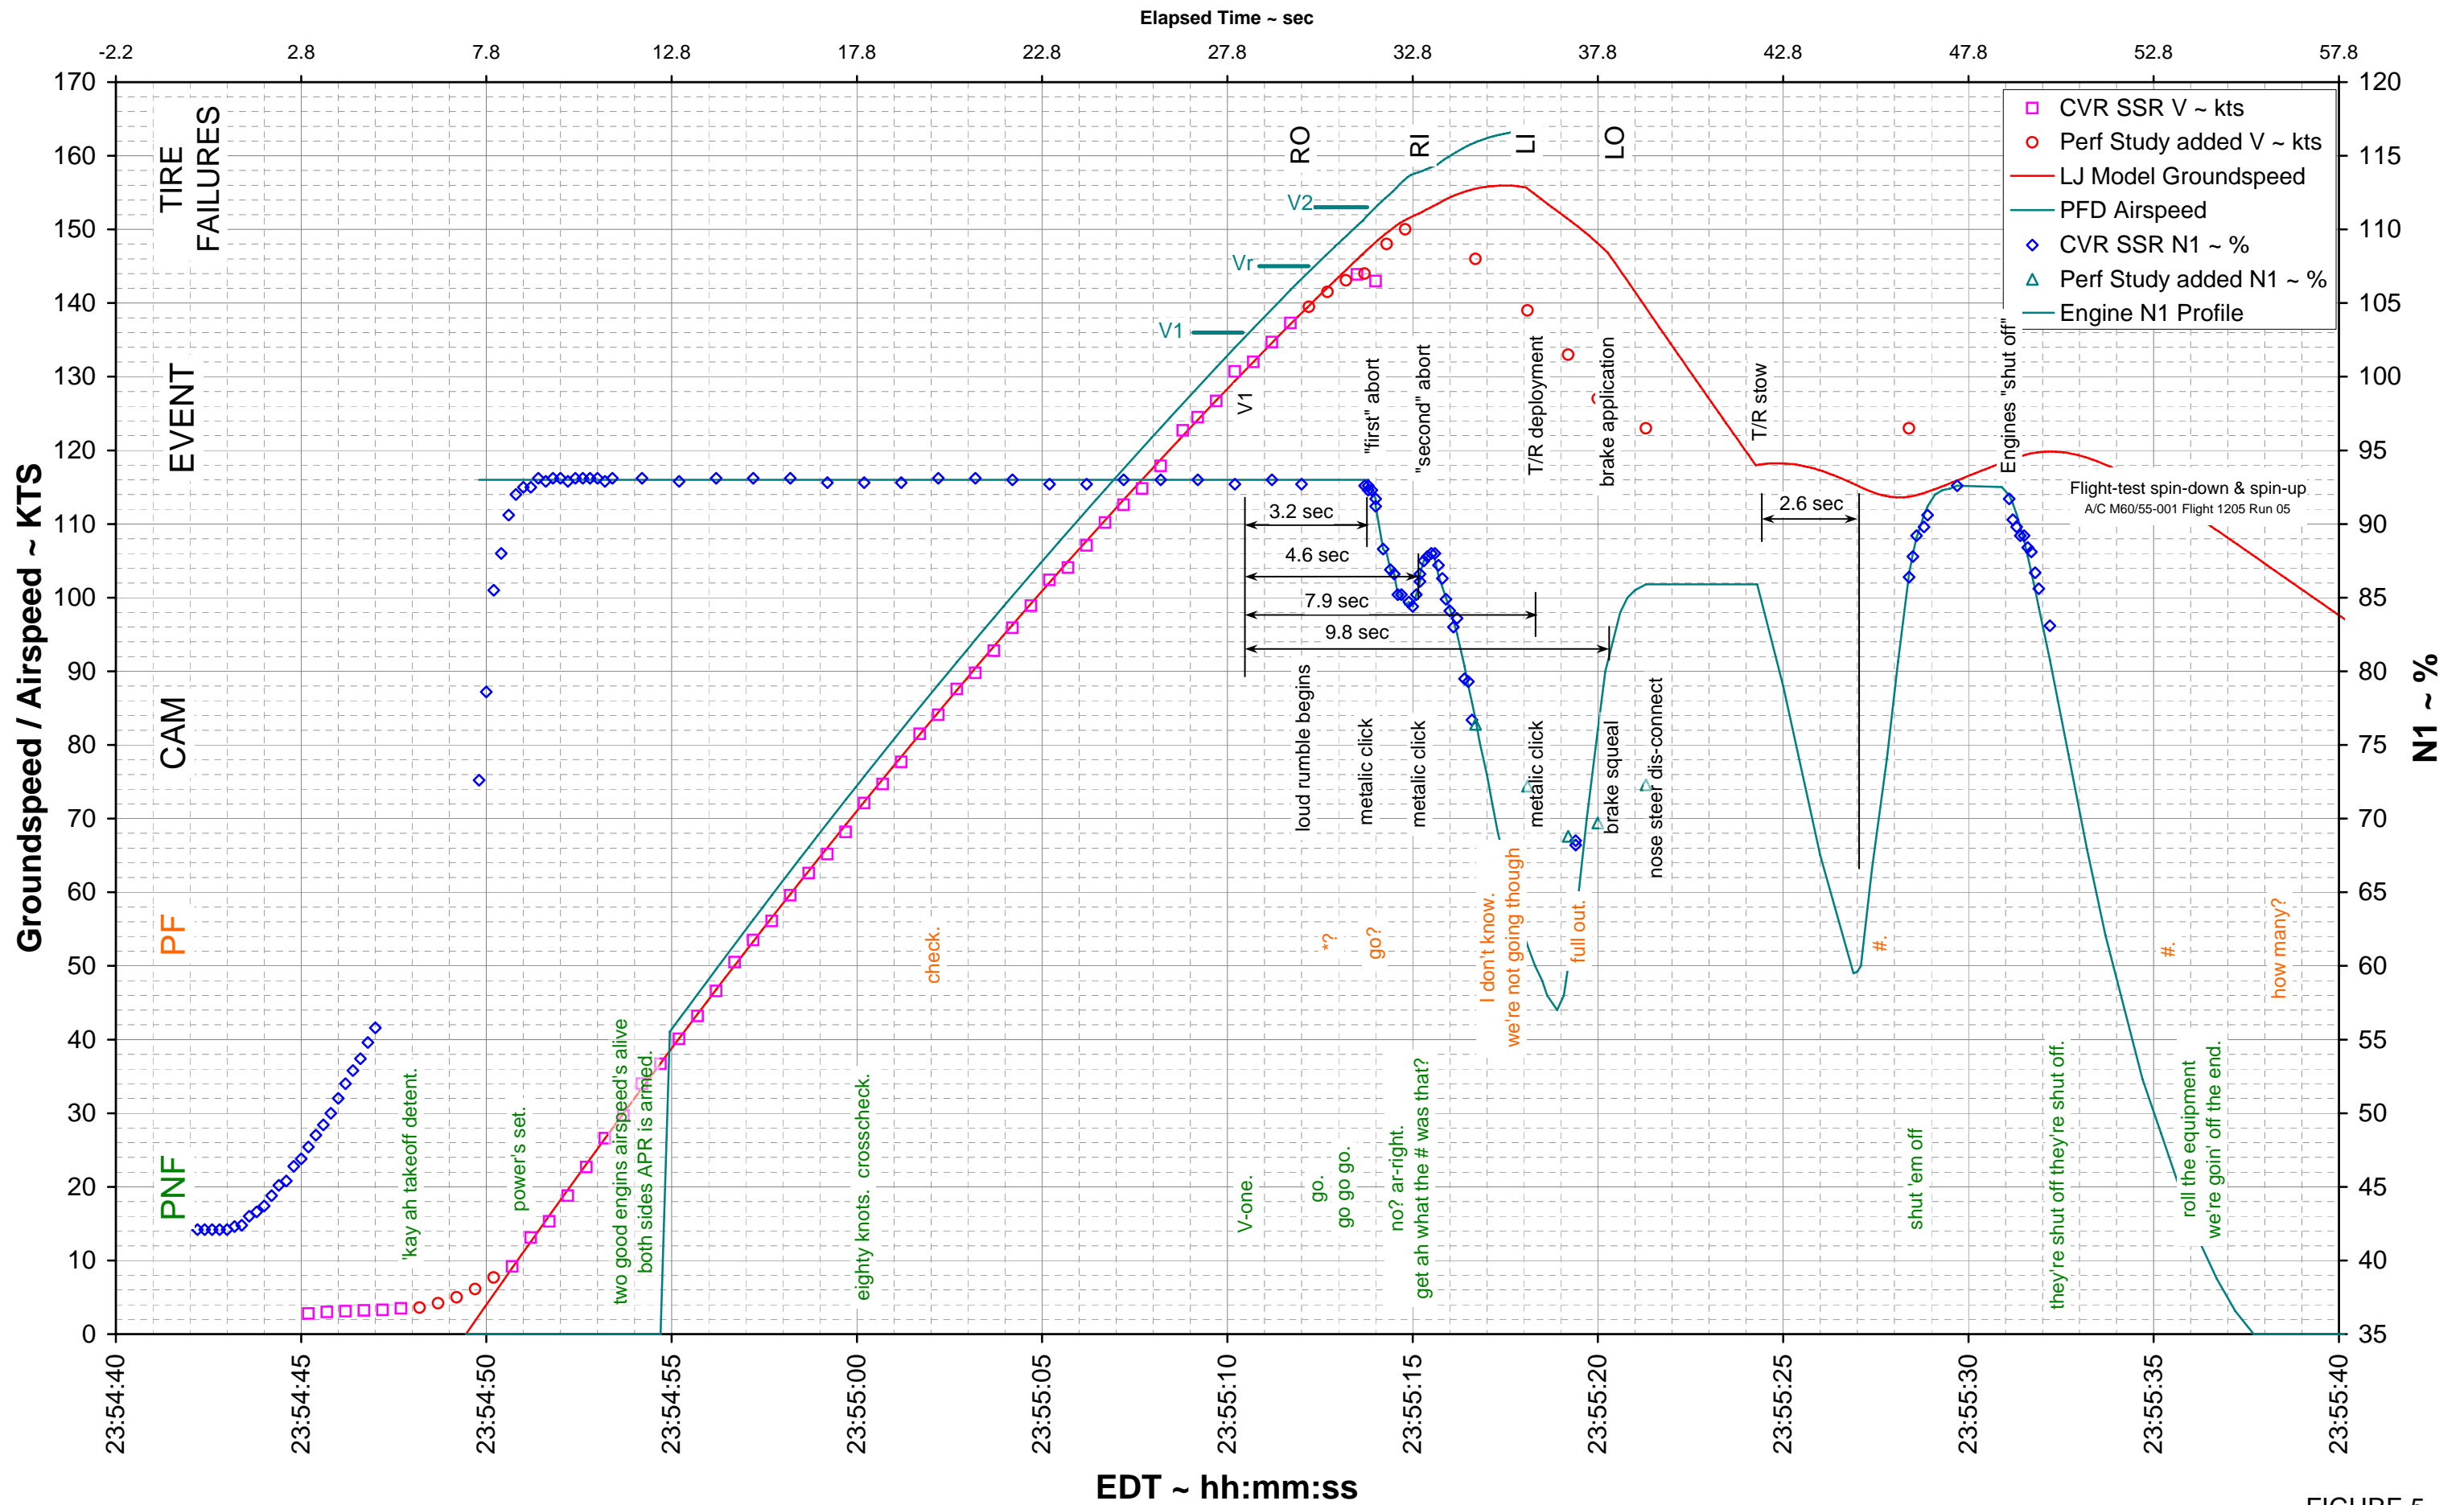
FIGURE 5

This leaves only the factual evidence that sustained brake application was first initiated 9.8 seconds after the ‘V1’ call at the brake ‘squeal’ event. Based on this fact, the remaining unknown of brake performance with blown tires can be solved for by applying the final constraint that the time at the end of the CVR recording (23:55:41.1 EDT) likely coincided with the aircraft’s exit from the paved surface. This requires an average aircraft braking coefficient of 0.19, which is about 44% of that achievable with good tires. Additionally, this would impart less than 17 Mft-lbs of energy to the brakes, which is more consistent with the Factual Addendum and Study for Tires and Landing Gear. Figure 5, Section VI of this Submission, presents the resulting groundspeed profile along with the data from Figures 3 and 4, Section VIII of this Submission. Figure 6, Section VIII of this Submission, shows only the ground speed profile and the distance profile, along with the ‘box’ constraint to achieve the end of the pavement near the end of the CVR recording. Figure 7, Section VIII of this Submission, replaces engine N1 data from Figure 5, Section VIII of this Submission, with the modeled aircraft acceleration.

There is no evidence that the aircraft was incapable of flight, and there is no evidence that the PF attempted to rotate. At the time appropriate for the 'rotate' call, the PNF instead said 'go', then 'go go go'. As shown in Figure 5, Section VII of this Submission, the first abort event occurred at approximately V2 airspeed, and the second (final) abort event was initiated about V2 + 5. Certification flight tests demonstrated abused all-engine takeoffs with rotation initiated 10 knots below the published speed. Therefore, as much as a five second window existed between VR – 10 and the initiation of the second (final) abort where the aircraft was capable of flight by simply rotating. Had the rotation been initiated at VR, it is likely

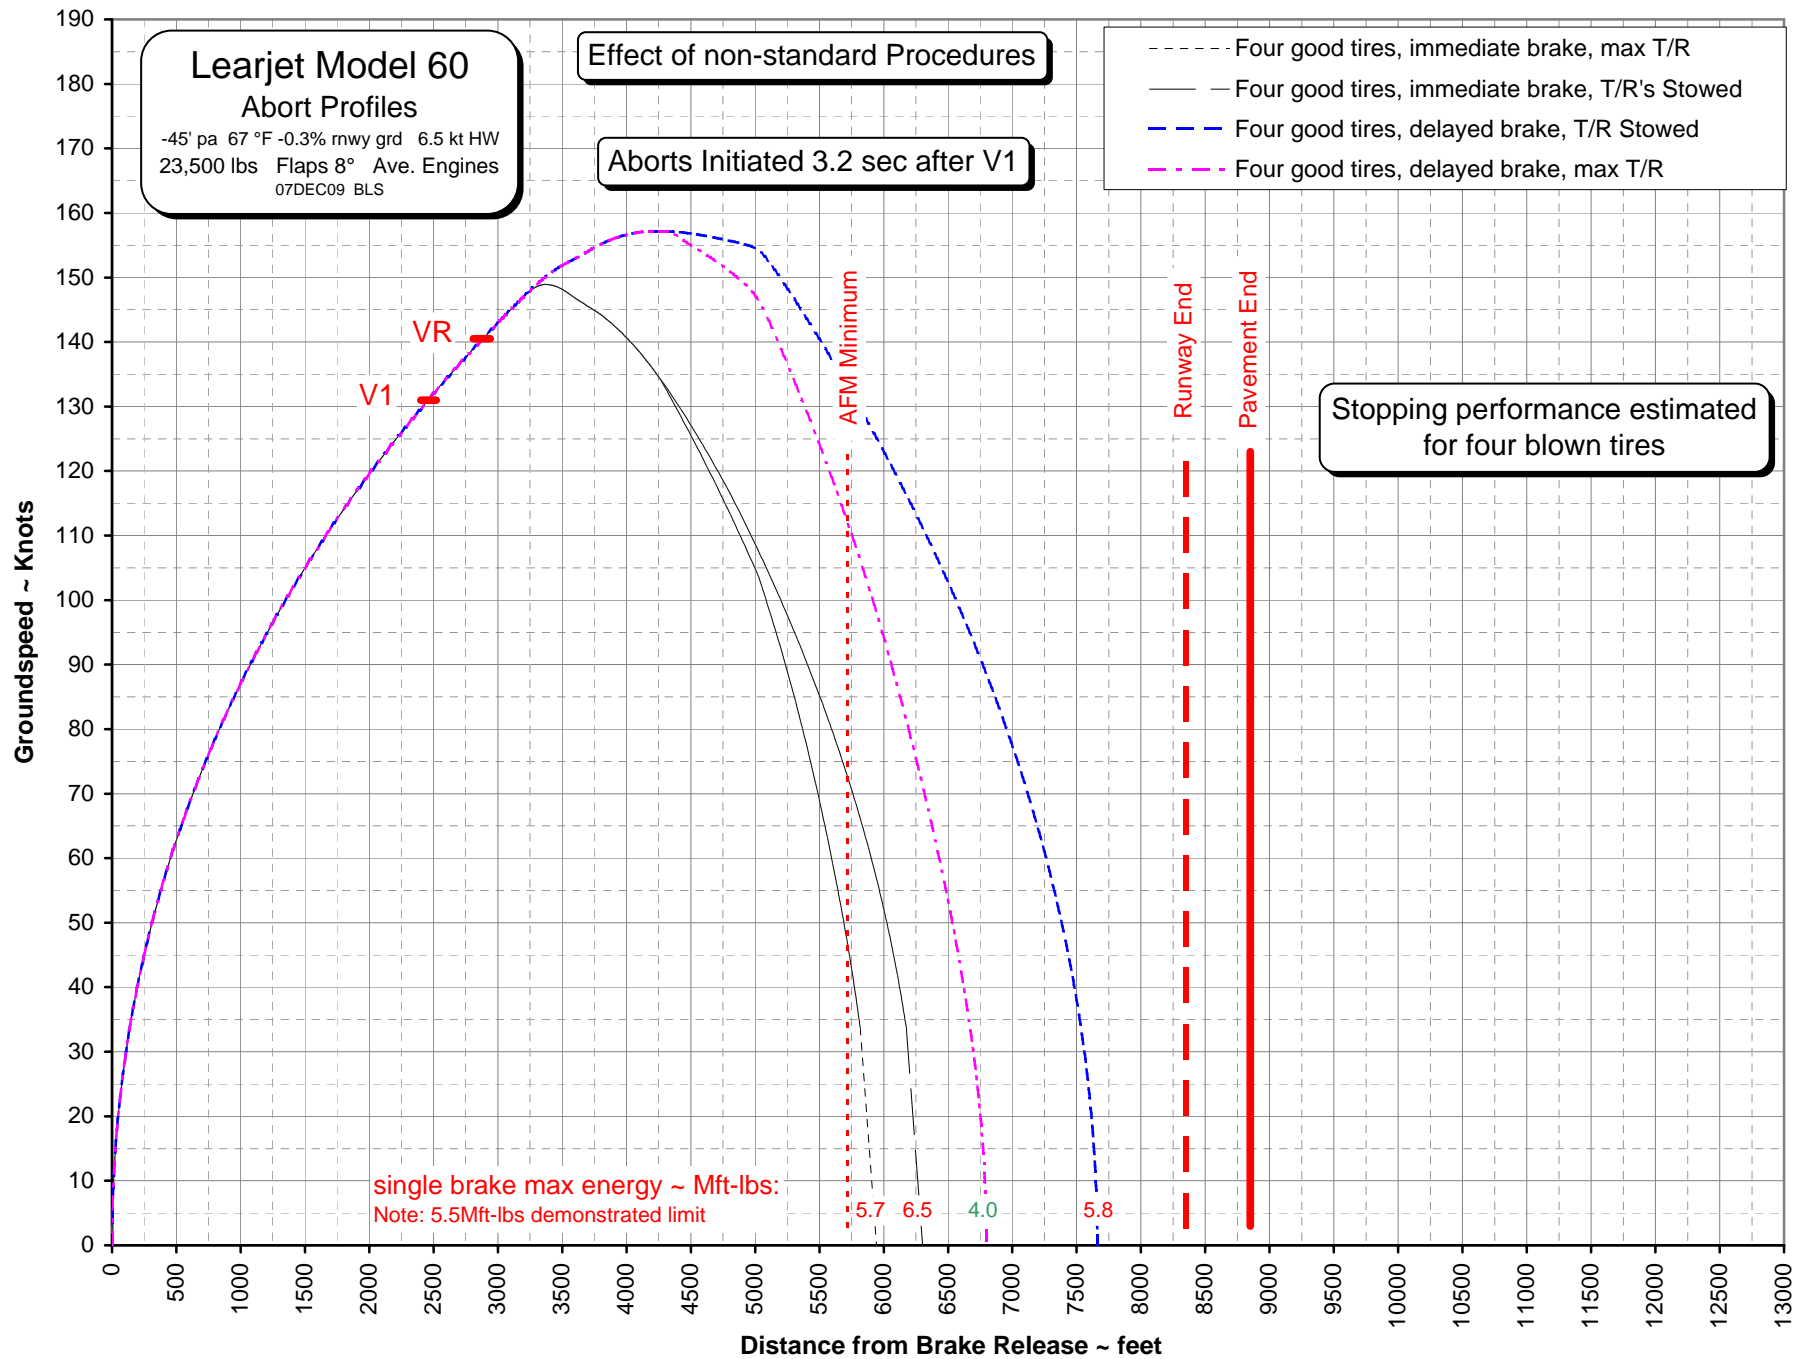
FIGURE 9

Figures 8, 9 & 10, Section VIII of this Submission, present a series of analytical groundspeed profiles for various scenarios. Profiles shown on Figure 8, Section VIII of this Submission, illustrate AFM procedures in combination with the failures encountered by 60-314. Profiles are shown for aborts from V1 with good wheels / tires / brakes both with and without thrust reversers, as well as the continuation of the takeoff with all engines to a height of 35' AGL. Failure profiles are shown with four blown tires using estimated braking performance as derived above. One profile is shown for a stop without thrust reversers and a second is shown assuming thrust reversers initially deployed, then stowed uncommanded with crew reaction similar to that derived above for 60-314. Figure 9 illustrates the effect of the nonstandard procedures employed by the crew of 60-314. All profiles on Figure 9 assume four good wheels / tires / brakes and employ the "double abort" thrust profile as documented above. One set of profiles assumes maximum effort braking applied and sustained from the "first abort" event 3.2 seconds after V1. The second set of profiles assumes a delay in sustained braking until 9.8 seconds after V1. Each set contains a trace for T/R's stowed and maximum reverse thrust. Note that three of these four profiles would result in an exceedance of the maximum demonstrated brake energy of 5.5 Mft-lbs per brake. Figure 10 then combines the effects of the nonstandard procedures and the failures encountered on 60-314. Note that this plot contains the probable profile as derived above, along with a hypothetical profile assuming T/R's stowed. The three AFM profiles (good brakes with and without T/Rs and all engine takeoff to 35') from Figure 8 are also shown for reference on Figure 10 in Section VIII of this submission. Reference lines are shown on all three figures for the approximate runway end and pavement end for CAE Runway 11 as well as AFM published required field length for the ambient conditions.
