The Egyptian Civil Aviation Authority requests and authorizes you to place the Response of EgyptAir to October 31, 2000 Submission of The Boeing Company regarding the EgyptAir Flight 990 investigation into the public docket for the EgyptAir Flight 990 investigation.

Response of EgyptAir  
to  
October 31, 2000 Submission of  
The Boeing Company  
Regarding  
The EgyptAir Flight 990 Investigation

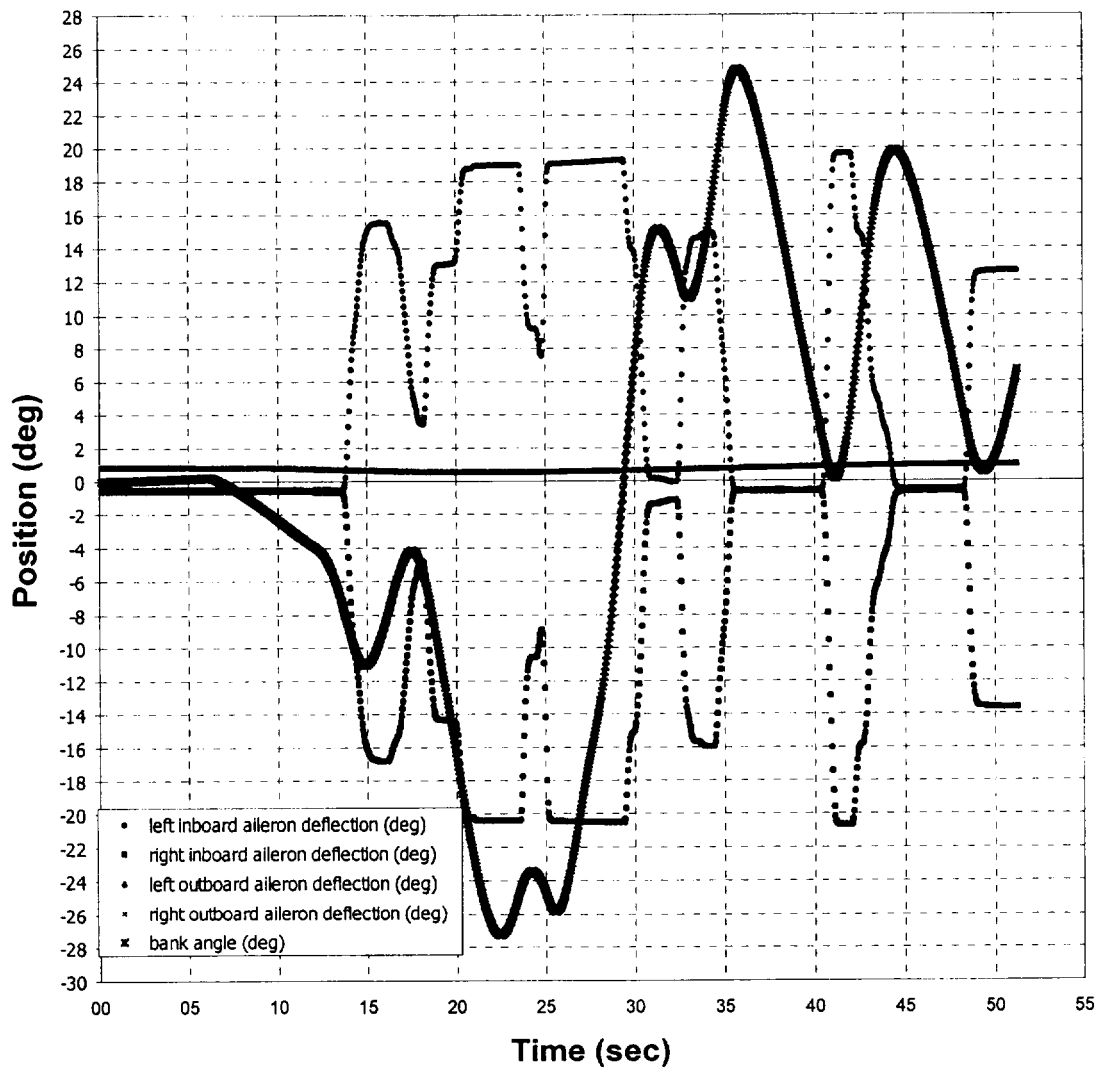
Figure 12. Aileron Deflection and Bank Angle from Data Recorded at the Second E-Cab Simulation Session

The effect of the pitching moment due to differential elevator deflection was also supported using data gathered during the second session of E-Cab simulations. During the second session, the programming of the simulator had been changed to allow differential elevator deflection. Plots extracted from the data recorded at the second E-Cab simulator session are shown in Figures 12 and 13. This example was recorded during a run in which the right elevator was deflected down approximately 5.5 degrees of right elevator deflection and the left elevator left to pilot control. Notice that differential aileron deflections of over 40 degrees are needed to keep the roll angle near zero. During the time of the alleged split elevator, the maximum differential aileron deflection recorded on the FDR was approximately 13 degrees (with the exception of one second at almost 20 degrees) and the average was about 6.5 degrees. These results can only be explained if the elevator did not actually produce the calculated rolling moment. Further, the positive load factor that was recorded on the FDR was due to the position

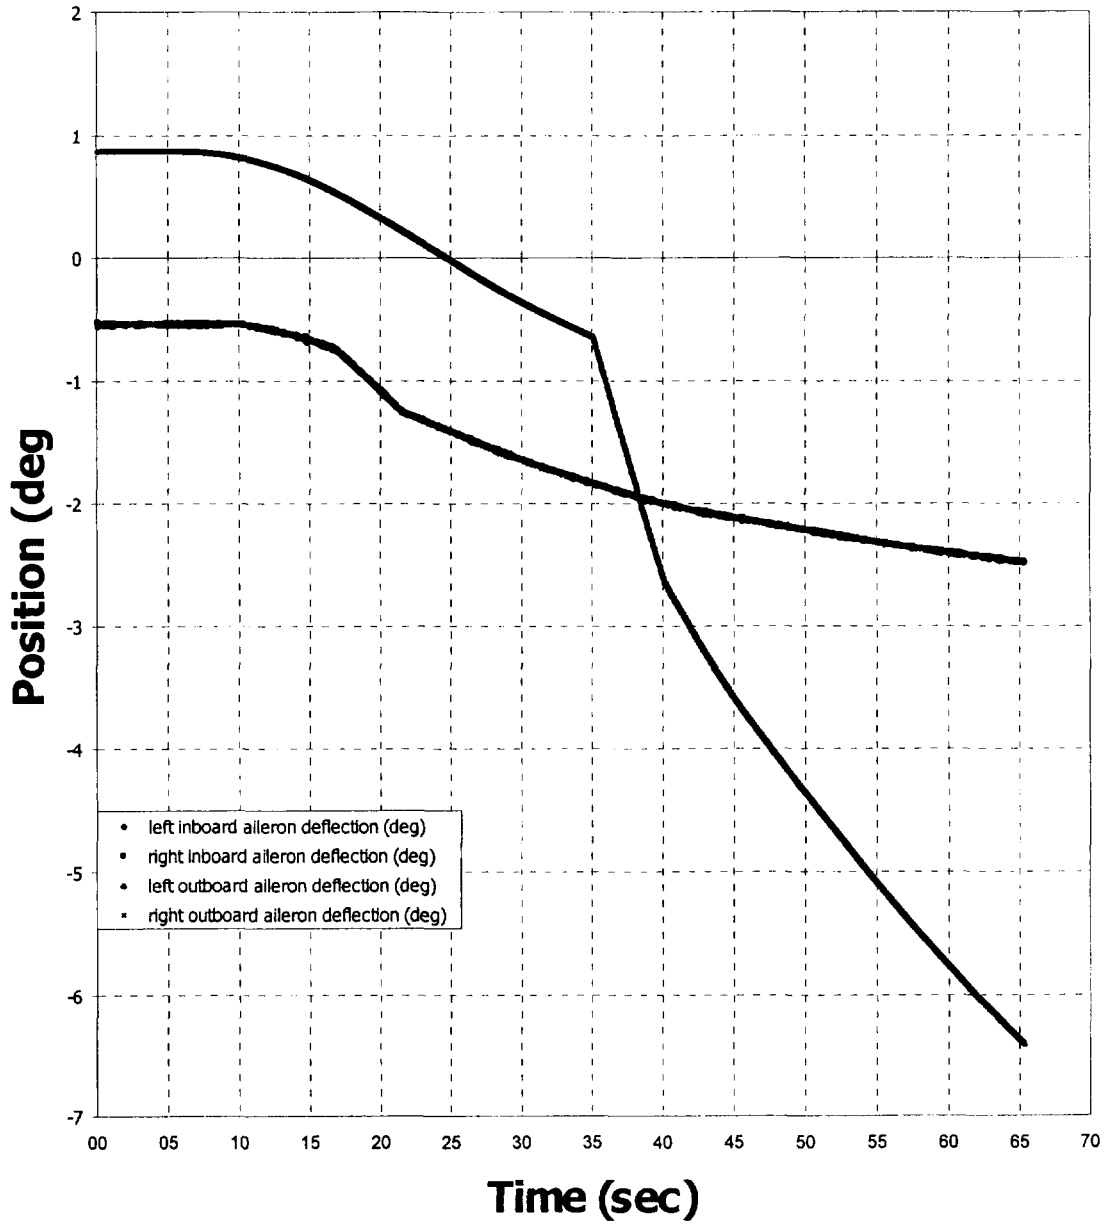
Figure 15. Aileron Position from B-767 Ground Test Results Extracted from Boeing CD

- The E-Cab data produced an unrealistic relationship between control wheel force and wheel movement (see Figure 14) and showed the movement of the outboard ailerons at speeds beyond the lockout speed (see Figure 15).
