# Continental Motors

## ENGINE FIELD INSPECTION REPORT RIGHT ENGINE

| ENGINE MODEL | IO470D (19) |
| CMI FILE NUMBER | 15-562 |

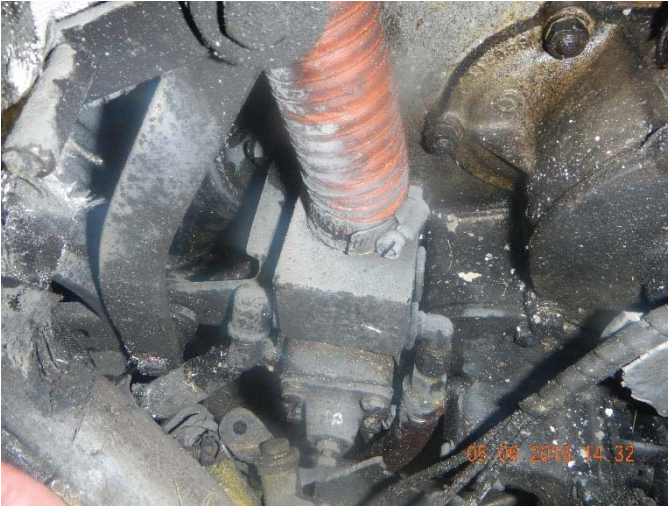
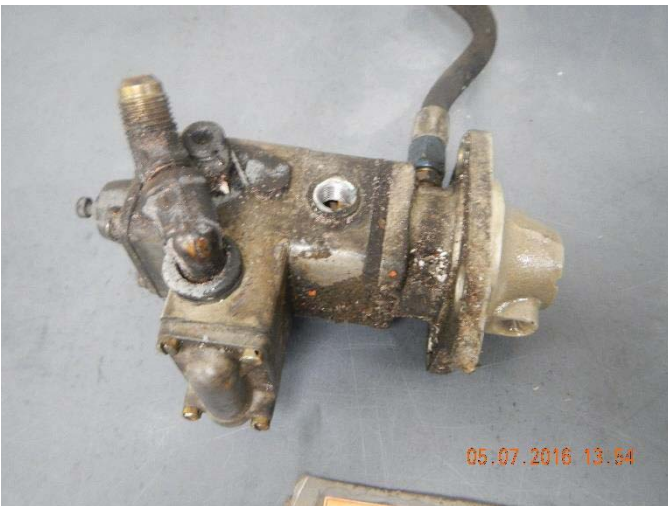
| <b>THROTTLE BODY METERING UNIT</b> | Manufacturer: TCM | P/N: 625219-2 | S/N: J178931AR |

| Condition: | The fuel hose nipples separated. The fuel screen was removed. No contaminate was present. The throttle plate was found in the wide open position but could be manually opened and closed by moving the throttle arm. | | |

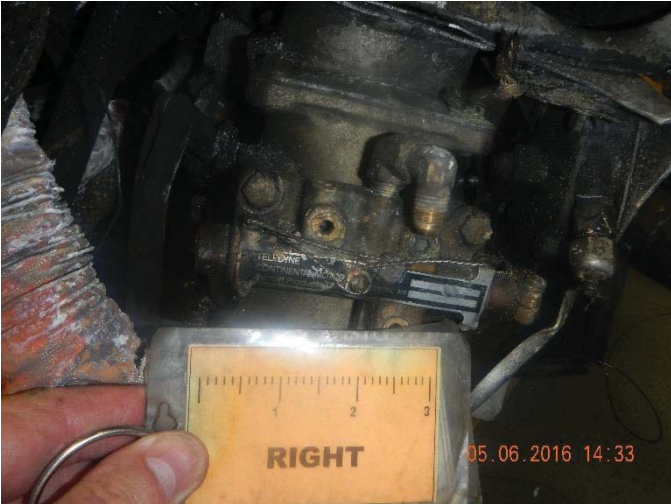
| <b>FUEL MANIFOLD VALVE</b> | Manufacturer: TCM | P/N: 631427422 | S/N: J175902CR |

Condition: The manifold contained uncontaminated fuel. All components were intact and the fuel screen was uncontaminated.

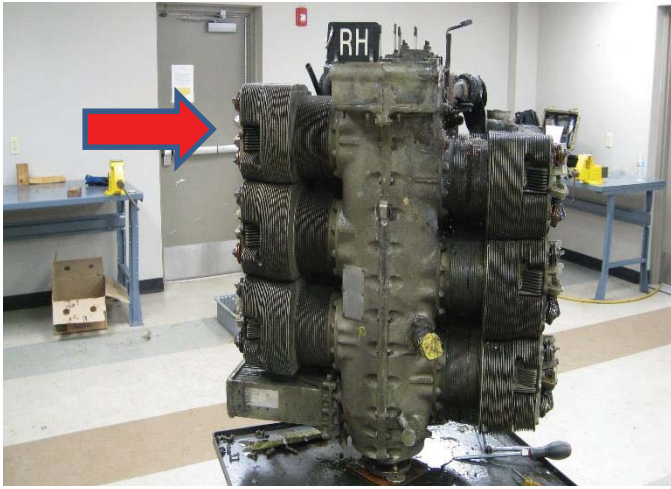
| <b>CYLINDER #3</b> | P/N: 35478 | S/N: Undetermined | Head Date: Undetermined |

| Condition: | Cylinder assembly was undamaged. Red arrow indicates cylinder # 3 | | |

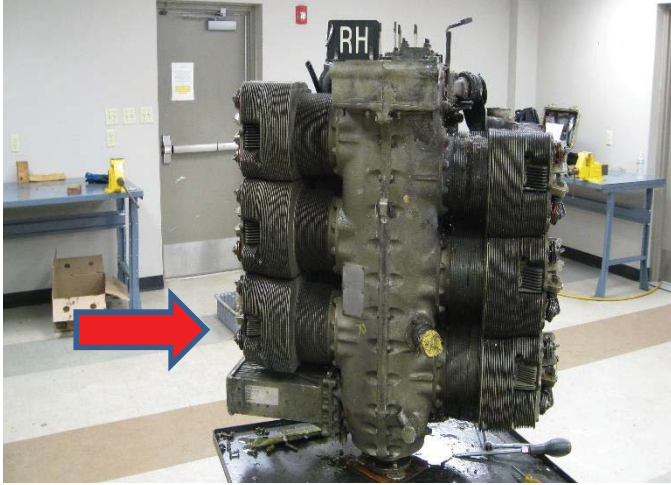
| <b>CYLINDER #2</b> | P/N: 354782 | S/N: Undetermined | Head Date: Undetermined |

| Condition: | Cylinder assembly was undamaged. Red arrow indicates cylinder # 2 | | |

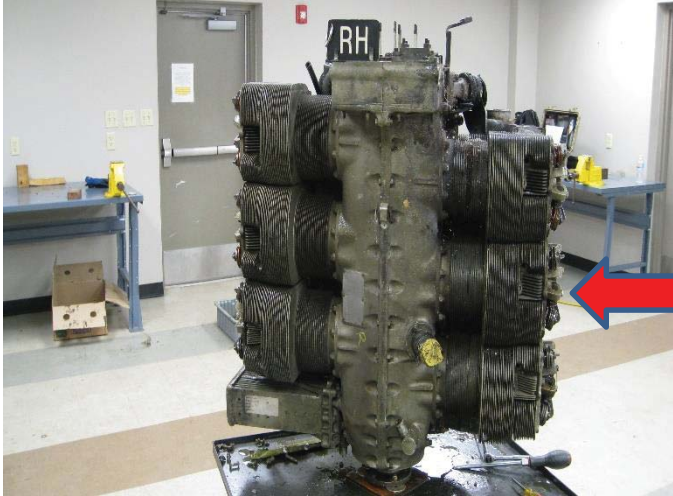
| <b>CYLINDER #6</b> | P/N:812376 | S/N: J8963-2 | Head Date: |

| Condition: | Cylinder assembly was undamaged. Red arrow indicates cylinder # 6 | | |

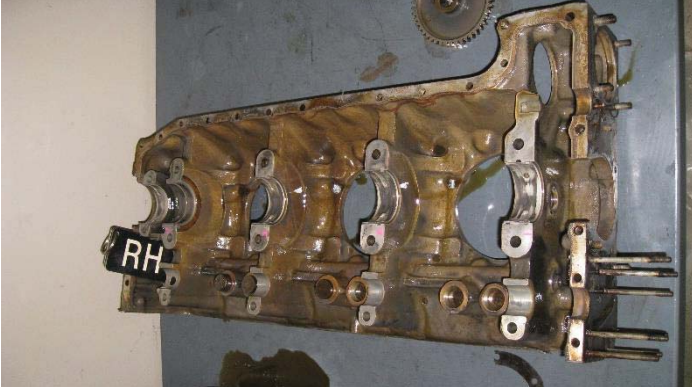
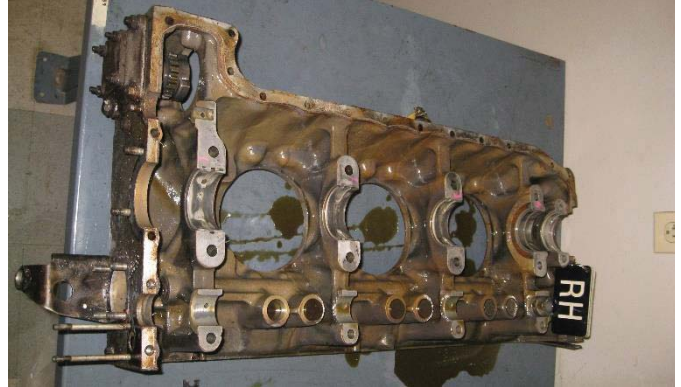
| <b>#1 MAIN BEARINGS</b> | P/N: SA630464 | Date Code: Not legible |

| <b>Condition:</b> | Bearings appear to exhibit normal wear |

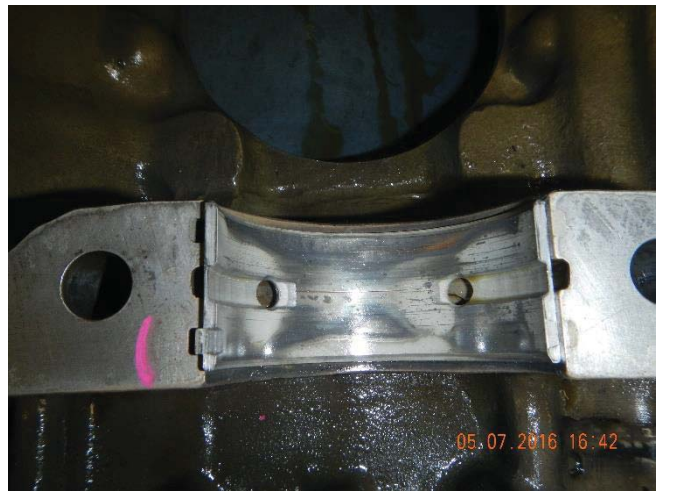
| <b>#2 MAIN BEARINGS</b> | P/N: SA630464 | Date Code: Not legible |

| Condition: | Bearings appear to exhibit normal wear | |

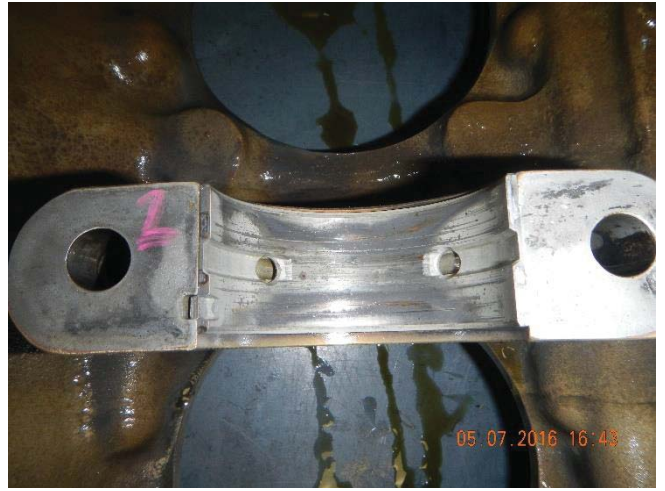
| <b>#3 MAIN BEARINGS</b> | P/N: SA630464 | Date Code: Not legible |

| Condition: | Bearings appear to exhibit normal wear | |

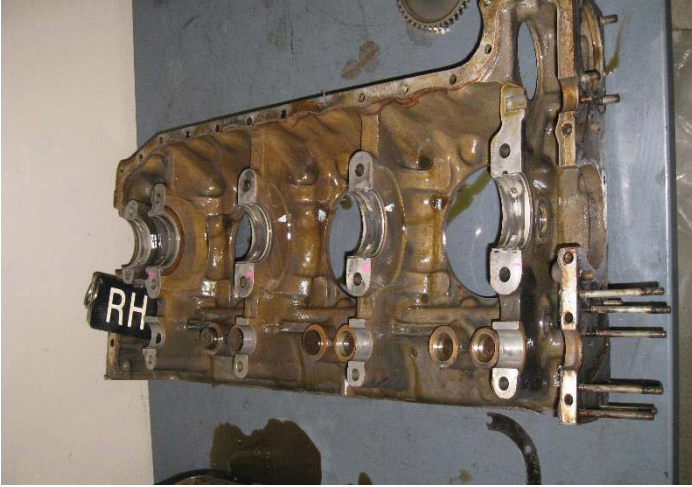
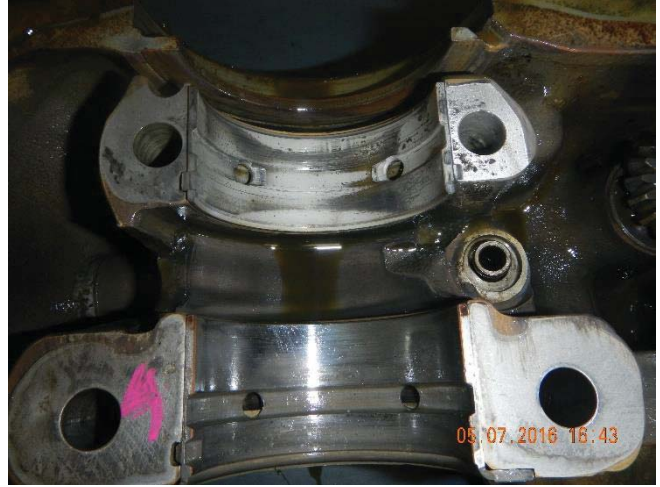
| <b>#4 MAIN BEARINGS</b> | P/N: Undetermined-not legible | Date Code: Not legible |

| Condition: | Bearings appear to exhibit normal wear | |

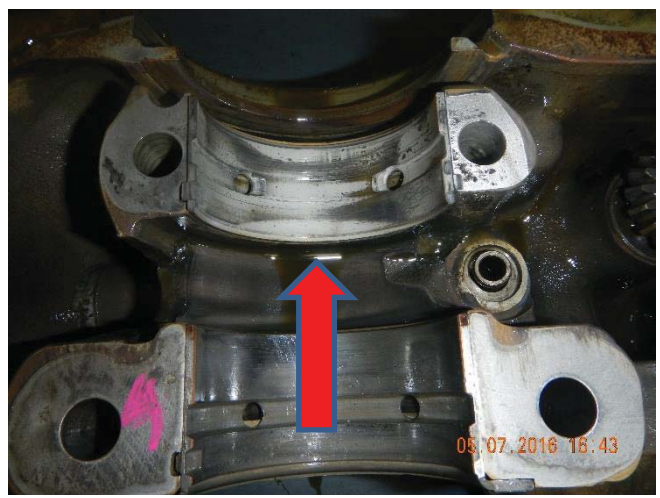
| <b>#5 MAIN BEARINGS</b> | P/N: SA63464 | Date Code: Not legible |

| Condition: | Red arrow points to # 5 bearing. Bearings appear to exhibit normal wear | |

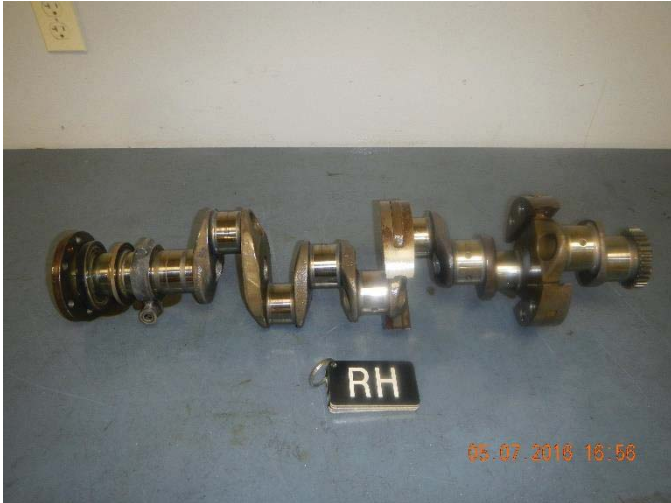
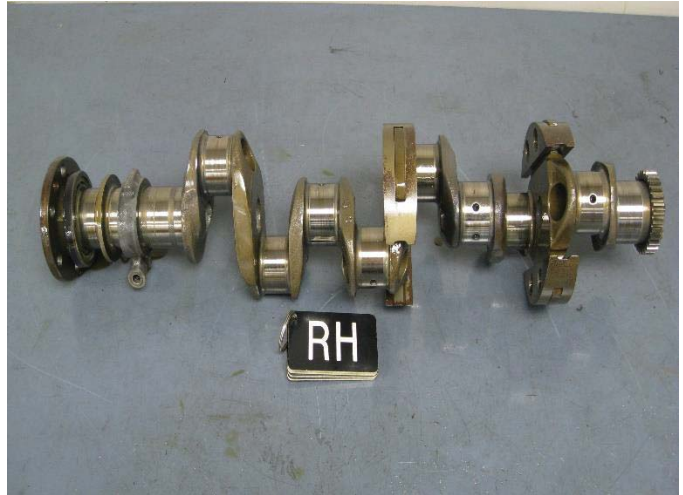
| <b>CRANKSHAFT</b> | Forging Number: 639664 | S/N: Undetermined | Heat code: M95 |

| Condition: | The crankshaft exhibited normal wear | | |

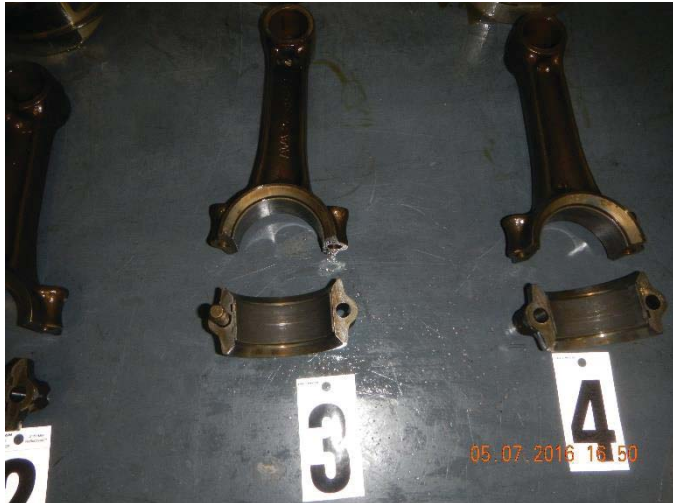
| <b>#3 CONNECTING ROD BEARING</b> | P/N: SA631826 | |

| Condition: | Normal wear was exhibited | |

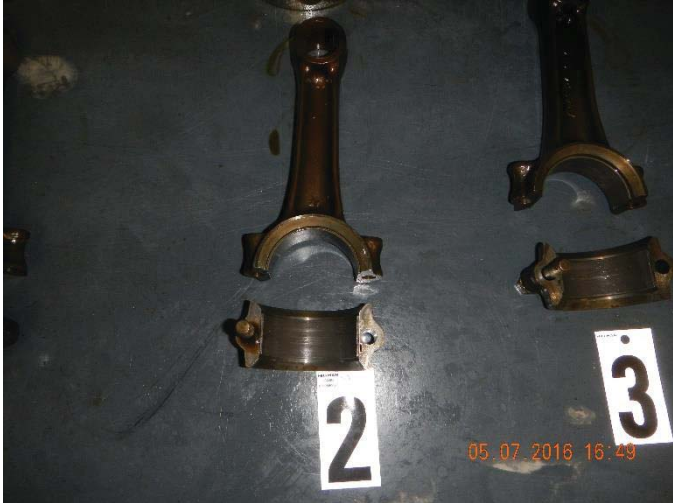
| <b>#2 CONNECTING ROD BEARING</b> | P/N: SA631826 | |

| Condition: | Normal wear was exhibited | |

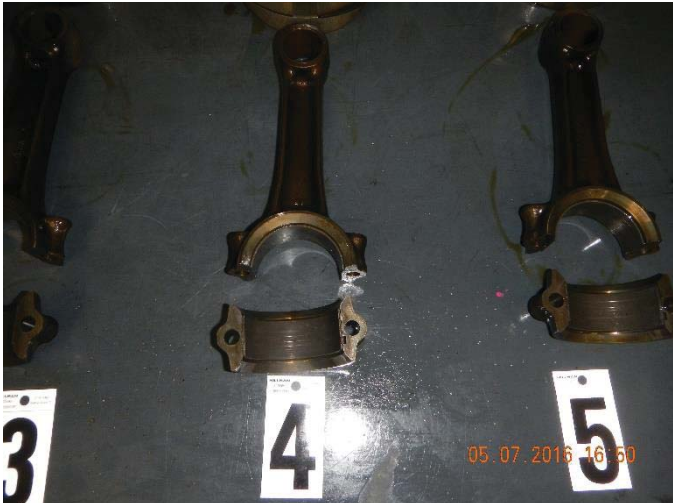
| <b>#4 CONNECTING ROD BEARING</b> | P/N: SA631826 | |

| Condition: | Normal wear was exhibited | |

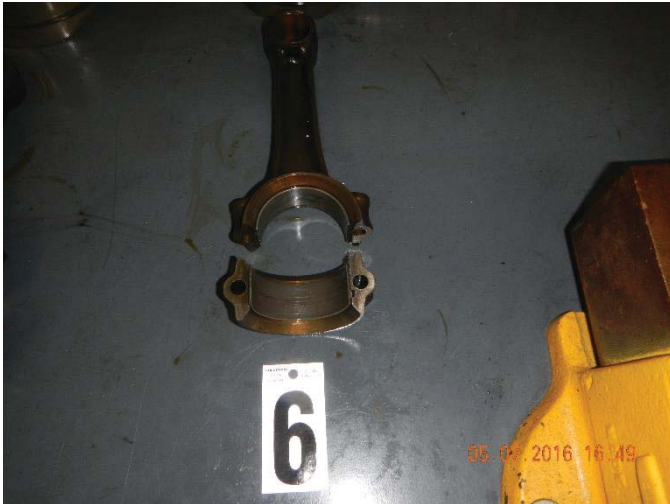
Normal wear was exhibited

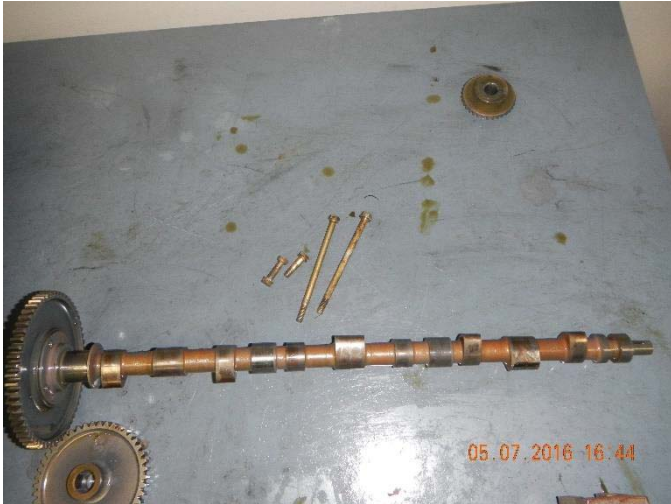
| <b>CAMSHAFT</b> | P/N: 535661 | S/N: Undetermined |

| Condition: | The camshaft was intact but exhibited spalling and abnormal wear on the # 5 & 6 intake lobe. | |

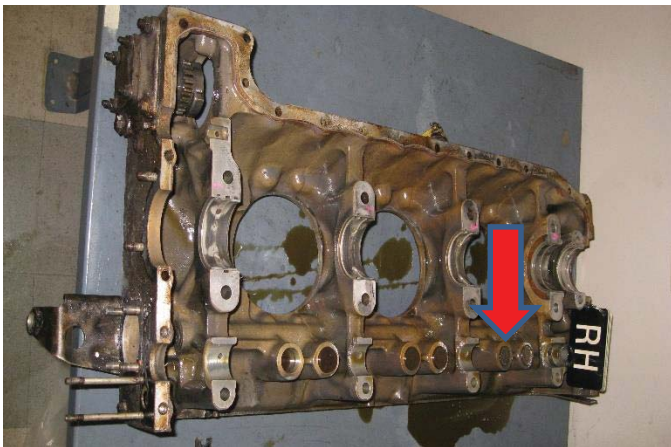
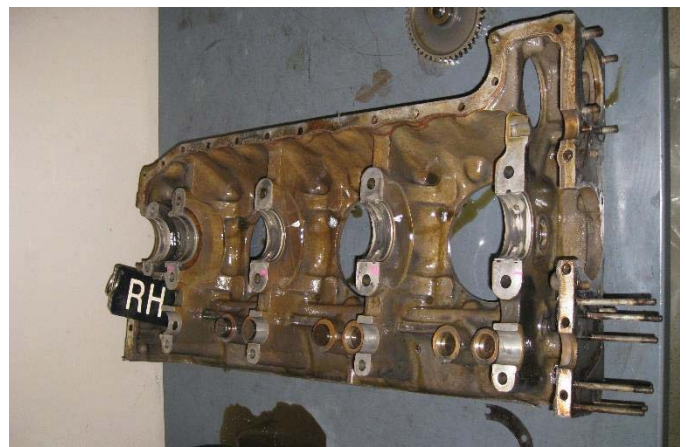
| Condition: | All lifters exhibited light pitting and spalling consistent with corrosion. The intake lifter associated with cylinder 6 exhibited severe spalling. Red arrow points to # 6 intake lifter. |

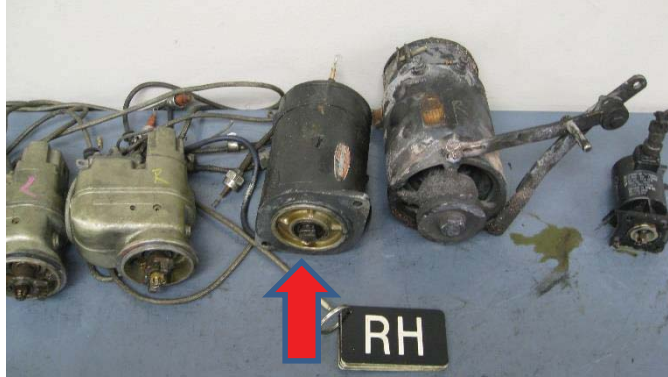
| <b>STARTER</b> | Manufacturer: Delco-Remy | P/N: 1108234 | S/N: 1711 |

| Condition: | The starter motor was removed and visually inspected. No damage was noted other than thermal damage. The red arrow points to the starter motor. | | |

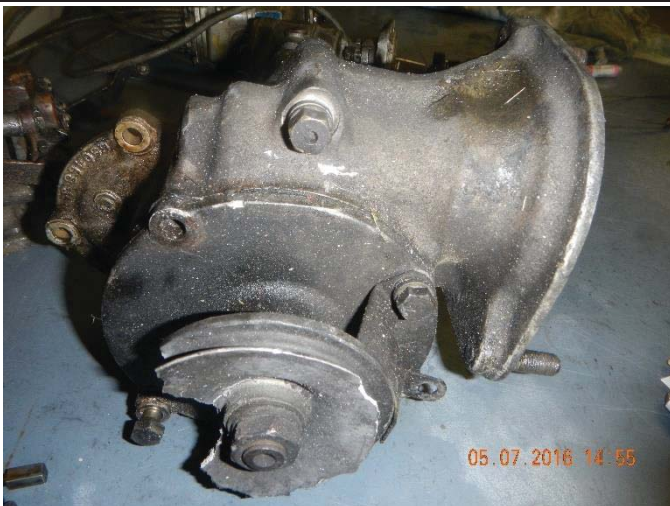
| <b>STARTER ADAPTER</b> | P/N: Undetermined |

The pulley extending from the starter adapter which drives the belt driven generator was broken and the belt separated.

| Condition: | The starter adapter was removed and visually inspected. The shaft rotated easily when the gear was rotated manually. The accessory drive pulley was impact damaged. |

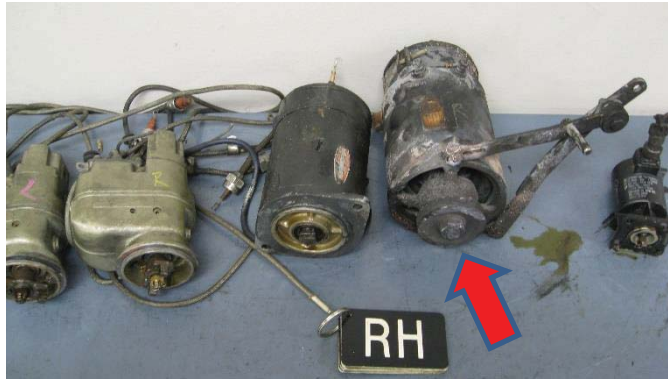
| <b>GENERATOR</b> | Manufacturer: Undetermined | P/N: R17198 | S/N: Undetermined |

| Condition: | The red arrow points to the generator. The generator exhibited thermal damage and the drive pulley received impact damage. The data plate was thermally damaged. | | |

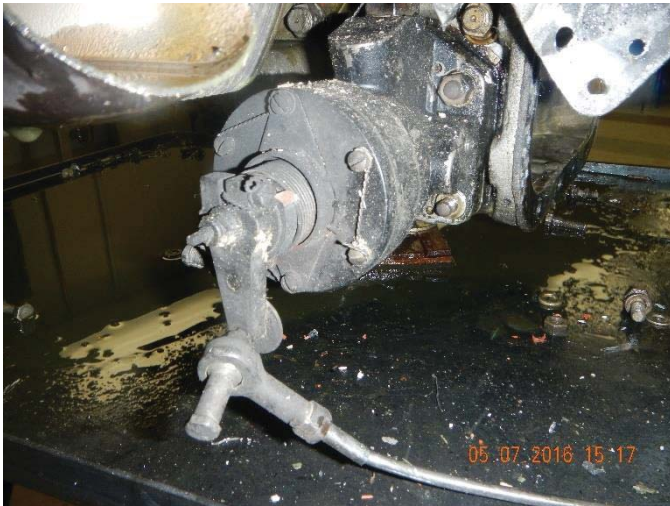
The governor was removed and inspected. No pre-impact damage was noted

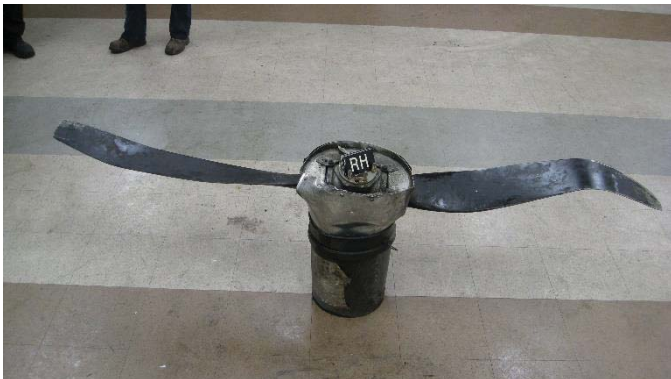
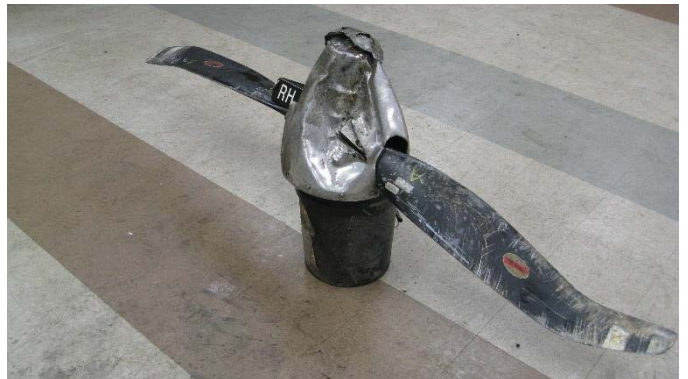
| Condition: | Blade A exhibited twisting rearward bending beginning approximately 4" outboard of the propeller blade root. A forward bending motion began at approximately 24" outboard of the blade root. Propeller blade B exhibits a slight rearward bending motion approximately 12" inboard from the propeller tip. The propeller spinner received crushing due to impact with the ground. Neither blade appeared to be in a feathered position. | | |
