INVESTIGATION REPORT

DATE	ENGINE MODEL	ENGINE SERIAL NO	REGISTRATION	File number
12/19/2015	Rotax 582 mod 99	6140712	N124LP	2015-083

NTSB Preliminary

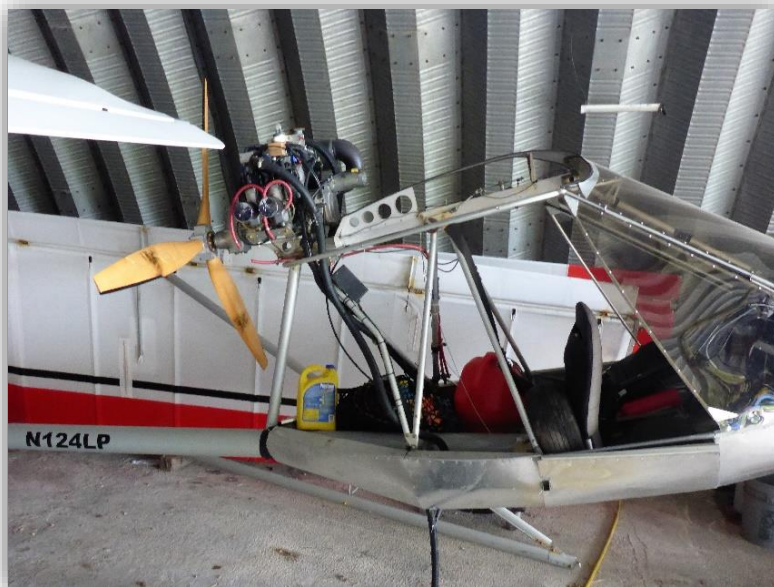
During the landing, the airplane incurred substantial damage to the fuselage. A post-accident examination of the engine revealed that there was fuel noted in the fuel tanks, fuel pump, fuel filter, and both carburetors. One spark plug was removed from each cylinder and thumb compression was obtained from all cylinders. However, when the propeller was rotated by hand, a metal scraping sound was heard in the vicinity of the gear box. The engine oil was drained and metal particles were noted in the oil. The engine was retained for further examination.
