INVESTIGATION REPORT

Date of accident:	02/28/2016	NTSB file number:	ERA16LA120
Location of accident:	Atlanta, GA	FAA Inspector:	Andre Cummings
Location of Investigation:	Atlanta, GA	Law Enforcement:	Unknown
Investigator In charge:	Leah D Read	Corner/Medical Examiner	None

Aircraft Make:	Czech Aircraft Works	Aircraft registration:	N187SF
Aircraft Model:	SportCruiser SRO	Aircraft S/N	08SC190
Propeller make, model & S/N	Sensenich 3 blade

Engine Type:	Rotax 912 ULS	Engine TTSN	Unknown
Engine Serial Number:	6779682	Engine TTSOH	Unknown
Engine Manufacture date:	01/26/2012	Engine position:	Tractor

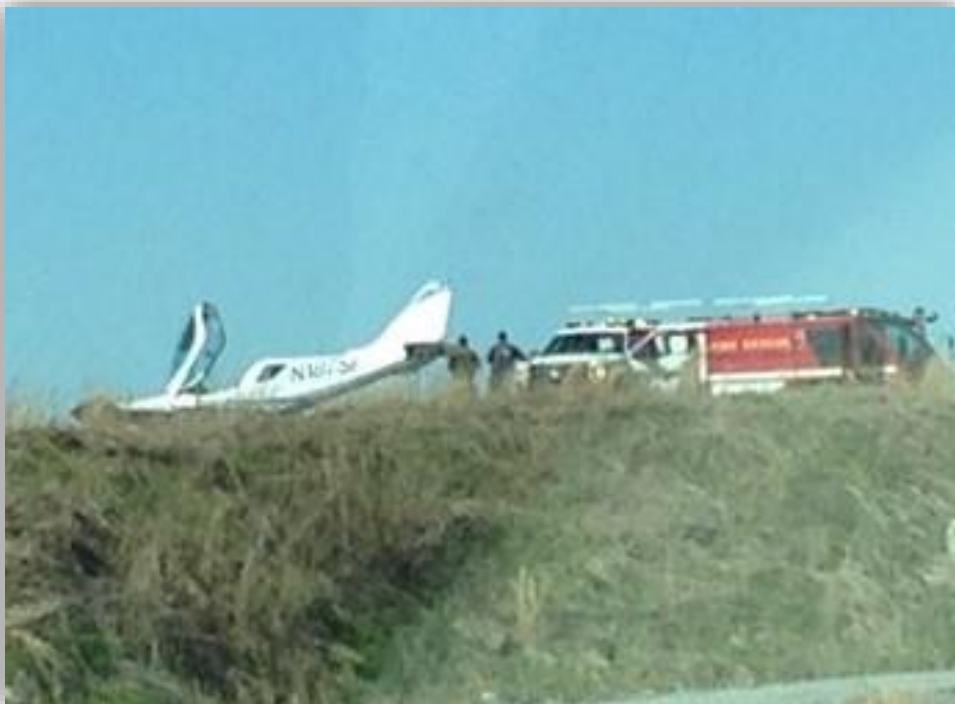
On February 28, 2016, at 1337 eastern standard time, N187SF, a light-sport Czech Sport Aircraft - SportCruiser, made a forced landing after a total loss of engine power while on takeoff from DeKalb-Peachtree Airport (PDK), Atlanta, Georgia. The airplane's left wing, firewall, landing gear and propeller were damaged. The private pilot/owner was not injured. Visual flight rules conditions existed at the time of the accident and no flight plan was filed for the flight that was being conducted as a 14 Code of Federal Regulations Part 91 personal flight. The flight was originating at the time of the accident.

The pilot stated that this was his first flight of the day. He conducted a thorough pre-flight inspection of the airplane before he started the engine and then let it warm up to normal operating temperature before taxiing to the runway. The pilot said he performed an engine run-up before taking-off and everything was normal. Both fuel tanks were full with about 15 gallons of auto-gas, and the fuel selector was on the left tank. The fuel pump was "on." The pilot said the engine run-up was normal and proceeded to takeoff on runway 21R. As the airplane began to climb, the engine lost power. He switched fuel tanks, but the engine did not re-start. The pilot declared an emergency and attempted to land on runway 3R, but landed about 300 ft southeast of the runway. The airplane and engine were retained for further examination.
