INVESTIGATION REPORT

Reference	WPR17LA133	Commercial File	N/A
Accident / Incident	RA-2017-152 / A-	Preliminary Information report A	Onsite Investigation
report	2017-008		Report A-2017-008

2.1 ENGINE EXAMINATION

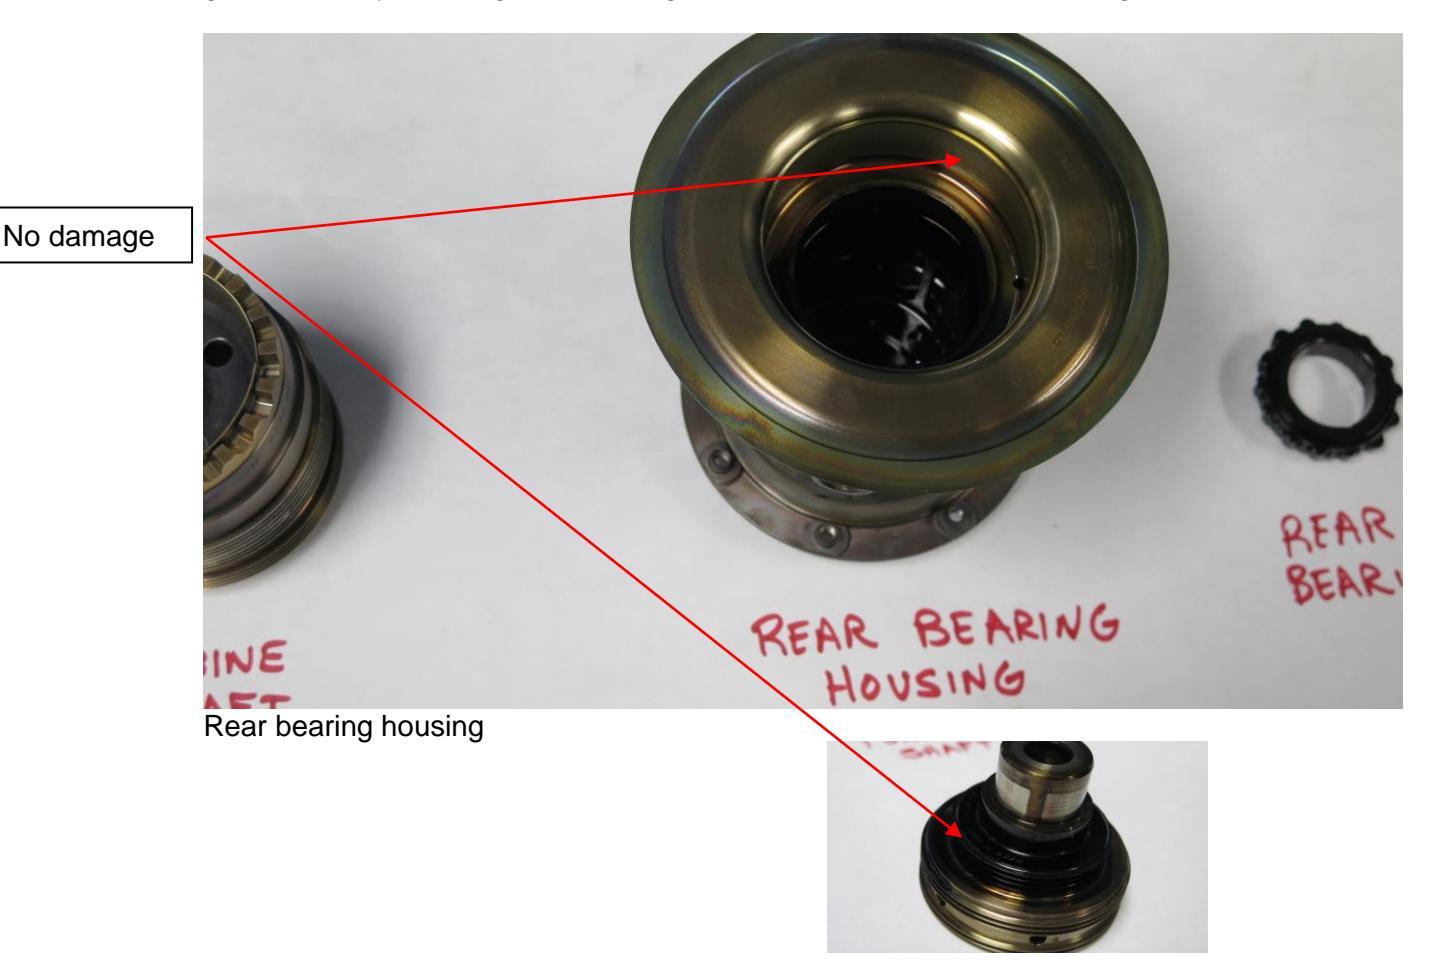
Gas generator rear bearing appeared normal and rolled freely. There was no damage to the piston shaft or rear bearing housing. This would indicate that the rear of the gas generator stayed in alignment during the failure of the module 2 bearing.
