Selected Non-Proprietary  
Correspondence from Boeing to Captain S. Kelada and Engr. Hamdy of EgyptAir

Split Elevator Failure Scenarios  
Effect of High Rate Column Inputs  
Dynamic Analysis  
Autopilot Disconnects on DFDR  
Action Items

9 June 2000 thru 15 December 2000

Subject: Split Elevator Failure Scenarios - Egyptair 767-300ER SU-GAP,  
Accident Off Nantucket, Massachusetts – 31 October, 1999

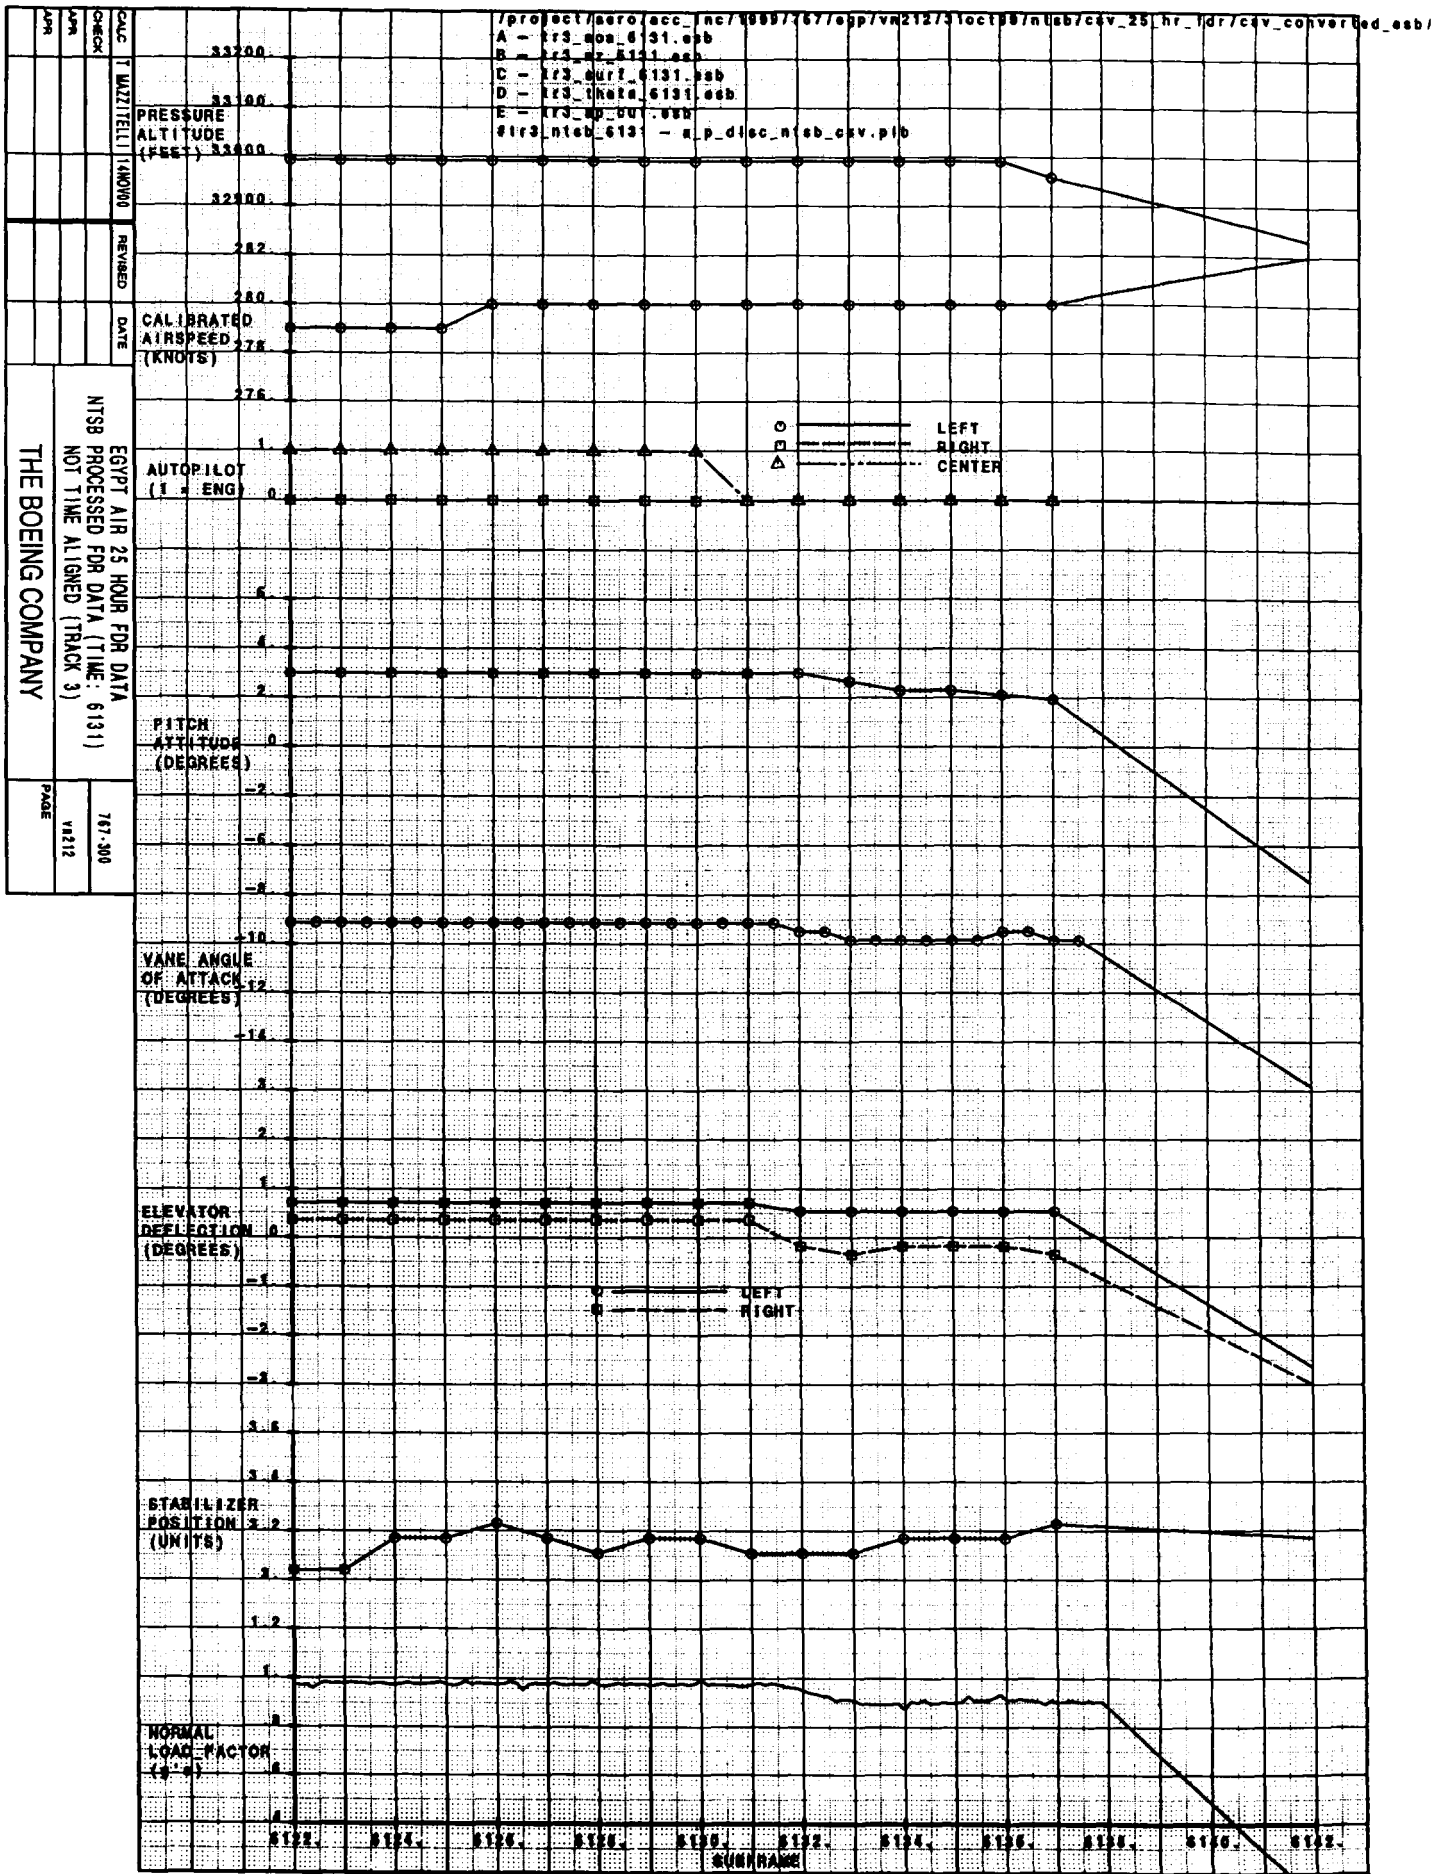
Figure 3 presents the DFDR data from the autopilot disconnect which occurred eight seconds prior to the beginning of EgyptAir flight 990's fatal dive. The center autopilot was disconnected at sub-frame of 6131 in figure 3.

In the nine seconds prior to the autopilot disconnect in figure 3, the two elevators track within 0.35 degrees (2 LSBs) of each other and average about 0.52 degrees (3 LSBs) of nose up elevator. Prior to the disconnect of the center autopilot, the flight parameters are stable.

amount of nose up force and the elevator control system returning to its no-load position. Following the autopilot disconnect, both elevators move slightly nose down. The amount of nose down elevator travel is less than the minimum autopilot trim threshold of 0.4 degrees so this amount of deflection is typical even for a perfectly rigged flight control system. The fact that the right elevator moved more than the left elevator when the autopilot was disconnected is consistent with the fact that the spring-cam mechanism provides the right aft quadrant with more centering force around neutral. The steady state position of the elevators following the autopilot disconnect in figure 3 is virtually identical to the no-load elevator system equilibriums shown in figures 1 and 2. In both figures 2 and 3, the left elevator is at a nose up position of 0.52 degrees and the right elevator is at nose down position of 0.35 degrees when the autopilot is disconnected. The elevator motion associated with the autopilot disconnect of figure 3 is normal and consistent with other recorded autopilot disconnect events on this aircraft.

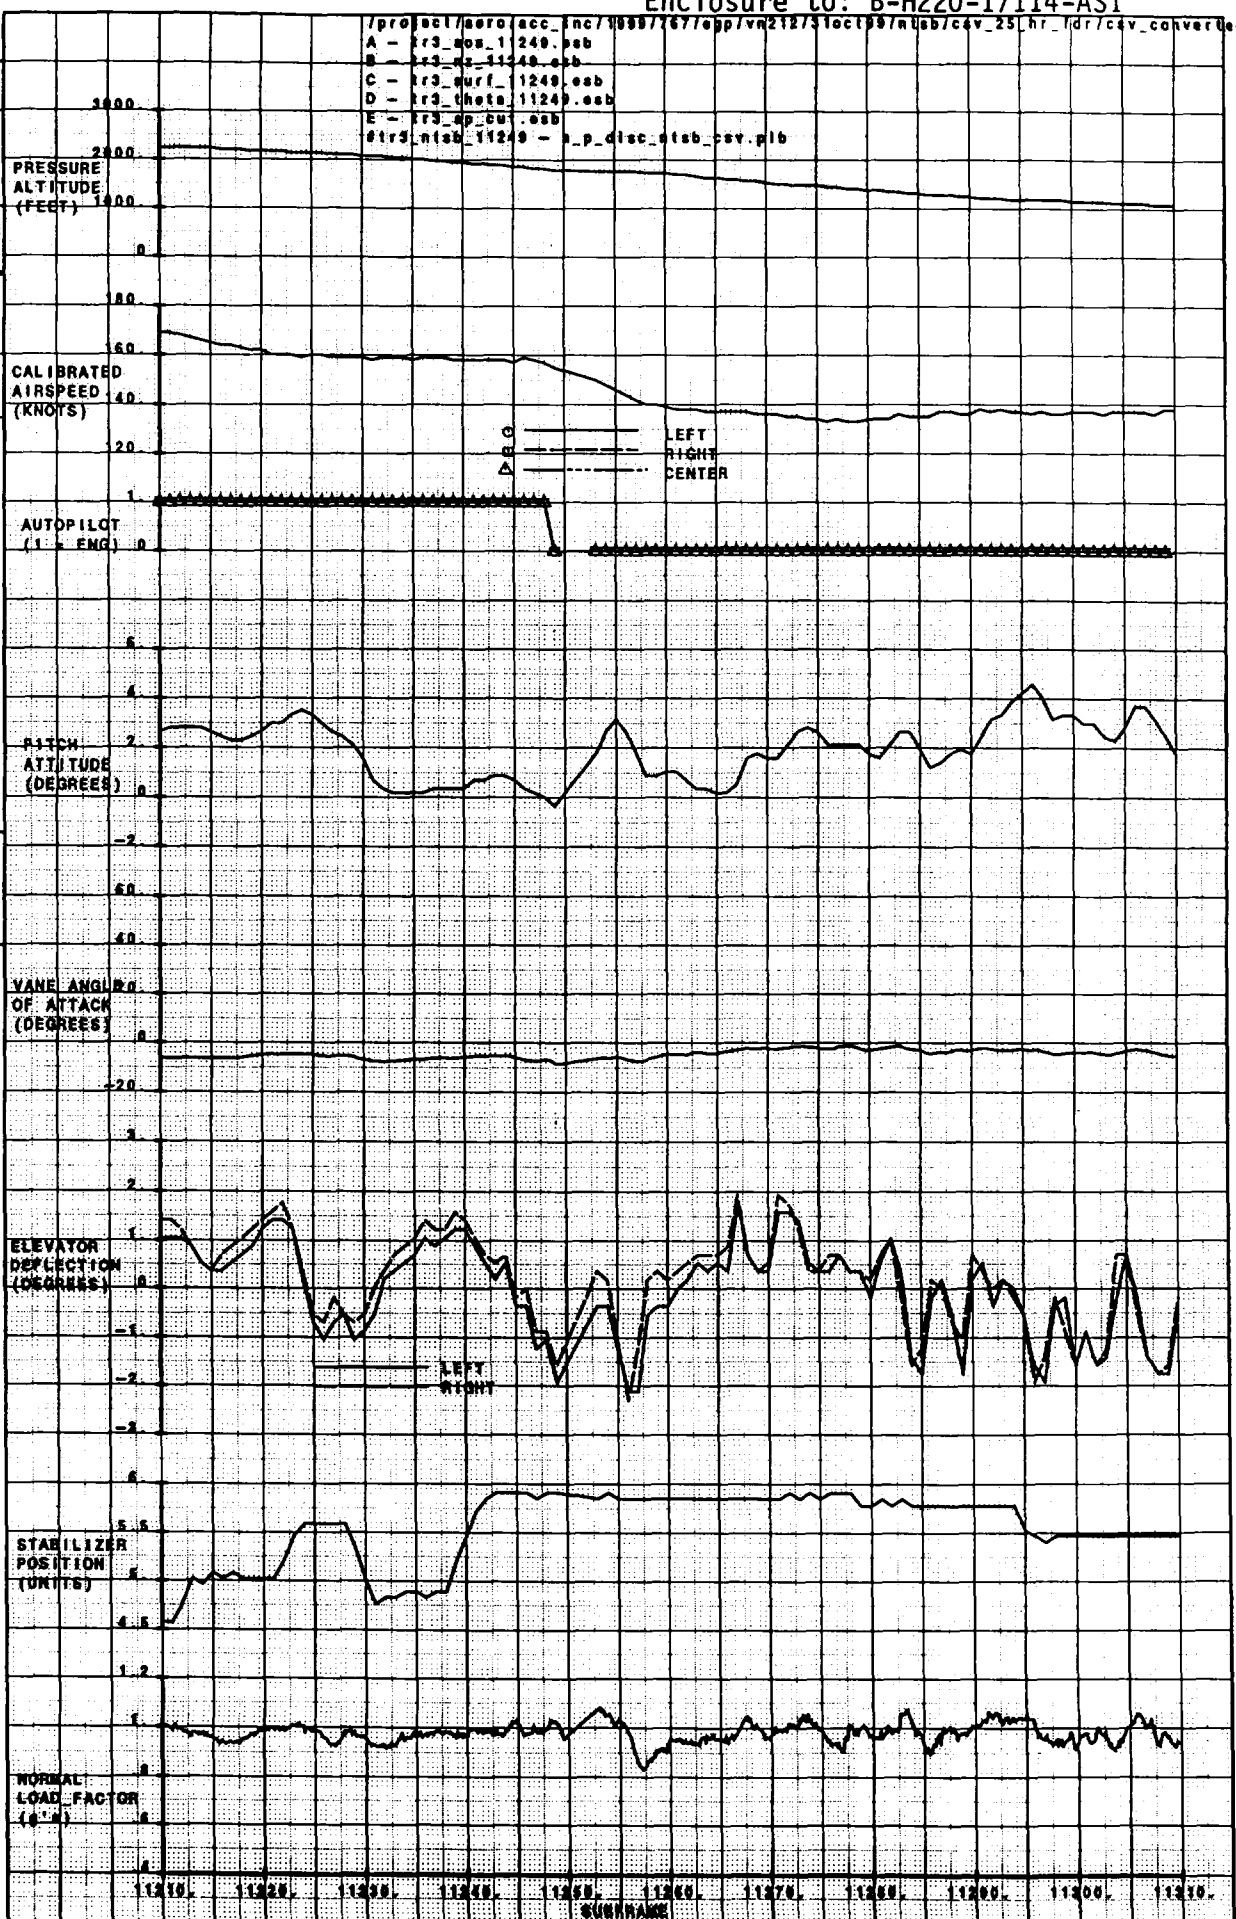
Figure 5 presents the DFDR data from a triple channel autopilot disconnect that occurred on approach. The autopilot disconnect event occurred at a sub-frame of 11249 in figure 5. Unfortunately, the DFDR data was invalid during the 3 seconds (sub-frames) immediately following the autopilot disconnect event in figure 5 so it impossible to determine whether there was an elevator surface transient associated with this disconnect event.

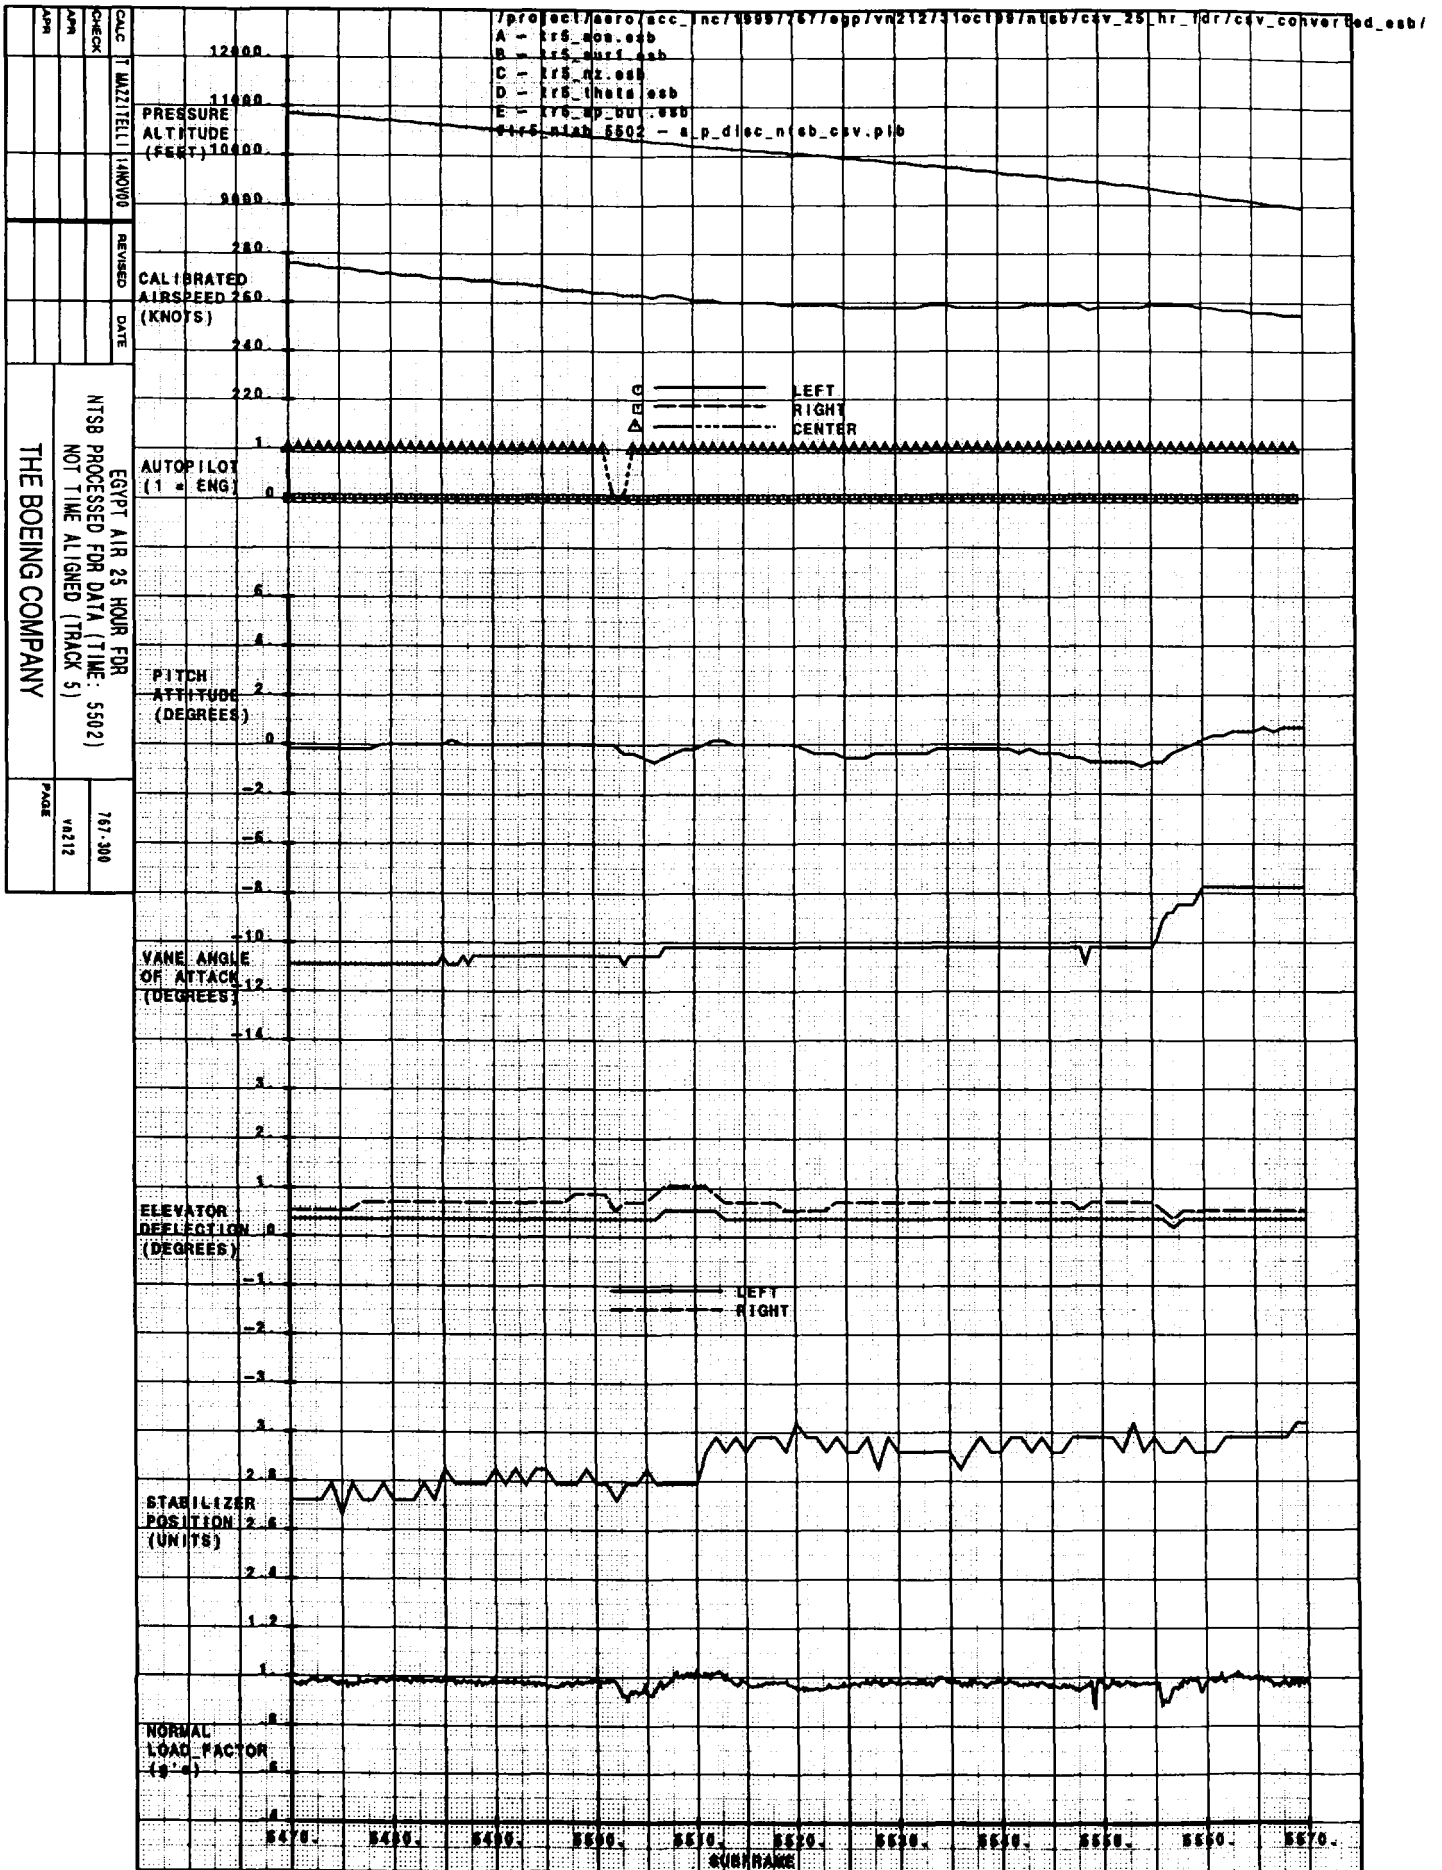
Figure 6 presents the DFDR data from a flaps-up autopilot disconnect event, which occurred during descent. The center autopilot was disconnected at a sub-frame of 5502 in figure 6. The total duration of this autopilot disconnect event was only 1 to 2 seconds. Since the elevator positions recorded on the DFDR are only sampled once per second, this data is of limited use for evaluating elevator surface transients associated with this autopilot disconnect event.

In the period prior to the autopilot disconnect in figure 6, the two elevators track within 0.17 to 0.52 degrees (1 to 3 LSBs) of each other and average about 0.52 degrees (3 LSBs) of nose up elevator.

In the period following the autopilot disconnect in figure 6, the right elevator may have moved 0.17 to 0.35 degrees (1 to 2 LSBs) in the nose down direction, but it is difficult to tell based on the limited number of DFDR data samples. This amount of elevator motion is within the range of motion allowed by the autopilot trim threshold.
