**Selected Non-Proprietary
Correspondence from Boeing to Systems Group Chairman**

**Autopilot Disconnect Warning
Stick Nudger operation
Dual Elevator PCA Jam Ground Test
Split Elevator Failure Scenario, 21 July 2000
Split Elevator Failure Scenario, Effects of Airloads
Split Elevator Failure Scenario, 29 Sep 2000
Elevator System Response to Hydraulic Power On
CG and Elevator Position Data
Potential Elevator System Failure Scenarios**

18 December 1999 to 27 June 2001

Subject: Autopilot Disconnect Warning - Egyptair 767-300ER SU-GAP,
Accident Off Nantucket, Massachusetts – 31 October, 1999

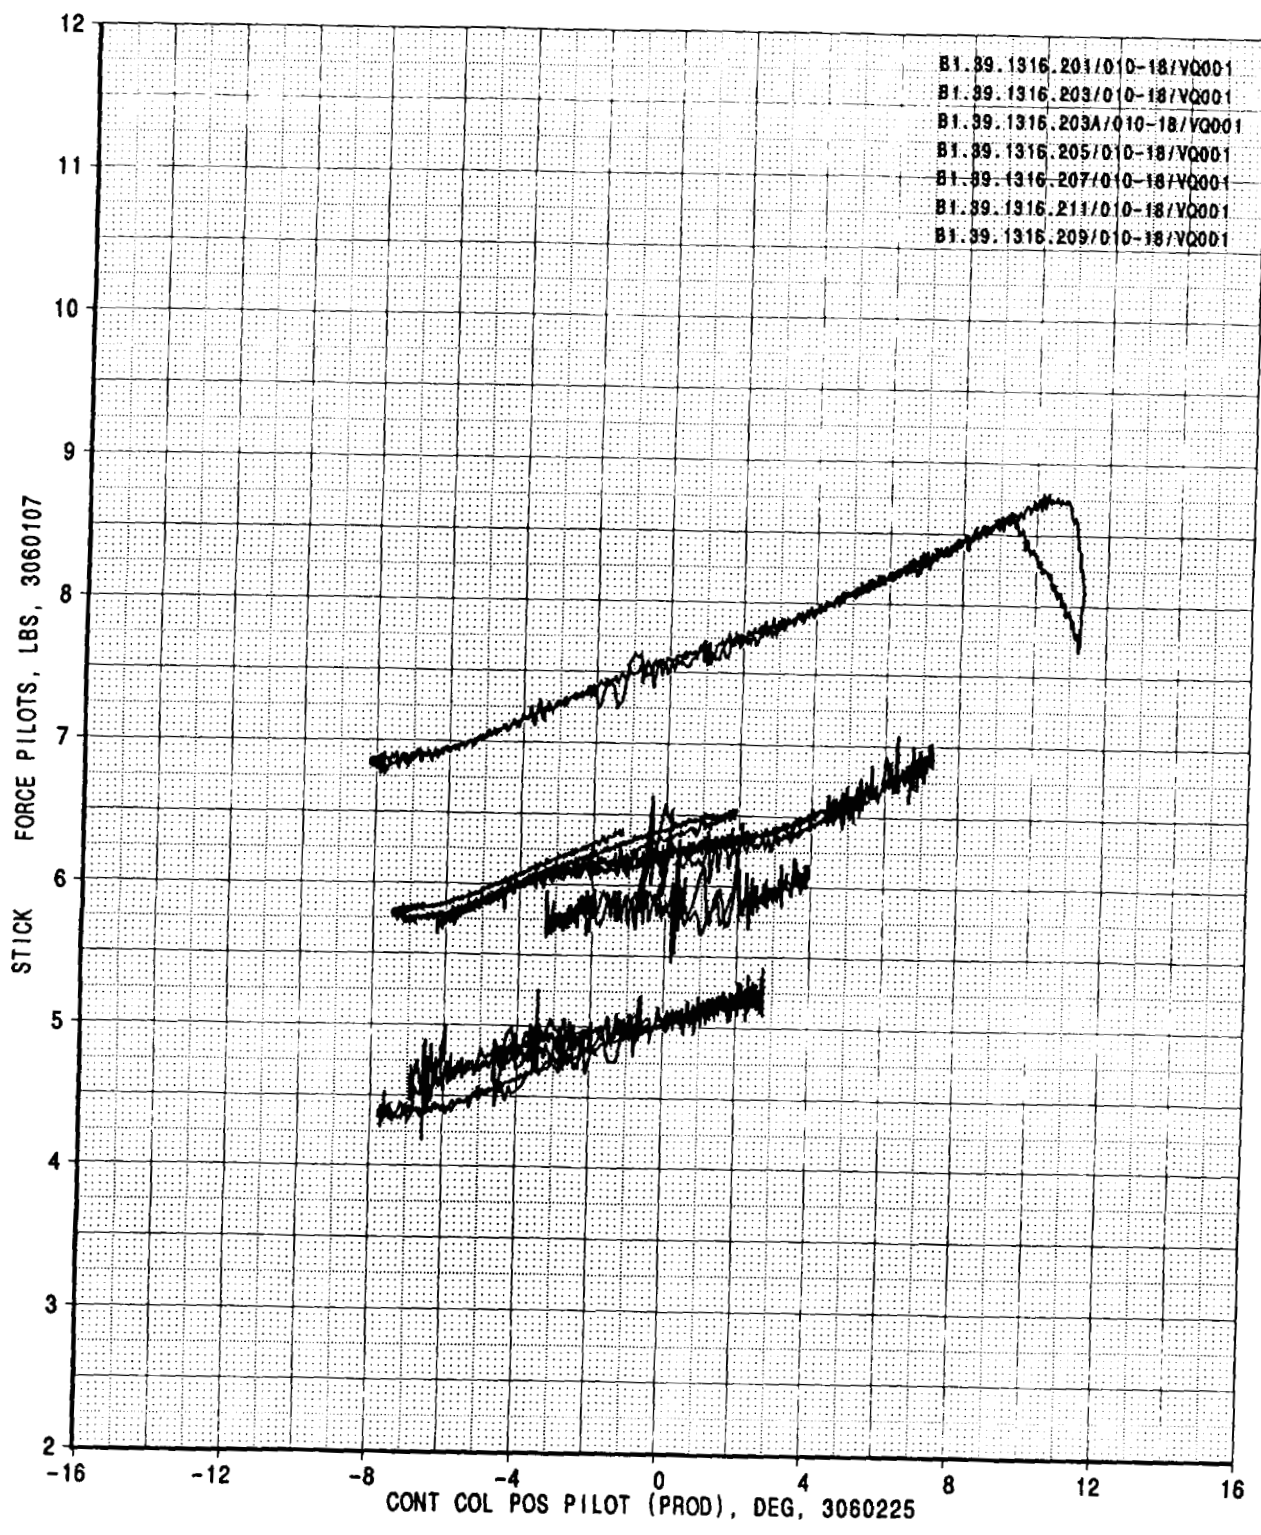
CALC	B. Cook	17Jul00	REVISED	DATE	First Officer's Column Force Biases During Test 10-05	767-400ER VQ001
CHECK						Figure 5
APPD.						PAGE
APPD.						12 of 16

The First Officer's column force biases during test 010-05 are shown in figure 5. Figure 5 was created by plotting the first officer's column force versus first officer's column position for all test conditions where the captain alone made the column inputs.

Examination of figures 4, 5, 6, and 7 reveals that the column force instrumentation biases all shifted during the course of the day's testing. The cause of this shifting is changes in temperature during the course of the testing. During the design of the strain gage simulator circuits, no attempt was made to produce biases that were constant with respect to temperature. For figures 4, 5, and 6, the shift in the column force instrumentation bias is less

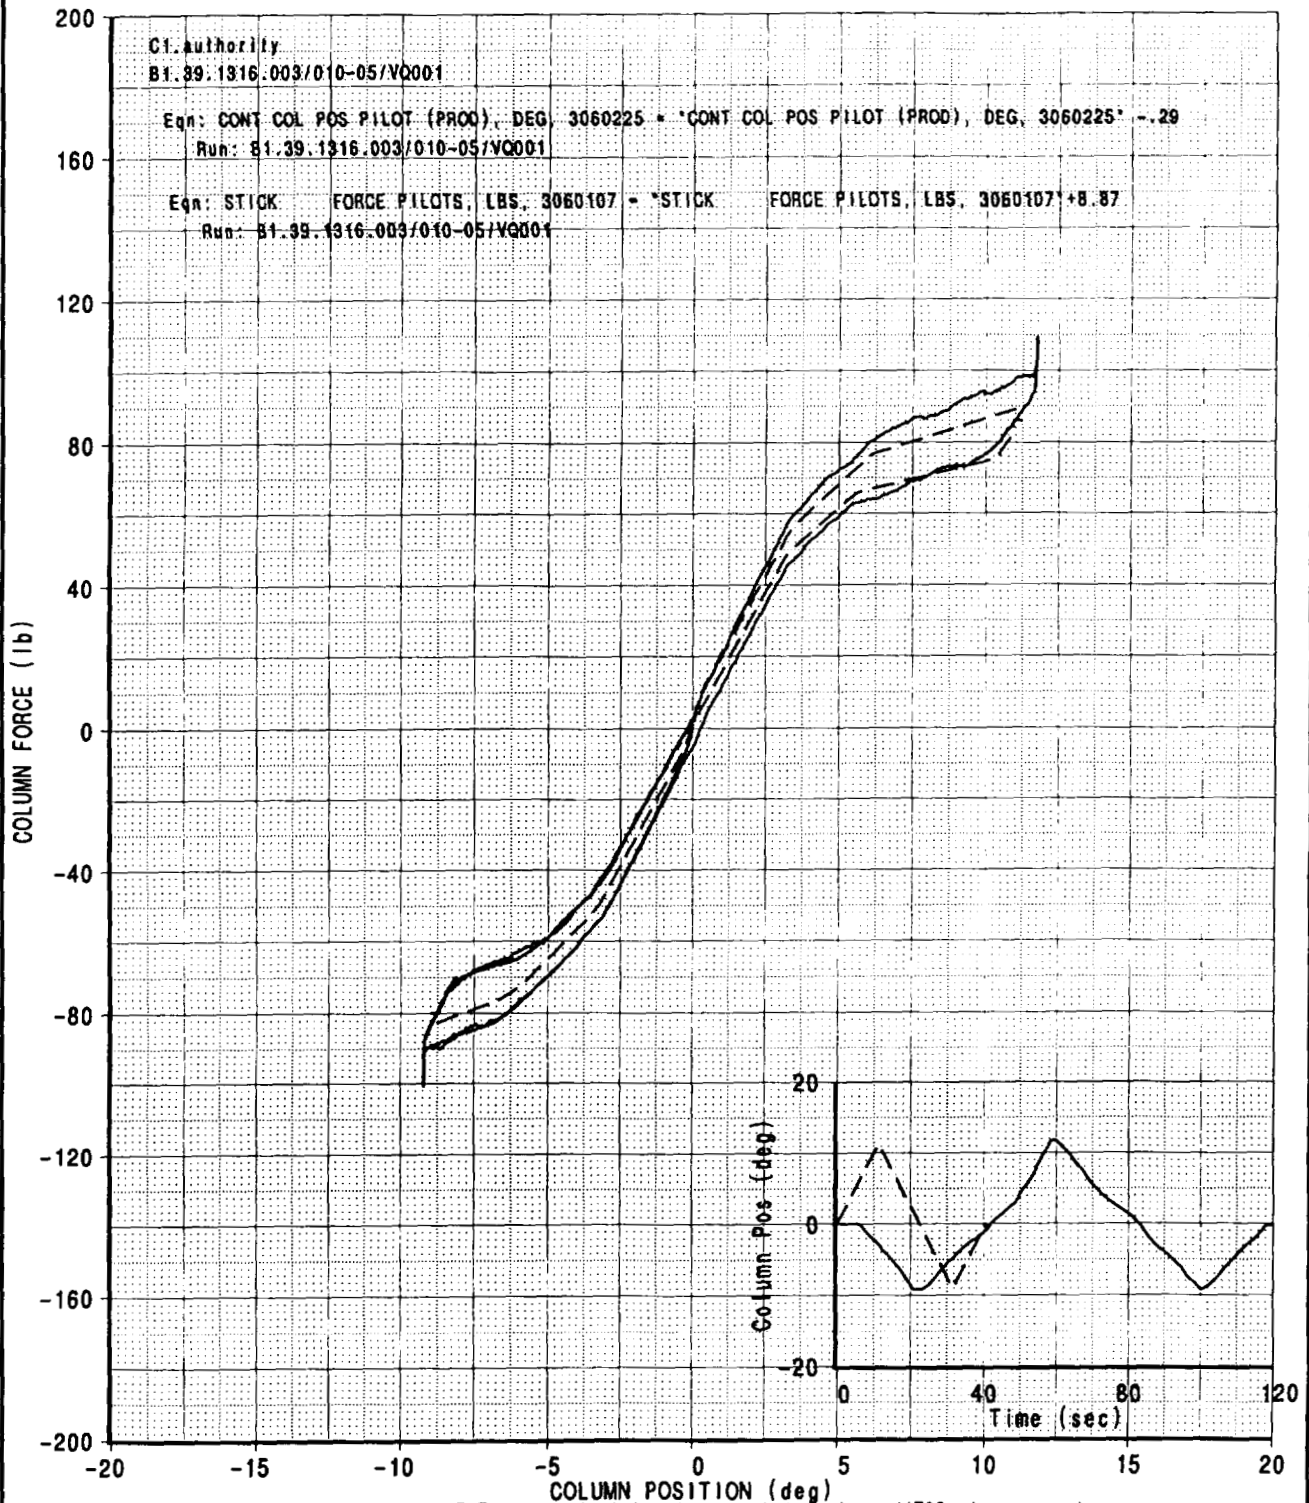
CALC	B.Richardson	17Jul00	REVISED	DATE	Ground Test/Simulation Proof of Match 770 psi Feel Sweep with Biases Removed	767-400ER VQ001
CHECK						Figure 9
APPD.						
APPD.						
						PAGE 16 of 16

Figure 8 shows a plot of column force versus column position during a column sweep on VQ001 at base feel pressure. Figure 9 shows a plot of column force versus column position during a column sweep on VQ001 when the feel pressure was set to 770 psi. In both figures 8 and 9, the VQ001 test data matched well with the predictions once the column force instrumentation biases were removed. This demonstrates that the column force test data gathered from VQ001 can be easily corrected by removing the instrumentation biases and that the forces measured by the instrumentation once this is done is accurate.

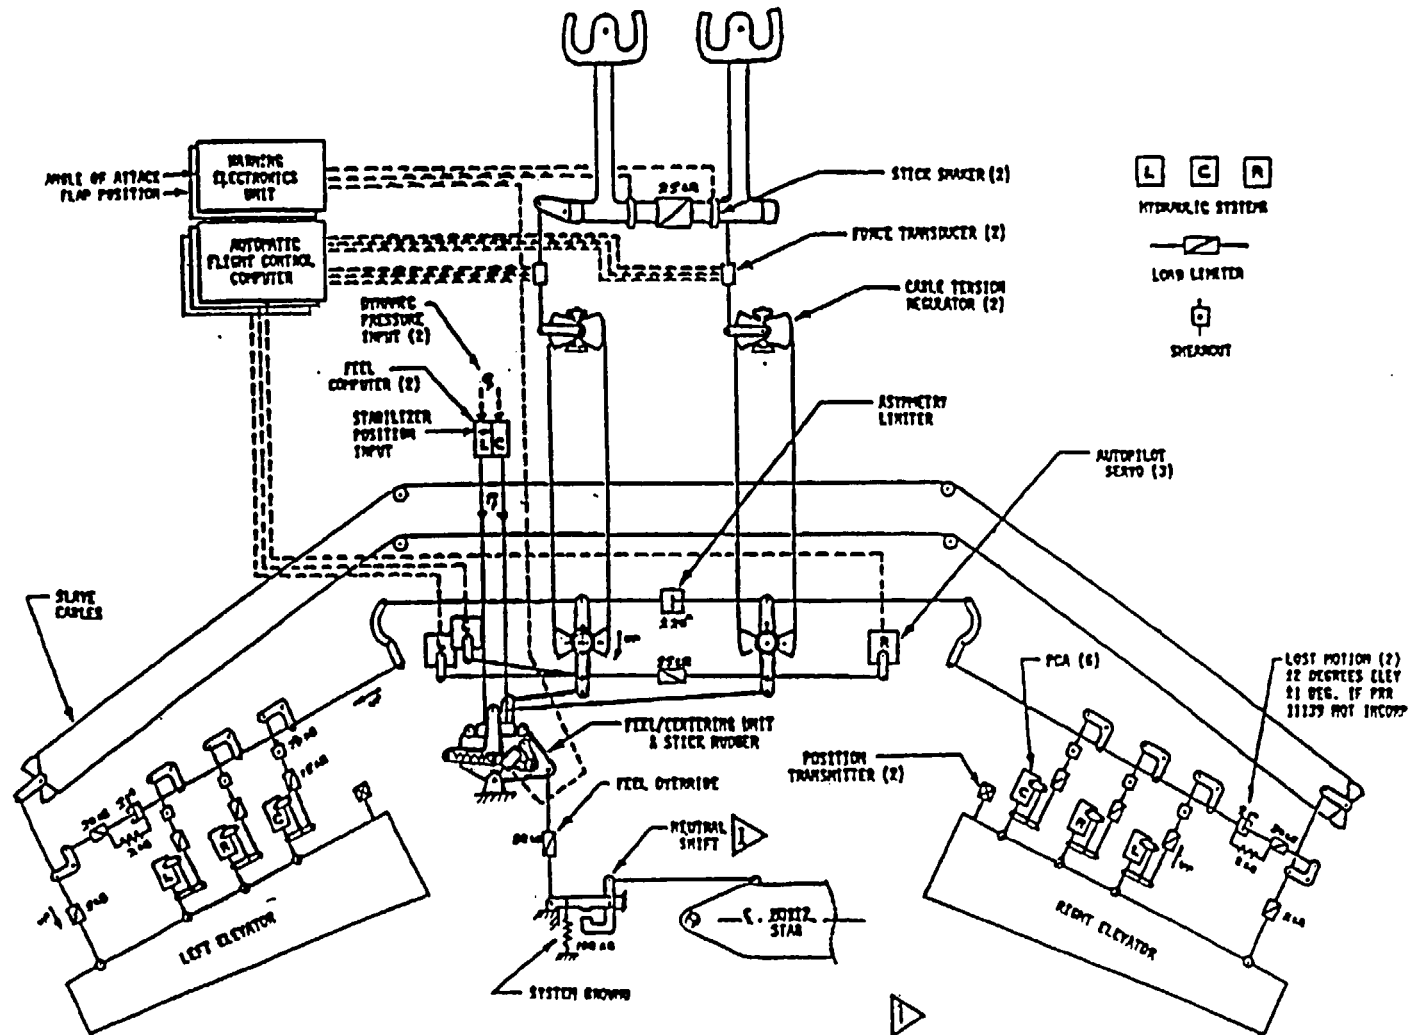
Figure 1. Elevator Control Schematic

The 767 has two elevators that are attached to the moveable horizontal stabilizer (see Figure 1 for a schematic of the elevator control system). In normal operation, the left and right elevators move together in response to pilot or autopilot commands. Each elevator is positioned by three independent hydraulic actuators, each of which is powered by a separate hydraulic system. Commands from the pilot or autopilot are transmitted to the actuators via cables and push rods to the input of the actuators. In response to a position command, the control valves in the three actuators (see Figure 2 for a schematic of the actuator) move to an open position, which causes high-pressure hydraulic fluid to be directed to the actuator pistons. This causes the pistons to move in the direction of the input command until the desired position is reached. When the actuator pistons reach the commanded position, the feedback linkage moves the control valve back to a closed position and the hydraulic fluid flow is shut off. With the control valve at neutral and hydraulic flow shut off, the static load holding capability is the 20% higher than the maximum hinge moment capability of one actuator (see Note 4 below for an explanation of this).

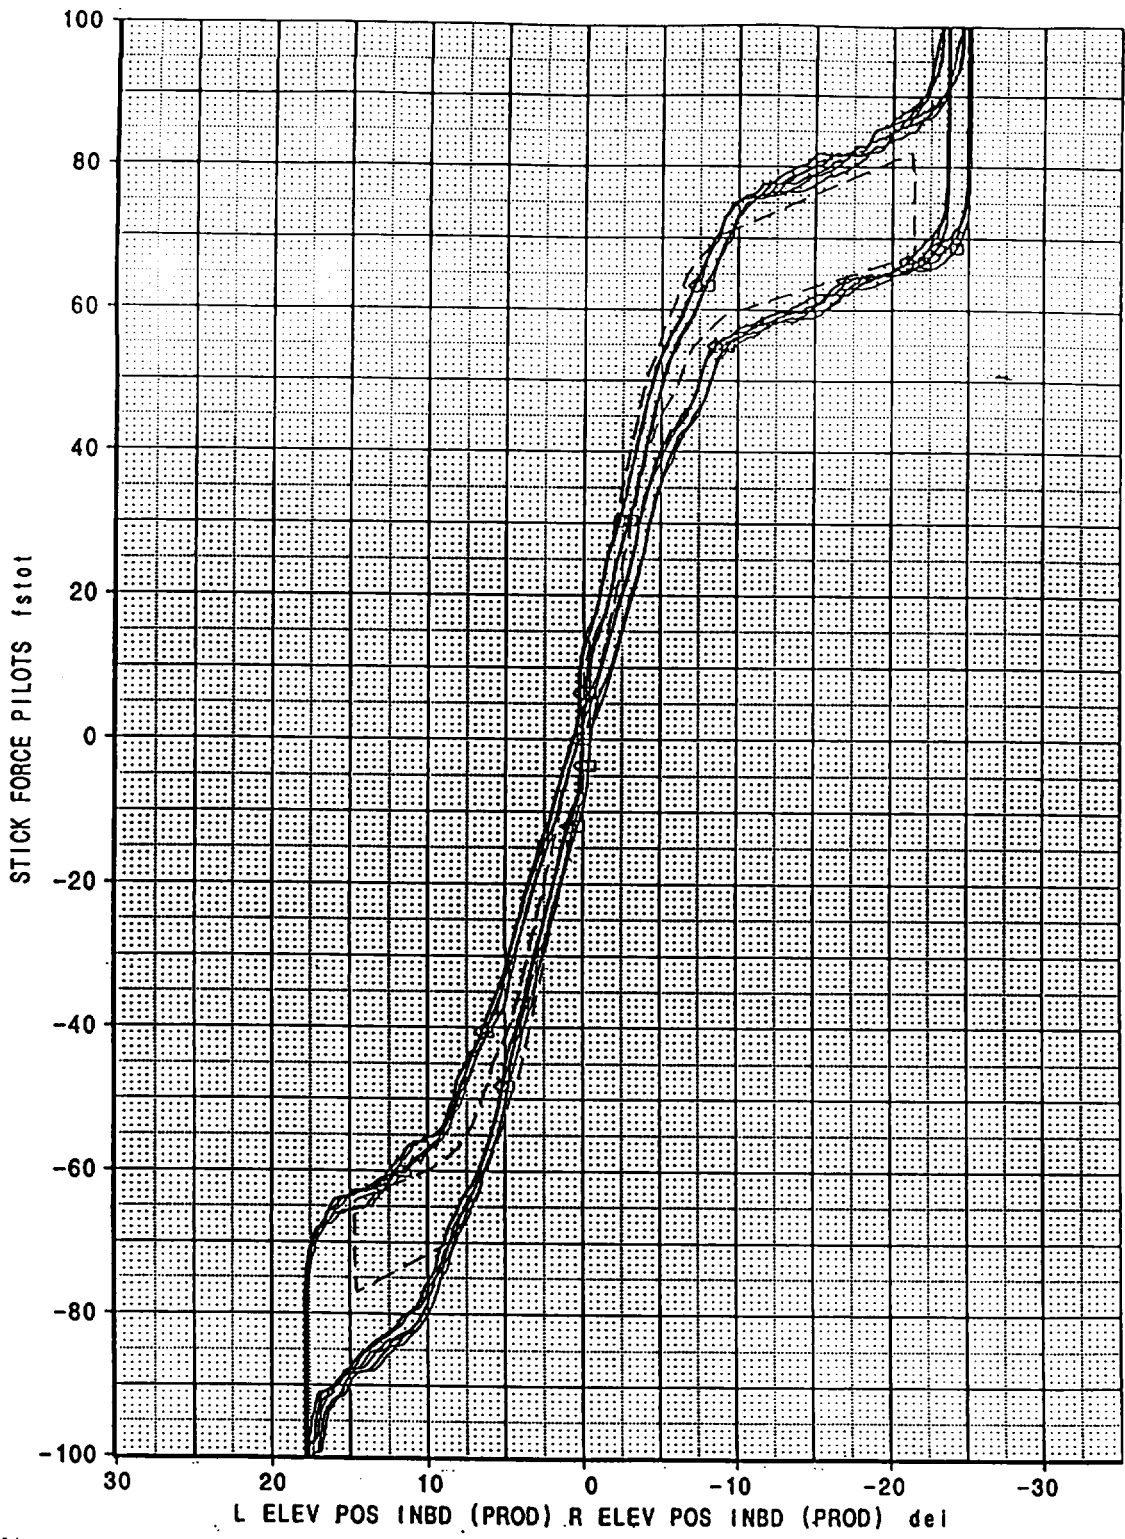
In the event of the combined failure discussed above in Failure Case 3, the initial elevator deflection would have been approximately the same as described above (4 degrees) for the failed elevator. However, the non-failed elevator would have deflected to only 1.5 degrees which is the point where the force from the input pogo of the jammed PCU is balanced by the centering force from the feel unit (see the column force versus elevator deflection curve in Figure 3.5).

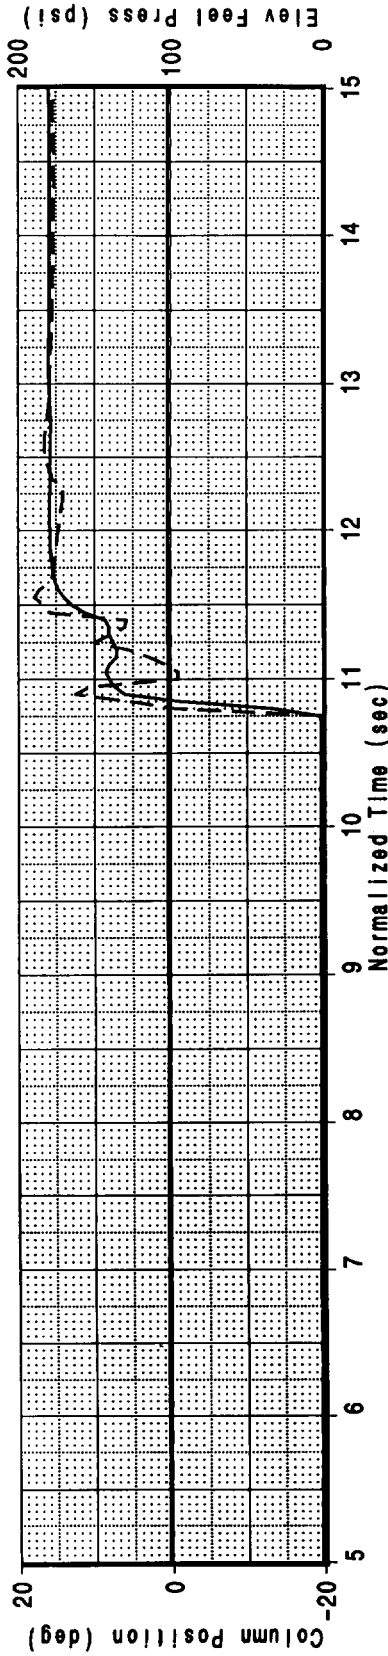
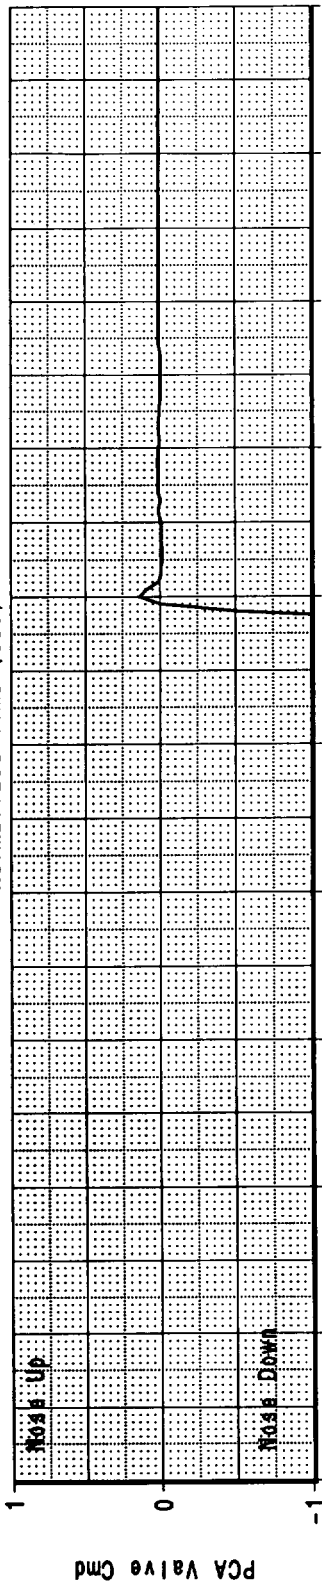
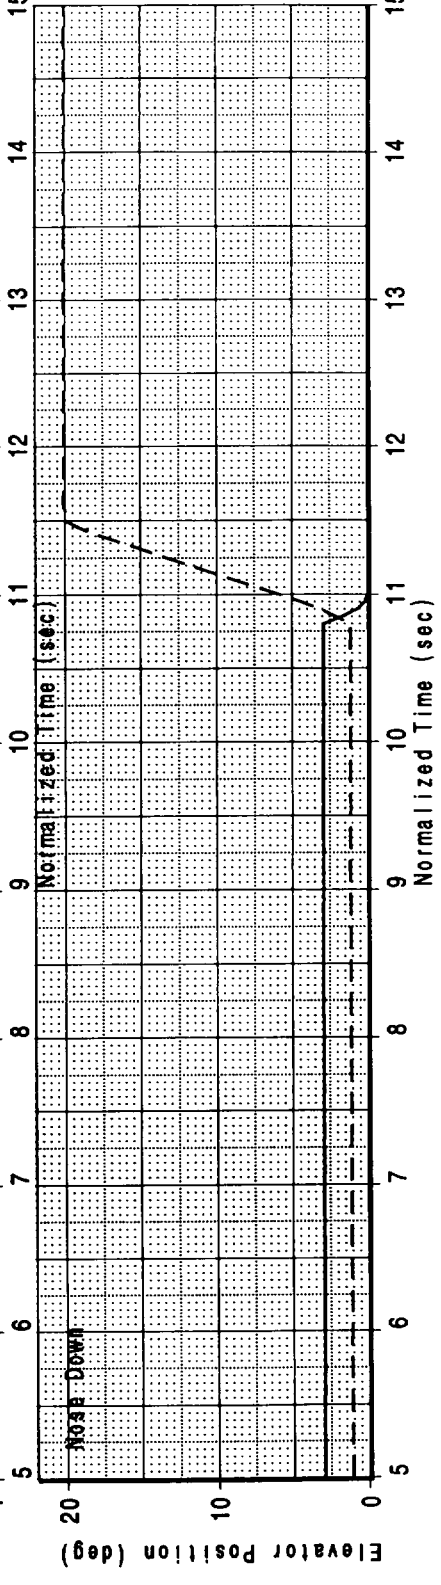
PAGE	767-400ER			
	VO001			
	BE328-000-152			
	FIG 4 REVA

This theory does not explain why the "two-step" movement does not occur during the dual disconnect ground test. There is insufficient data to understand the different characteristics between the disconnect failures and the jam scenario failures. It should be pointed out that the condition shown in Fig 4 RevA would not be expected to exhibit the "two-step" characteristic because the left hydraulic system (pressure to the outboard/non-failed PCA) was turned on after the surface position had already traveled to the full nose down position.
