**NATIONAL TRANSPORTATION SAFETY BOARD
WASHINGTON, D.C**

**METALLURGY / STRUCTURES SEQUENCING GROUP
CHAIRMAN'S
REPORT OF INVESTIGATION**

**Supporting Documentation for
OVERALL BREAKUP SEQUENCE
Materials Laboratory Report No. 97-38**

Appendix B: Detailed Rationale

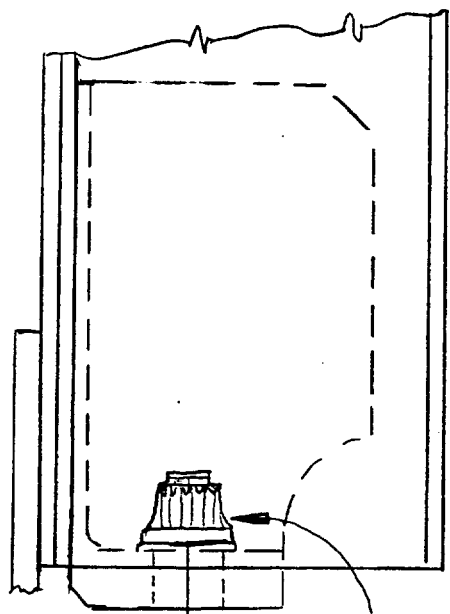
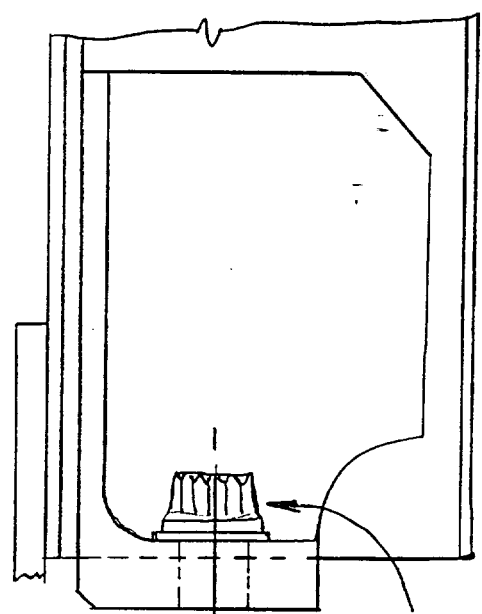
NUT STILL
IN PLACE
WITH BOLT
THREADS

NUT STILL
IN PLACE
WITHOUT
BOLT
THREADS

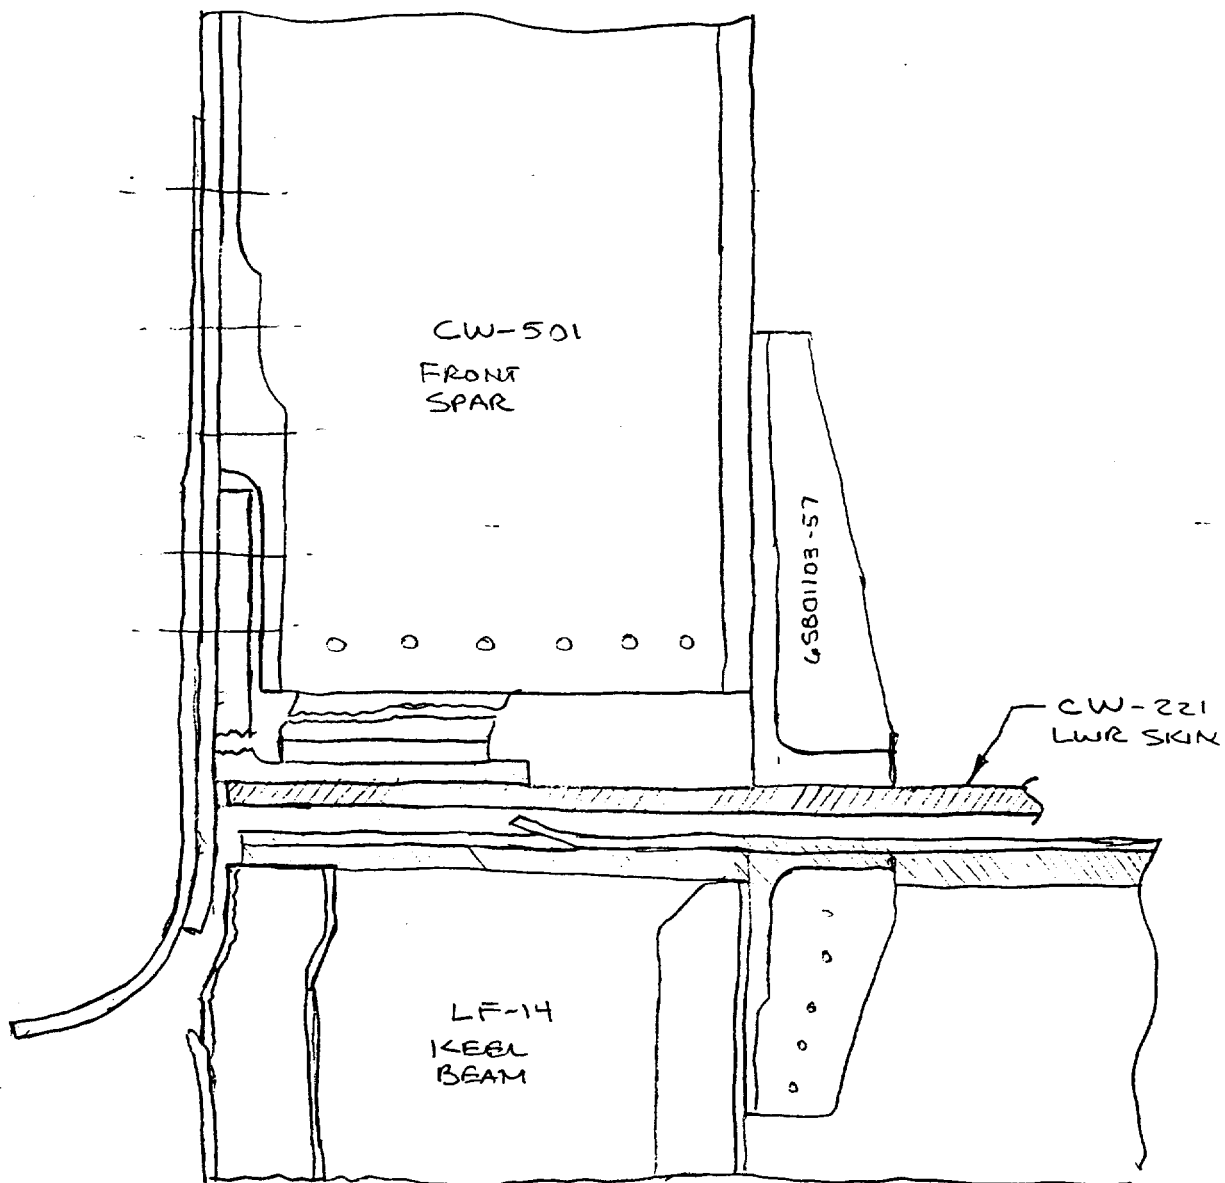
FIGURE B-10

FRONT SPAR AND KEEL BEAM INTERFACE

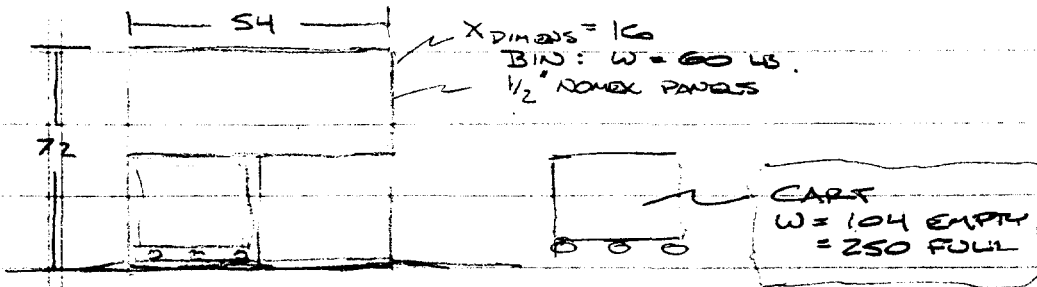
STORAGE BIN BASE PLATES:

THIS AGREES EXACTLY WITH THE MFR. DATA FOR PRES. REQD. TO CREATE THE DEFORMATION OBSERVED IN THE BASE PLATES, AND CAN BE CONSIDERED AS VALID IF THE ASSUMED DESCENT OF 7 FT BELOW THE WATER SURFACE IS VALID. ON THE BASIS OF OTHER OBSERVED WATER ENTRY BEHAVIORS, THE ASSUMPTION IS JUDGED TO BE APPROXIMATELY CORRECT, AND IT DOES RESULT IN THE EXPECTED RESULT FOR THE BASE PLATE.

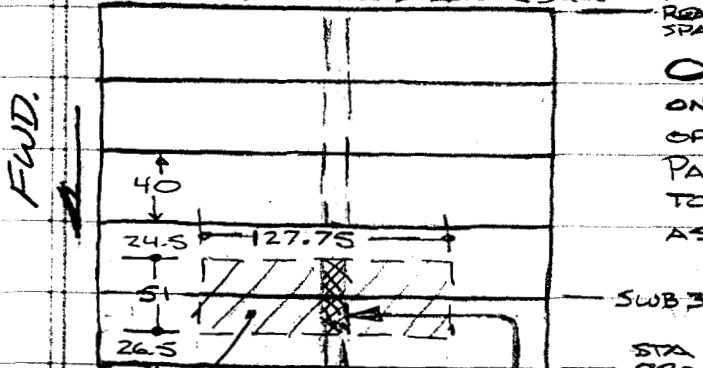
VIEW LOOKING DOWN WCS LOWER SKIN

OVERPRESSURE IN WCS TANK PUSHES DOWN ON LOWER SKIN & CAUSES TENS. SEPARATION OF SWB 3 LOWER CHORD FROM SKIN (SEE P. 12). PART OF THE UNSUPPORTED BAY LOAD IS DISTR. TO KEEL BEAM & IS DISTR. TO PRES. BLKD. AS SHOWN ON P. 11 [$V_{PRES. BLKD.} = 63.6K$]

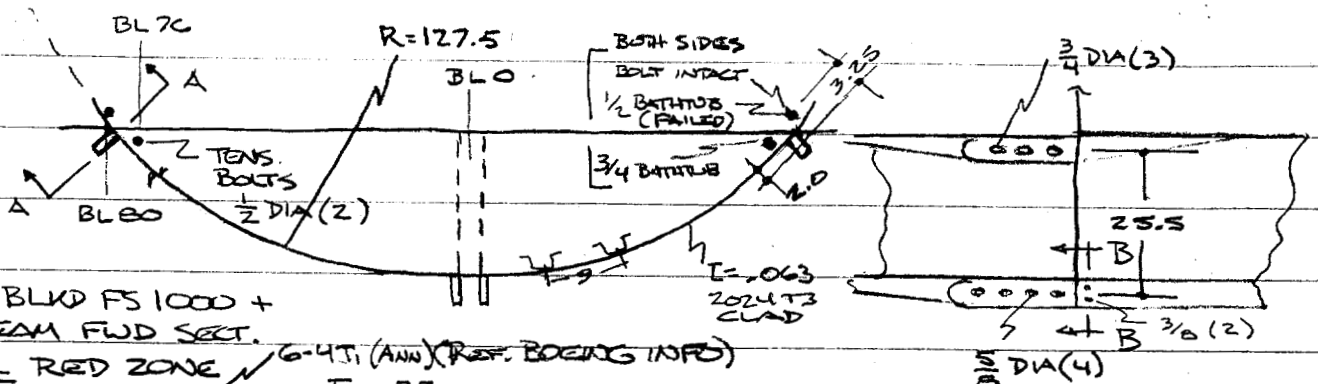
VIEW LKNG AFT ~ LOWER BLKD FS 990

LFGA, BLKD FS 1000 + KEEL BEAM FWD SECT. ARE ALL RED ZONE

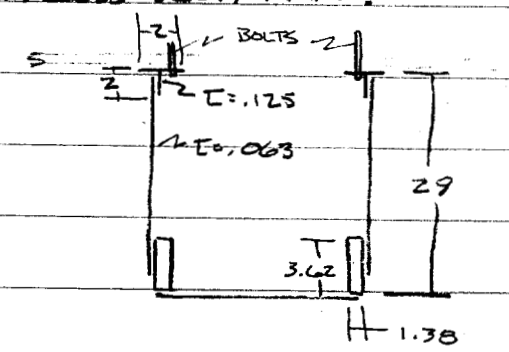
TOP CROSS-SECT. A-A :

*** NUTS STRIPPED [2 OF 4 1/4" / 2 OF 2 1/2"]

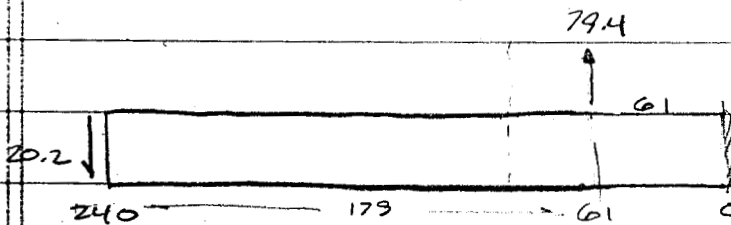
$$V = 79.4 \left(\frac{61}{240} \right) = 20.2$$

$$M = 20.2(179) = 3612$$

KEEL WILL FAIL BEFORE THIS BOLT GROUP FAILS!

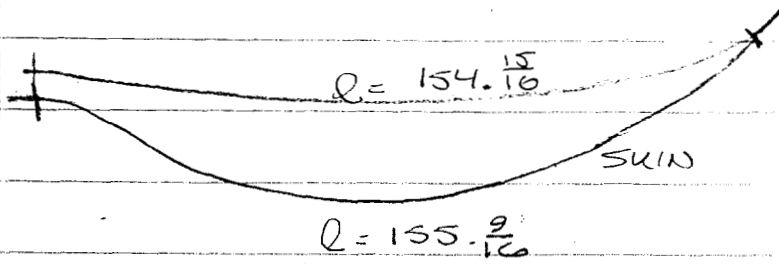
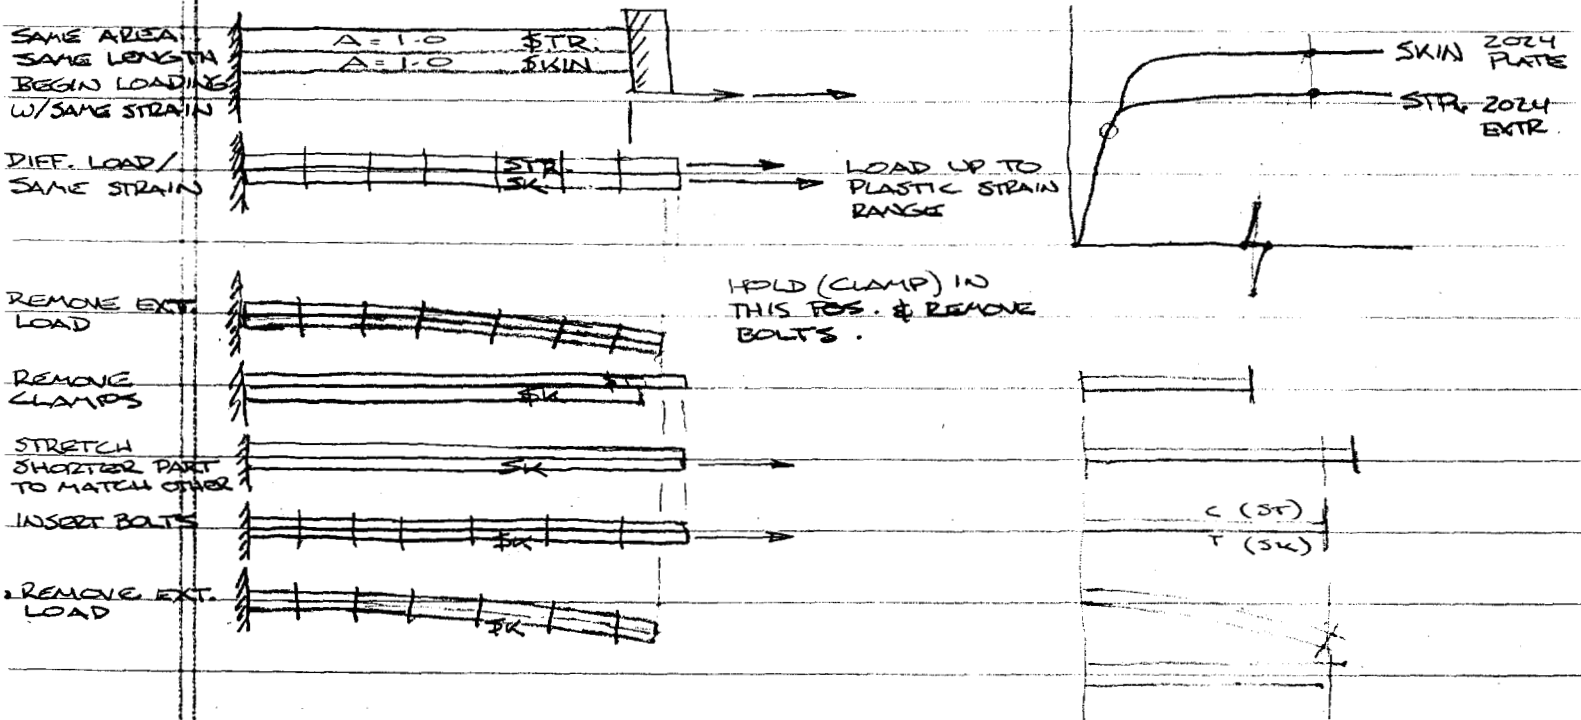
RHS LOWER SKIN/STRINGER DEFORMATIONS :

155.562 SKIN
154.937 STR
.625

$\epsilon = \frac{.625}{155} \approx .004$
 $f = .002(10^7)$

THE ABOVE OBSERVATIONS DESCRIBE THE EXPECTED CONDITION OF A BOLTED COMBINATION OF 2024 PLATE (SKIN) & 2024 EXTRUSION (STRINGER) AFTER EXPOSURE TO UNIFORM TENSION STRESS INTO THE PLASTIC RANGE WHILE RESTRAINED TO FOLLOE EQUAL STRAINS IN BOTH PARTS.

THE CONDITION FOUND @ THE RHS LOWER SKIN (WS 382 @ FRONT) WAS AS SHOWN ABOVE WITH THE STRINGER SEPARATED OVER A LENGTH OF 155 IN. THE SKIN ELEMENT WAS LONGER THAN THE STRINGER, INDICATING THAT THESE PARTS DID NOT ARRIVE AT THE OBSERVED STATE AS A RESULT OF UNIFORM TENSION INTO THE PLASTIC RANGE WHILE ACTING AS PART OF THE INTACT WING WITH APPLIED WING BENDING LOADS. [FOR THIS LOCATION]. OTHER LOCATIONS EXHIBIT DIFFERENT CONDITIONS OF THE SKIN/STRINGERS WHICH COULD SUPPORT THE BOEING VIEW THAT THE WING WAS YIELDED BY BENDING INTO THE PLASTIC RANGE.

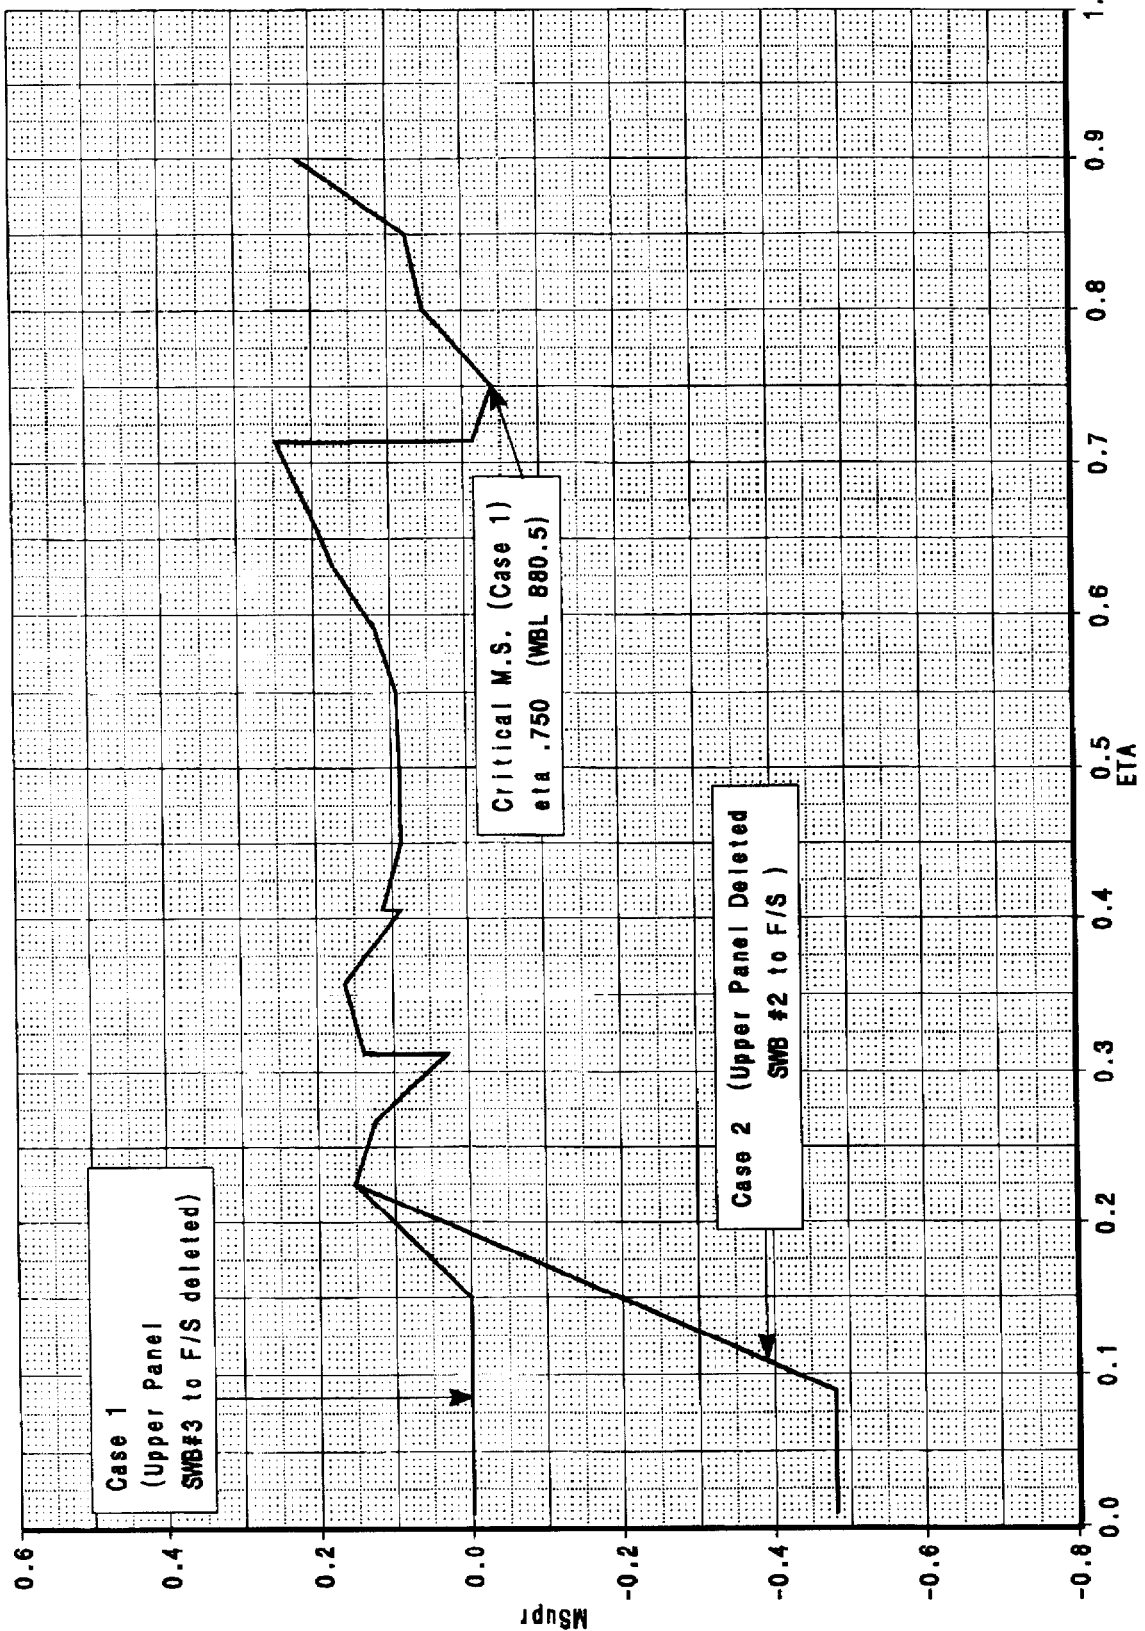
FIGURE E-1

The computer model was adapted to simulate the failure of SWB #3 and the front spar as described in Sections 4.10 and 4.11. For the purpose of these analyses a sustained overpressure of 25 psi was assumed in the wing center section. This number was selected because it is somewhat higher than the minimum breaking strength of center section spanwise beams which would make it reasonably representative of a fuel-air combustion minimum overpressure. The fuselage was pressurized to 4 psi cabin pressure differential.

The model confirms that the mass of the potable water tanks will impede the forward motion in the center region of the front spar under overpressure loading. Failure of the remaining upper chord and web at LBL 66 and RBL 66 would be the expected result from the model. The model was then run with the front spar and lower bulkhead webs fractured at LBL 66 and RBL 66. Figure E - 1 shows the predicted fuselage ring chord and skin stress in the hoop direction to be approximately 60 KSI. This would therefore exceed an allowable stress of approximately 55 KSI resulting in a predicted net tension failure of the fuselage at S-40 (BL 66).

Failure Initiation; Fuselage Lower Lobe

- ① Keel Beam overpressure related loading still present in lower pressure bulkhead (RELATED TO ASSUMED 25 PSI)
- ② Load reaction is concentrated in ring chord and adjacent fuselage skin at RBL 66 and LBL 66 where web has failed
- ③ Ring chord and adjacent fuselage fail in net tension at RBL 66 (S-40R) 60 KSI PREDICTED 55 KSI ALLOWABLE
- ④ Fuselage crack propagates forward to access door opening at STA 810

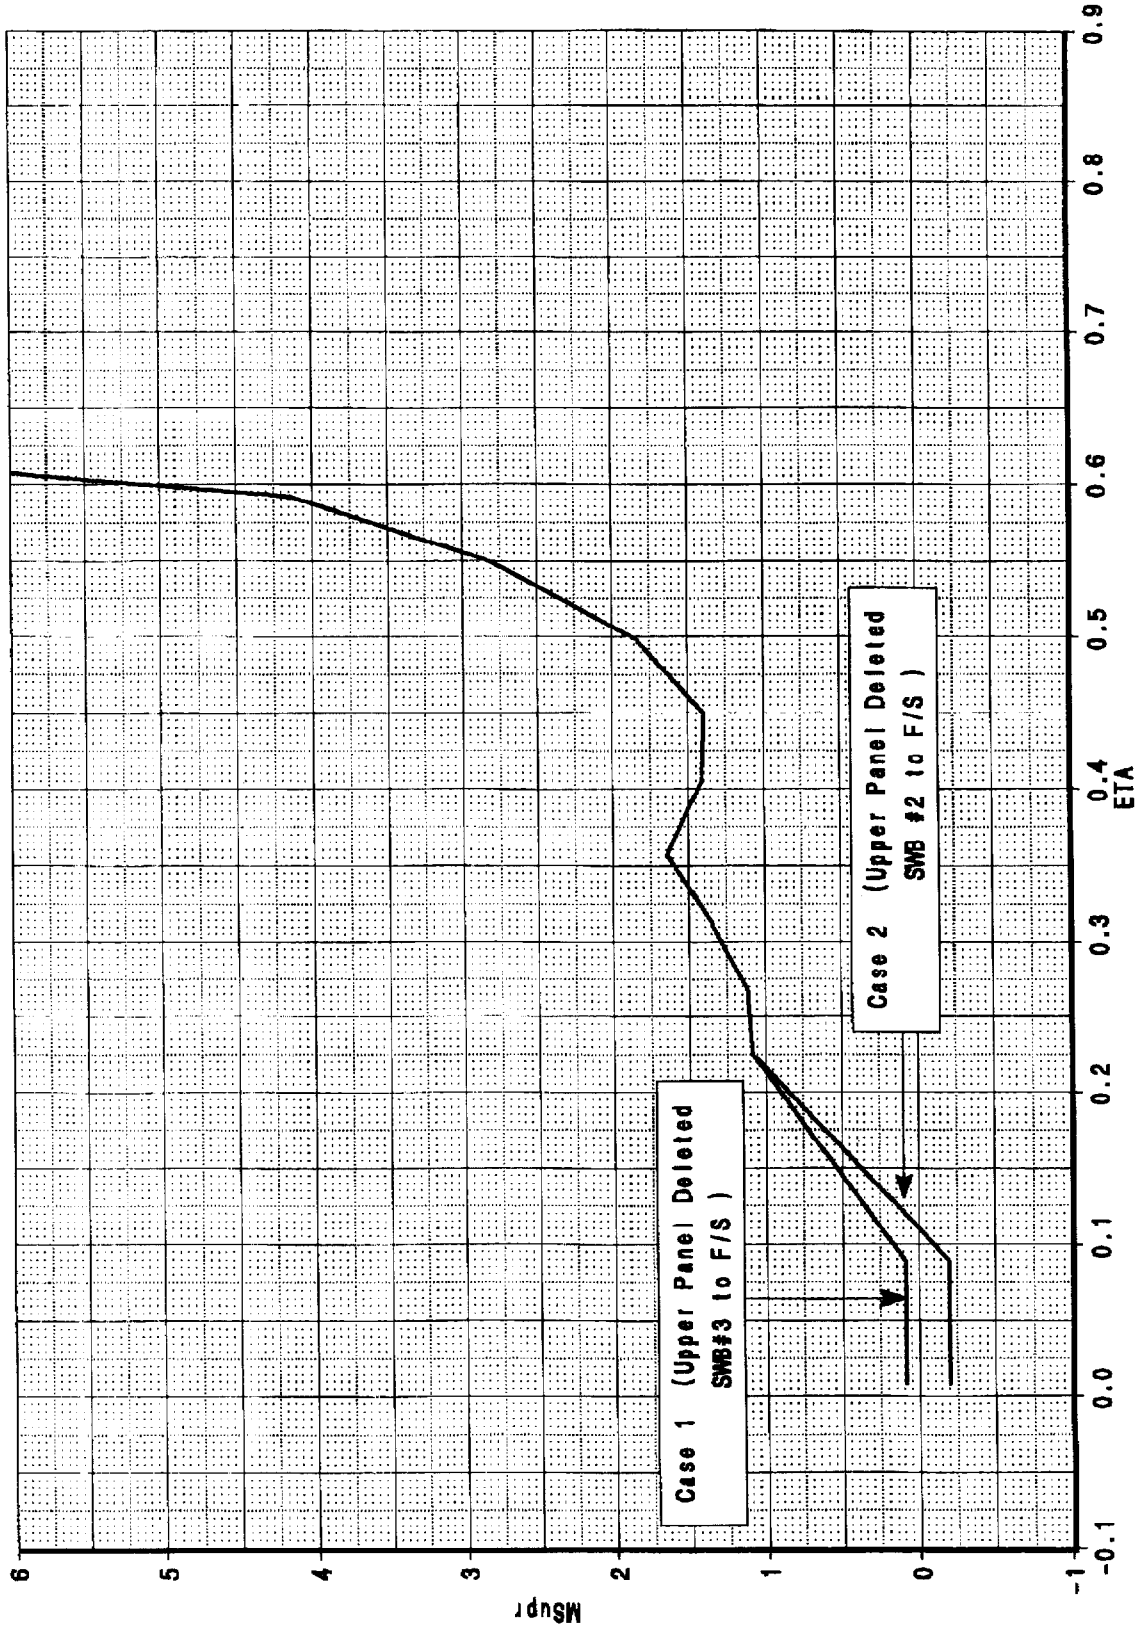
FIG E-3

With the aerodynamic loading assumptions modified to account for the wing tip removed the analysis was then rerun to determine if it is still rational to expect the center wing box to fail after the tip is gone. Figure E - 3 shows the results of this analysis illustrating that the wing upper panel would buckle if the damage was somewhat more severe than the minimum level of "Case 1". This loading case represented a further increase in load factor of approximately 1 "g" over and above the flight condition which resulted in the prior wing tip failure. The two wing bending analyses (tip on and tip off) do appear to support the premise that SWB #2 was still sufficiently intact to provide substantial support to the wing upper panel. This would be consistent with localized damage to only the mid-portion of the beam due to keel beam separation.

747-100
 Maximum Wing Load Tip Off
 Margins of Safety - Upper Panel

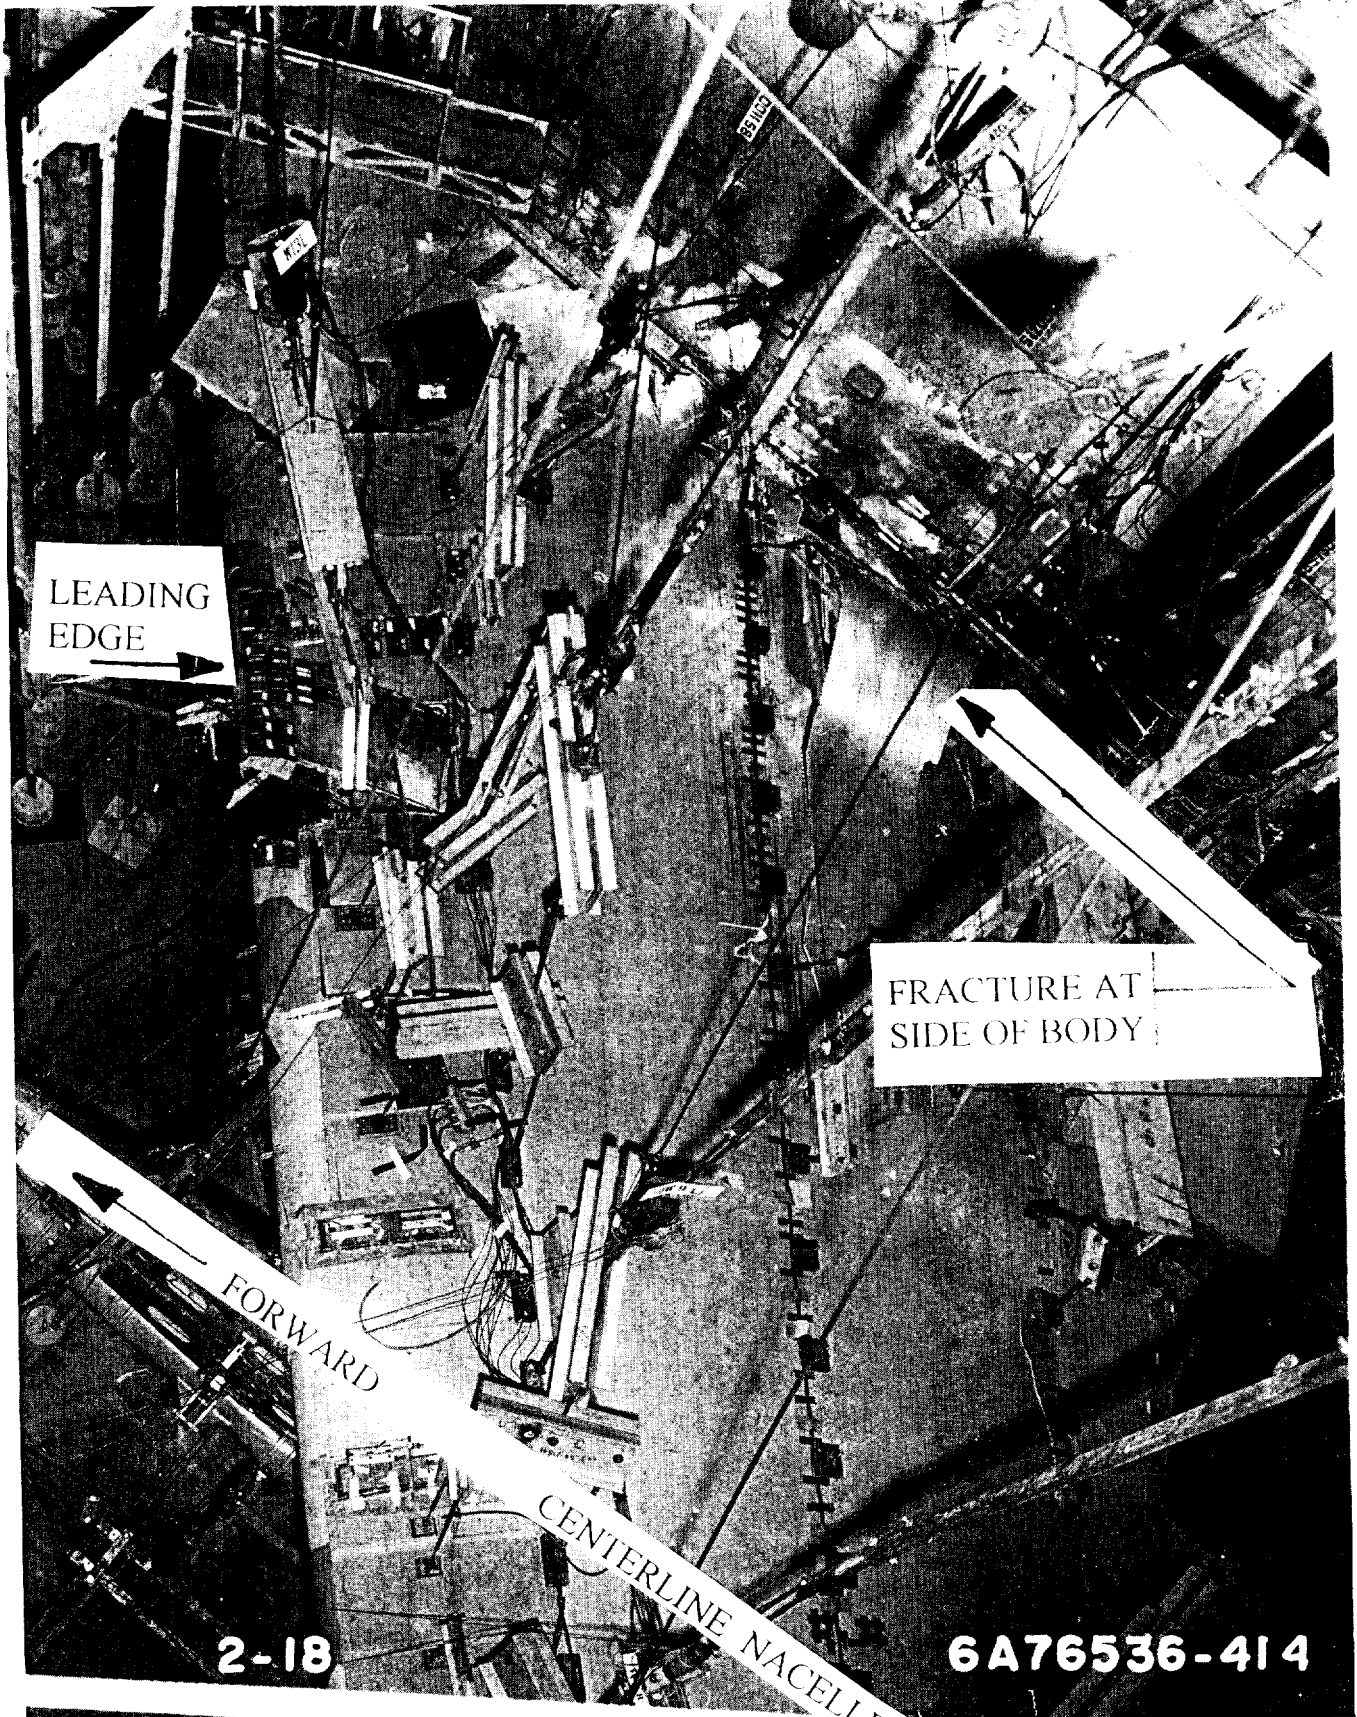
As another check on the relative wing bending strength of the wing tip region versus the center section the original 747-100 static test airframe wing destruction test was reviewed. In this test the primary failure was upper panel compression buckling just outboard the left side of body. However there was also a secondary failure a fraction of a second later at (also upper panel compression buckling) at WS 1196 just outboard the #1 nacelle. A photo of the side of body failure is provided as Figure E - 4 and a photo of the wing tip failure is provided as Figure E - 5. Both photos are looking at the top of the left wing. The failure at the wing tip area on the test airplane is almost identical in location and type to those documented for left and right wing on Flight 800.

overpressure damage the upper panel buckling initiation would move from just outboard the side of body to just inboard (as documented near the left side of body on Flight 800). The fact that the initial wing failure on Flight 800 was biased toward the wing tip versus the compromised center section can still be explained by the respective wing loadings of the test airplane versus Flight 800. The most significant difference relates to loss of lift on the inboard wing of the Flight 800 airplane due to the aerodynamic inefficiencies associated with the missing forward body and wing to body fairing.

FRACTURE AT
SIDE OF BODY

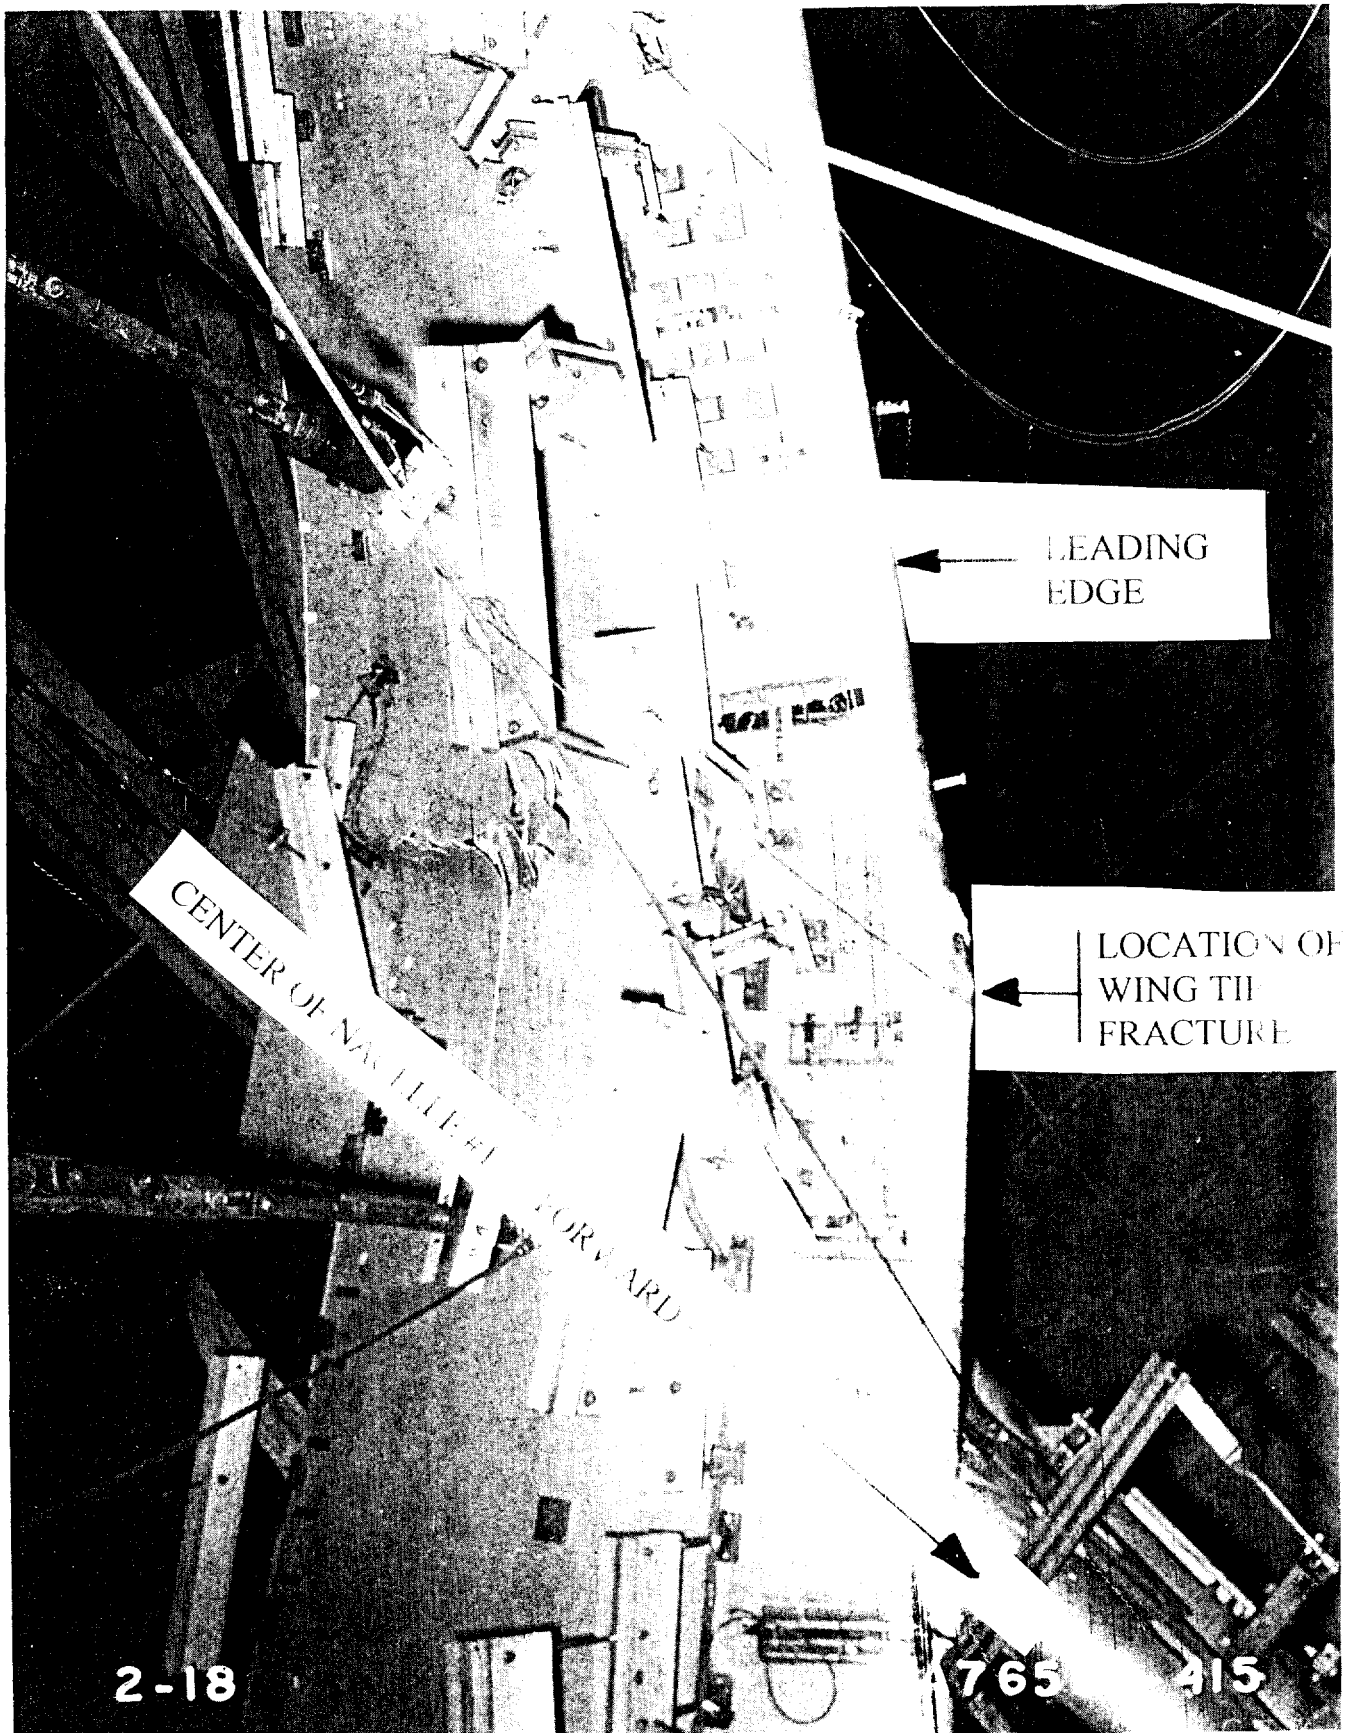
The analysis concluded that at a high angle of attack and approximately 5.5 to 6.0 "g" load factor the wing tips would fail while the wing center section with the lesser level of damage would continue to carry the predicted loads. Figure E - 2 shows the margin of safety for the upper wing panel in compression (up bending) buckling versus wing percent span. As the figure shows, the margin of safety just outboard of the outboard engine is minus four percent.

LOCATION OF WING TIP FRACTURE
