PIAGGIO AERO INDUSTRIES S.p.A.

SERVICE BULLETIN (MANDATORY) N.: SB-80-0262 REV.3 ATA CHAPTER: 55-20

TITLE: P180 - HORIZONTAL STABILIZER TO ELEVATOR HINGE FITTING - INSPECTION AND MODIFICATION

Rev. N. **3** Date: **November 14, 2011**

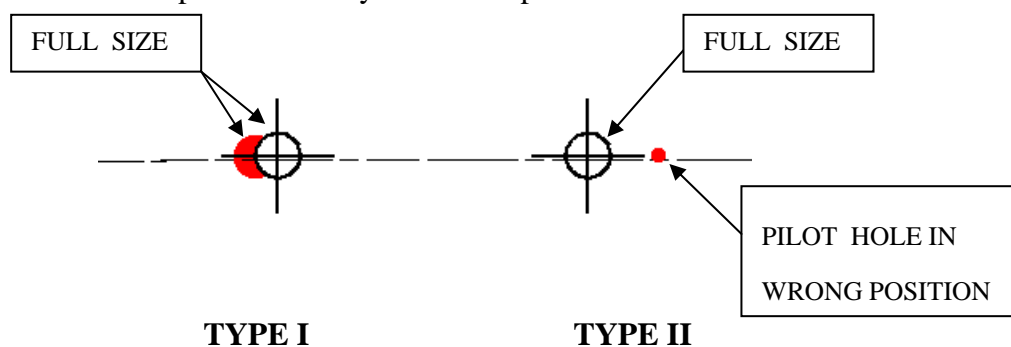
TYPE II: 2.5 mm pilot holes that are drilled in the wrong position (see also figure 3)

NOTE: The pilot holes may be found open or covered with conductive sealant

- 8b If defect (TYPE I or TYPE II) is covered clean it from any residual of sealant and other debris
- 8c Verify there are no other defects around holes in the rear spar flanges (upper and lower flange)

- 8e If the defect is as TYPE I or TYPE II and (for TYPE II only) complies with the previous step 8d, no repair is needed except the cleaning of the defects.

- 8f Take a picture of the holes, measure their dimension (diameter) and position. Fill in the Failure report form as per latest issue of Service Letter 80-0097 latest revision.

- 8g Send the Failure report to Piaggio Aero Industries

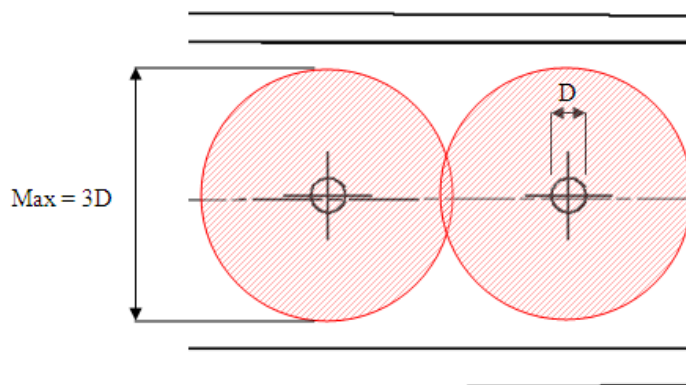
- 8d Only for defect TYPE II, verify that the position of the defects is within 3D from the main holes (D is the diameter of the main holes) . Nominal value of D=.199 - .202 in.
